## CHAPTER EIGHTEEN

### Hurricane Alicia Storm Surges And Shore Processes

#### Abstract

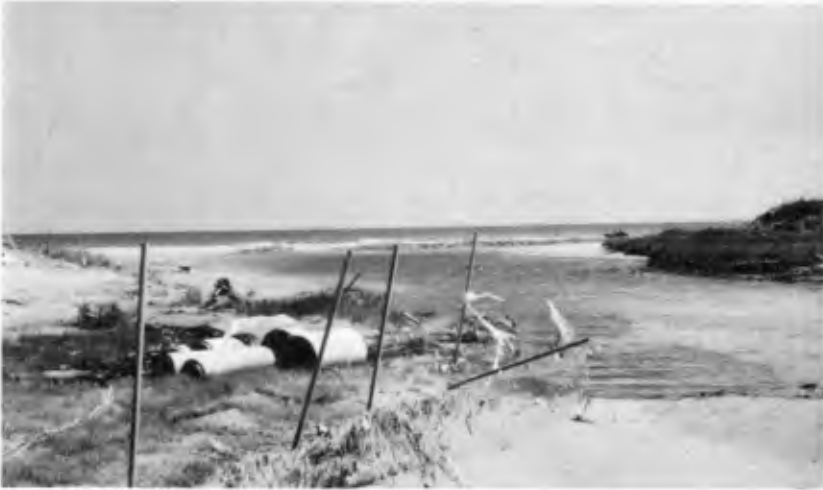
Figure 3. View toward Gulf showing channel cut by overtopping Gulf water on East Beach. Note vegetation along back of beach, showing cut did not extend through beach, and beginning of outwash fan that forms the landward end of the cut.

Along the front of East Beach, the beach was overtopped by 2 to 4 feet (0.62 to 1.24 m) of water which then flowed landward toward the seawall. When the overtopping water reached the seawall, it turned eastward and ran over the shoreward part of the north jetty into Galveston Inlet. The higher dunes on the front of East Beach were not overtopped, but were partially eroded while acting as headlands that created accelerated flow and scour channels in low areas between dunes (Figure 3). Observations along the front of Galveston Island west of the seawall showed that the front of the island had been overtopped by a foot (0.31 m) or more of water along most of the island length. Two areas not overtopped, a half-mile (0.8 km)

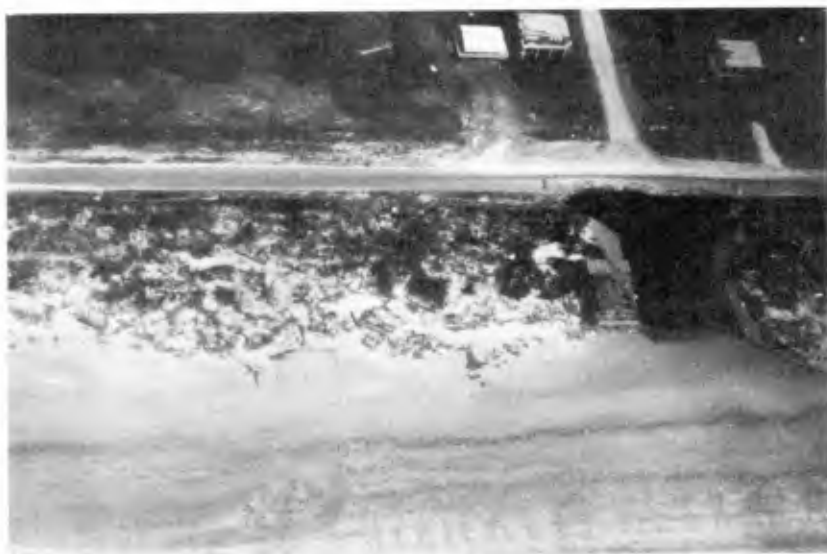
Figure 4. Aerial view of cut formed by Gulfward flowing water on Follets Island.

Follets Island is immediately west of Galveston Island across San Luis Pass. Only the eastern eight and one-half miles (13.7 km) of this island were covered by the ground survey. In this area, flow evidence was remarkably consistent - water flowed only from the bays toward the Gulf. Maximum water elevations in the bays were about 10 feet (3.05 m) or more. Maximum water level evidence consisted of debris lines on the bay side of the dunes at distances of 1.5, 2.0, 4.5, 7.5 and 8.5 miles (2.4, 3.2, 7.3, 12.1 and 13.7 km) from the eastern end of the island and a stranded houseboat between the highway and the dunes fronting the Gulf at the 4.5 mile (7.3 km) point. Evidence for flow direction was the location of debris lines on the bay side of the dunes, the location of the grounded houseboat and the characteristics of several cuts through the dunes and body of the island between the highway and the Gulf (Figures 4-6).

These cuts started at the beach and ended seaward of or at the highway; however, one cut extended completely through the highway and other cuts ended in the highway pavement (Figures 4 & 6).

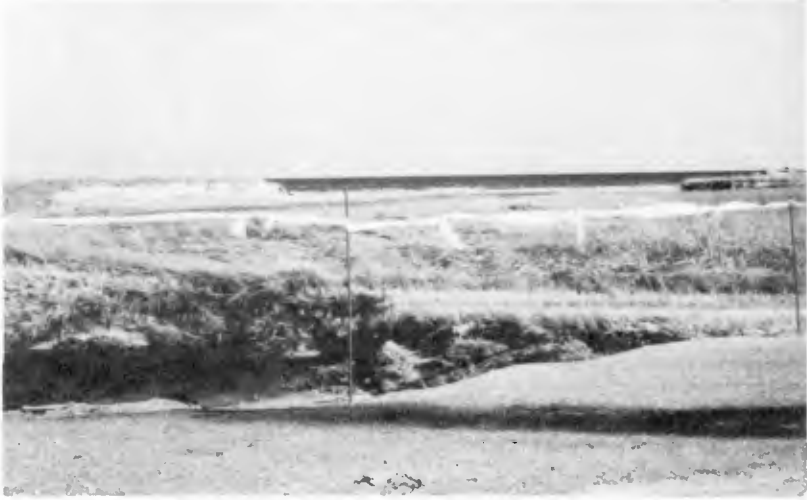
Figure 5. Gulfward view of Follets Island cut showing erosion of dunes behind beach. Highway pavement is in foreground.

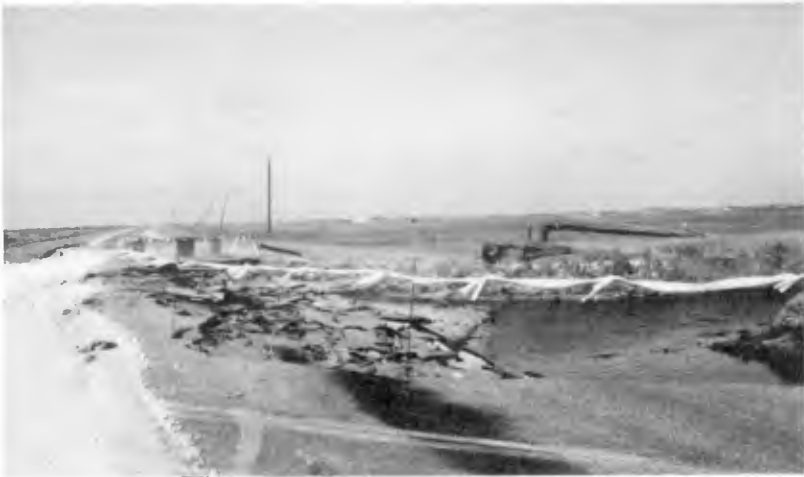
Figure 6. Landward end of a Follets Island cut showing undercutting of road pavement.
