CHAPTER ONE HUNDRED THREE

BEACH RESPONSE TO COASTAL WORKS

GOLD COAST, AUSTRALIA

H.V. Macdonald* and D.C. Patterson*

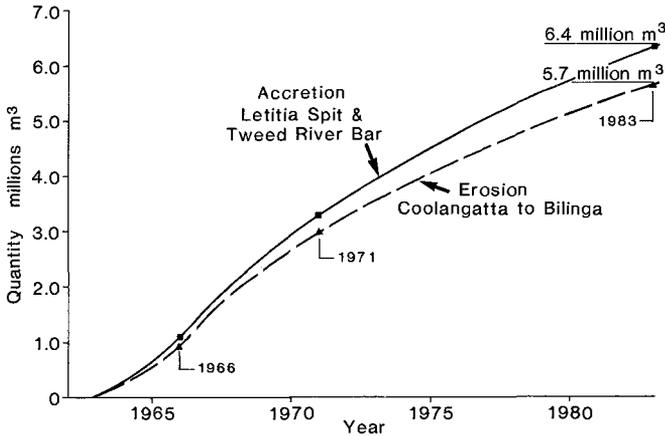
Figure 6. Time History of Updrift Accretion and Downdrift Erosion Resulting From Tweed River Training Walls.

The time history of total accretion, including that along Letitia Spit and in the new entrance bar, is shown in Figure 6, reaching a total of 6.4 million cubic metres in 1983. The accretion trend indicates that further sand accumulation in this area can be expected, although the rate of such accumulation should decrease as the rate of natural sand bypassing to the Gold Coast beaches increases.

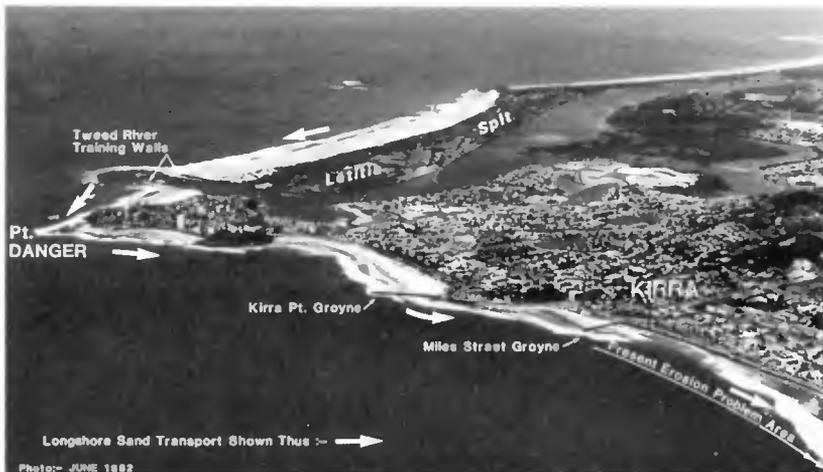
The Tweed River training walls have trapped on Letitia Spit 6.4 million cubic metres of sand that would otherwise have moved northward to the Gold Coast beaches. The construction of groynes at Kirra in an attempt to overcome the resulting beach erosion problem has further interrupted the flow of sand, and has moved the problem area further north.

The groyne works undertaken in this region are shown in Figure 3 and include the Tweed River training walls (aimed at improving navigation to the river) and groynes at Kirra (aimed at offsetting erosion caused by the training walls). The river mouth was trained originally around 1900, however the strong longshore transport subsequently re-established the entrance bar. The training walls were extended a further 400 metres during 1962-1964 by the New South Wales Government.

Groynes interrupting the net longshore sand transport have trapped sand on the updrift side and caused an equivalent quantity of erosion on the downdrift side. The extent and time scale of these effects depends on the effective length of the groyne and the total longshore transport intercepted by the groyne. It is apparent that the effective groyne length of river training walls is greater than for equal length groynes on a continuous beach, presumably because of the additional effects of the river flow. Entrance bar development may add significantly to the total quantity accumulated by such training walls, as appears the case at the Tweed River. The quantity of sand accumulated by these walls now exceeds 6 million cubic metres.

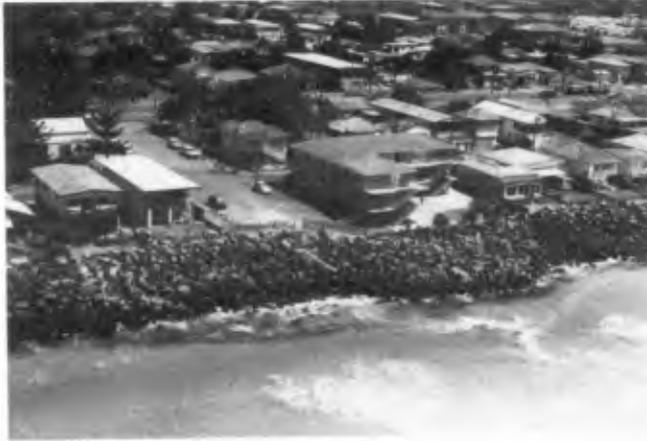
Palm Beach in 1980 with residential development protected by rock seawall and no usable beach.

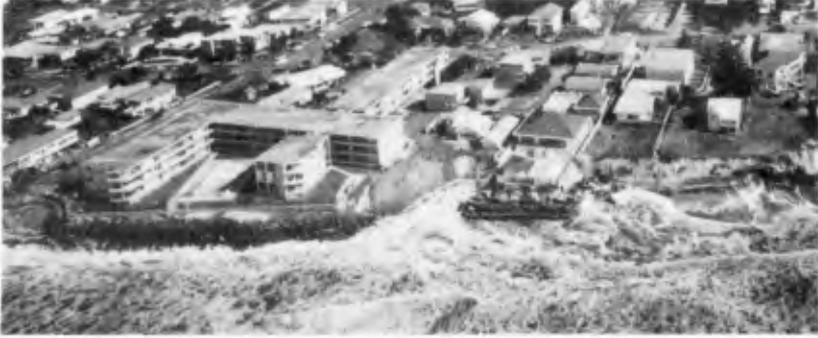
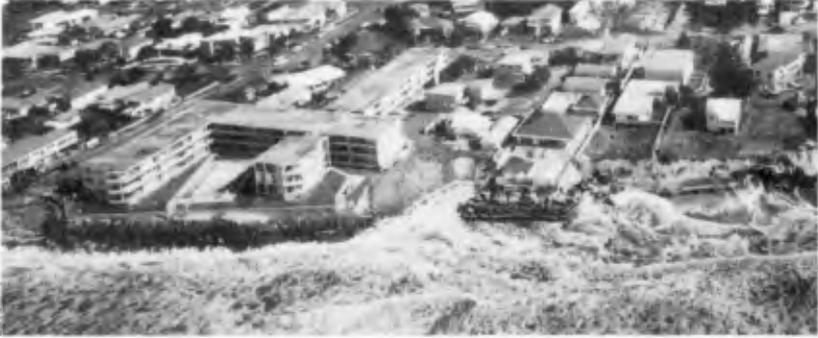
All of the Gold Coast beaches were substantially eroded by cyclones in 1967. Severe problems were experienced where development was located close to the beaches, such as in the Surfers Paradise area (pictured).

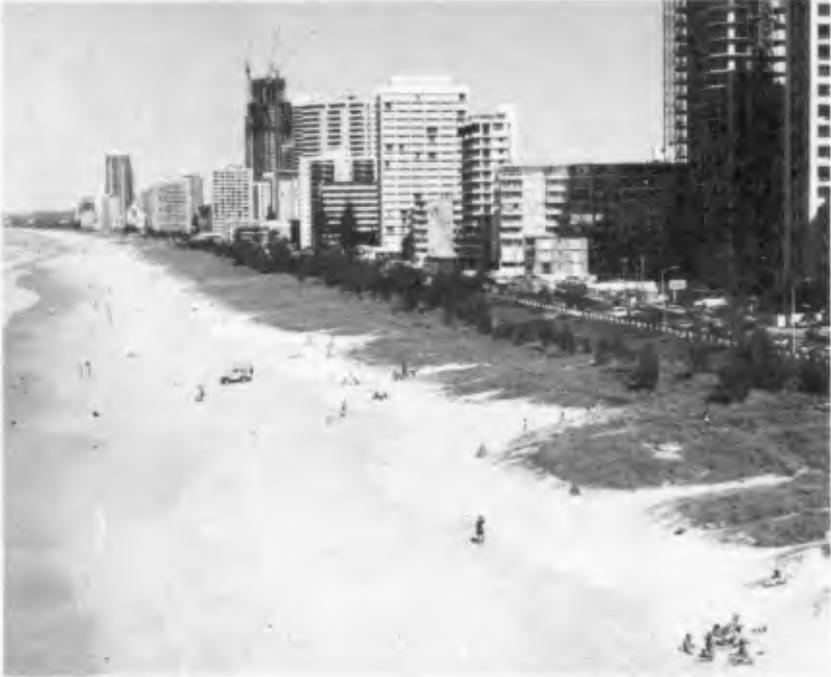
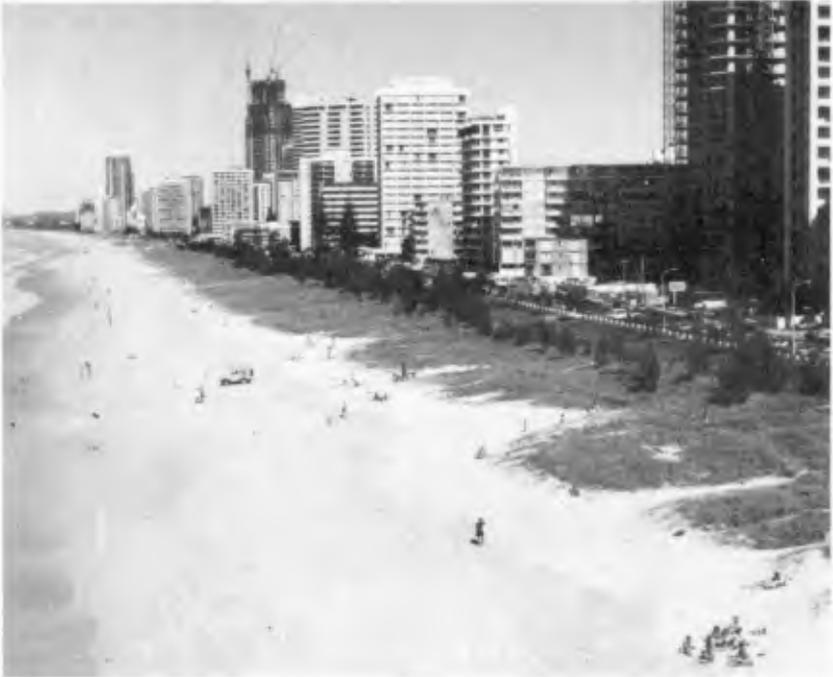
Beach nourishment to Surfers Paradise in 1974 has established a new beach and dune system in front of the seawall. The photo shows the beach in 1983 in good condition.
