## CHAPTER ONE HUNDRED TWENTY NINE

Offshore Breakwater, Wheatley, Ontario

G.T. Beaulieu<sup>1</sup>, M.G. Skafel<sup>2</sup>, W.F. Baird<sup>3</sup>

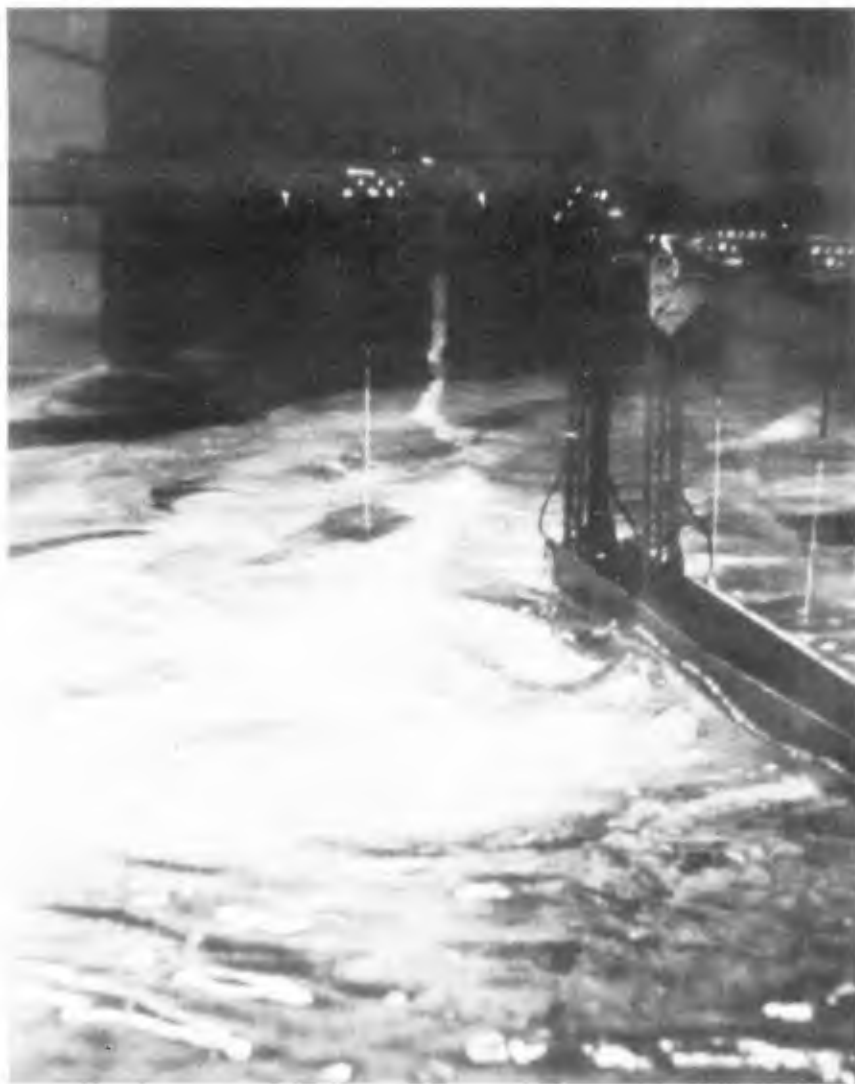
Figure 4. Breaking Wave at Harbour Entrance, Model.

The model tests, combined with the wave climate, indicated that severe breaking wave conditions could be expected during four storms in an "average" year. This conclusion was verified in discussion with the local fishermen. Reproduction in the model of the severe breaking condition is shown in Figure 4.

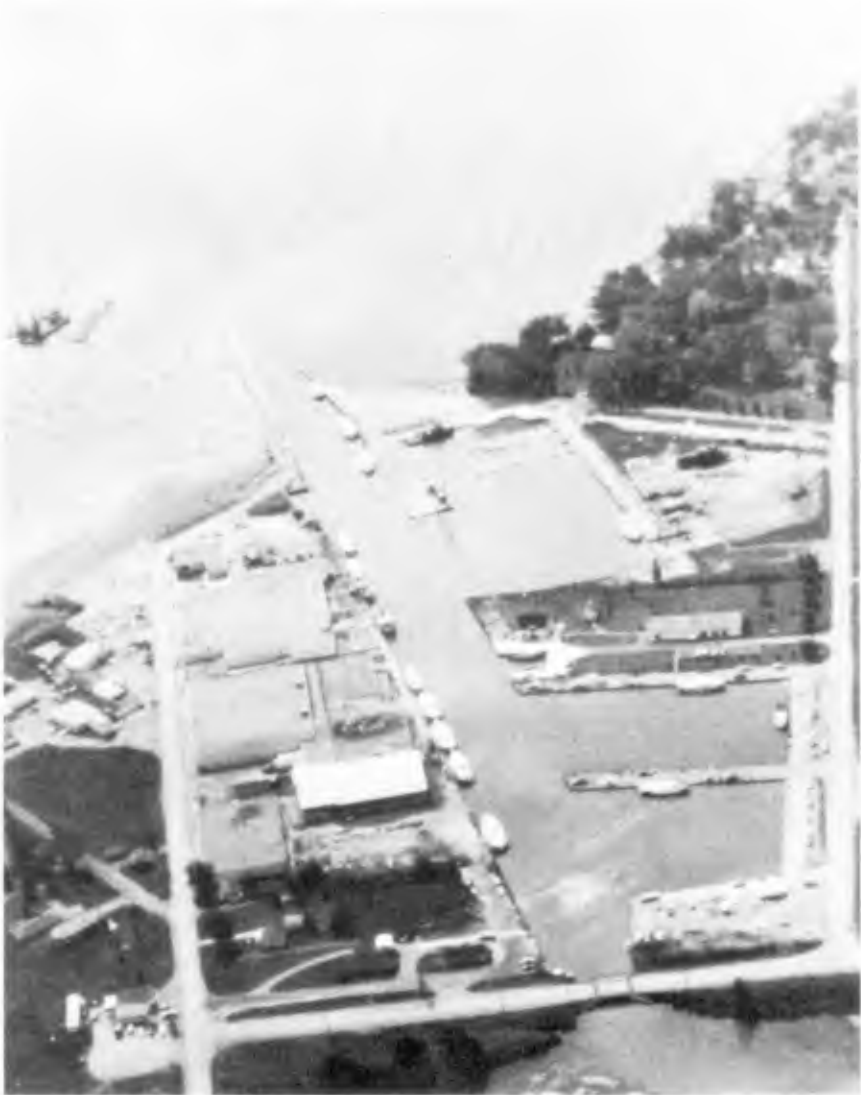
Figure 7. Oblique Aerial Photo of Wheatley Harbour.

A breakwater approximately 62 metres long was selected, located as shown in Figure 5 and Figure 7. It consists of a rubble mound core protected by two layers of armour stone. The core material is 22 kg to 360 kg shovel quarry run material, with 50 percent greater than 225 kg. The armour stone is 3.6 - 5.4 tonnes with 70 percent of the stone greater than 4.5 tonnes (Figure 6).
