## CHAPTER ONE HUNDRED FORTY

### EFFECT OF RIP CURRENT BARRIER ON HARBOR SHOALING

Tamio O. Sasaki\*, M. ASCE and Hiroshi Sakuramoto\*\*

#### ABSTRACT

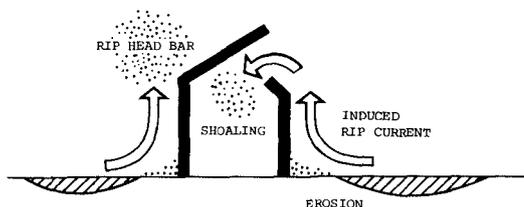
Fig. 1a Schematic diagram of induced rip current and harbor shoaling due to presence of a breakwater.

Two case studies are presented which demonstrate the mitigating effect of rip current barrier structures on the shoaling of small craft harbors. A rip current is a fast and narrow current that carries sediment offshore. One of the major reasons why harbor breakwaters and jetties cause beach erosion on adjacent beaches, offshore sediment loss to form rip head bars, and shoaling inside of harbors is the formation of rip currents induced by and adjacent to the structures (Fig. 1a). The construction of sand traps is often adopted as a protection measure where the longshore drift dominates, (e.g., at Channel Island Harbor, Bruno and Gable, 1976; Pointe Sapin Harbor, Pratte et al., 1982). However, the detailed functioning of a sand trap is not well understood, and a large amount of maintenance dredging may be necessary.

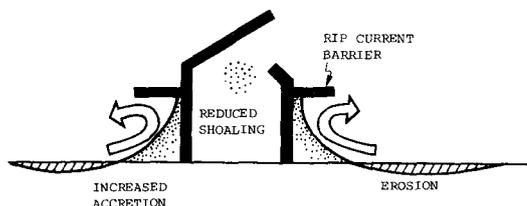
Fig. 1b Schematic diagram of a rip current barrier. Accretion at the feet of the breakwaters increased and shoaling in the harbor decreased.

The present paper focuses on the role of rip currents in the shoaling process, based on field observations. Then the rip current barrier concept to block rip currents is presented as a possible cost-effective solution (Fig. 1b). The study sites, Taito Katagai Fishery Harbors, are respectively located on the southern end and middle of the Kujukuri Coast, facing the Pacific Ocean (Fig. 2).

To mitigate harbor shoaling and sediment loss offshore, some control of rip currents is needed. A rip current barrier is defined as a shore-parallel structure that blocks the path of a rip current. It reduces the current velocity and turns the current direction shoreward to form a forced cellular circulation (Fig. 1b).

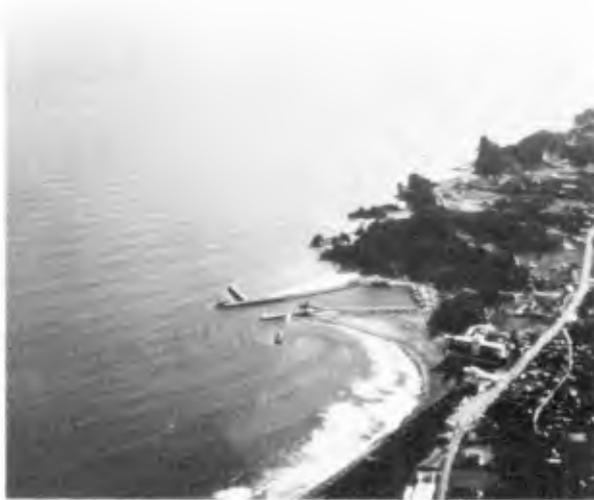
Fig. 3 Overview of Taito Fishery Harbor and the vicinity to the northwest.

Kujukuri Coast is a 55 km-long, very shallow coast bounded at both ends by eroding sea cliffs, Byobugaura and Taito Point (Fig. 3), 10 km and 2 km long, respectively. The average beach slope up to the 20 m depth is about 1/100. The dominant drift of sand is from both ends to the middle of the coast (Sunamura and Horikawa, 1977). The beach consists of fine sand (0.2 - 0.3 mm). The tidal range is 1.0 - 1.5 m.

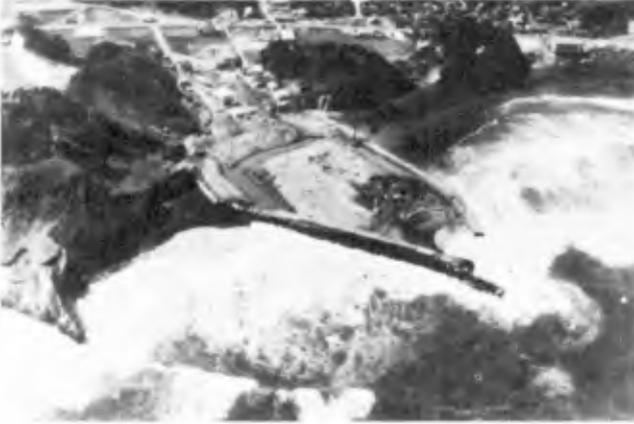
Fig. 4 Taito Harbor totally filled with sediment.

An extreme case of harbor shoaling occurs at Taito Fishery harbor (Figs. 3 & 4). Taito Fishery Harbor originally had two shore-normal breakwaters that extended about 150 m seaward. As seen in Fig. 4, the harbor was totally filled with sediment soon after construction. To recover harbor functioning, extension of the breakwaters and construction of "wing-like" breakwaters which stop rip currents from flowing directly offshore was tried (Figs. 5 & 6). As a result, accretion at the root of the north breakwater has increased and sediment shoaling has been mitigated.

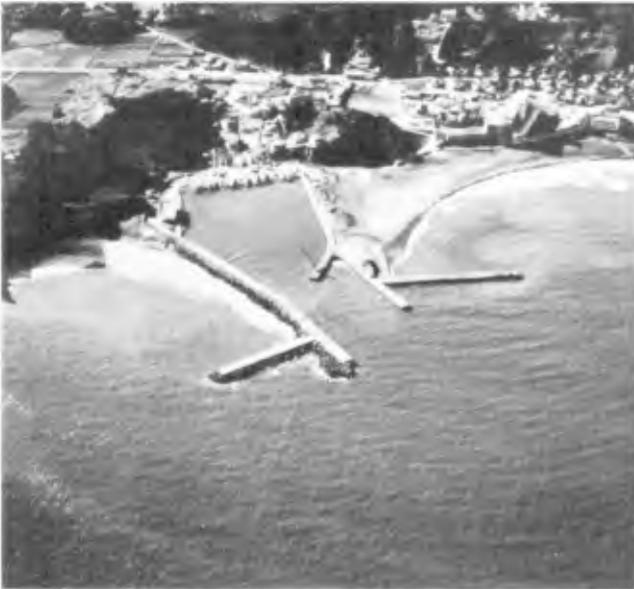
Fig. 5 Recovered Taito Harbor after rip current barrier construction.

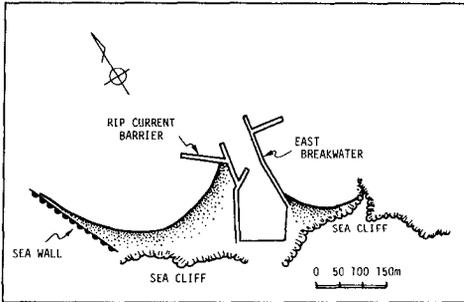
Fig. 6 Plan of Taito Harbor.

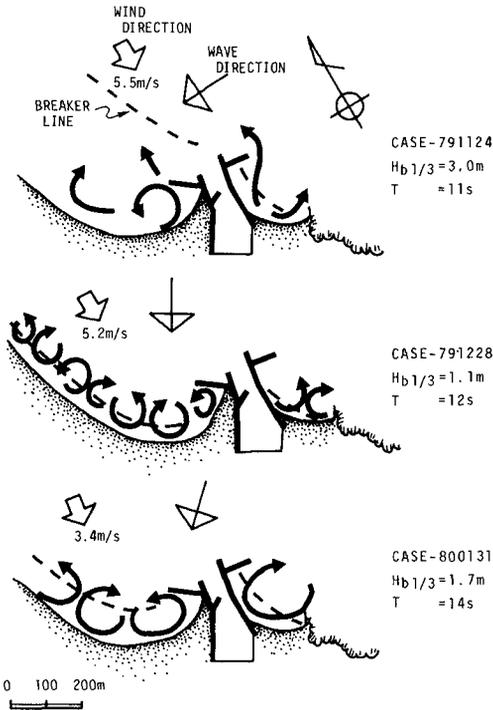
Fig. 7 Nearshore circulation patterns in the vicinity of rip current barriers.

Observations of the rip currents at the site were conducted in November and December 1979, and January 1980. The breaker heights were 3.0, 1.1 and 1.7 m, respectively. The circulation patterns shown in Fig. 7 were obtained from photographs of successive dye patch dispersion patterns (Fig. 8). The photographs were taken with a Hasselblad 500EL camera mounted on a hovering helicopter. A total of 10 - 20 kg of fluorescent dye was released at 6 - 12 points within and outside of the surf zone.

Several very regular nearshore circulation patterns and barrier-induced rip currents were found on the north side of the harbor during the Dec. 1979 and Jan. 1980 experiments (middle and bottom of Fig. 7). However, at the east side, a typical blocked rip current as shown in Fig. 1b was not found except in the Jan. 1980 experiment, due to the size and orientation of the south rip current barrier. In CASE-791124, the eastern rip current barrier was ineffective, and thus a rip current developed seaward. The wave height was large in this case, so that most of the harbor structures were inside the surf zone.

Field observations of the breakwater-induced rip currents at Taito Fishery Harbor under conditions of a 3 m breaker height suggest that if the barrier is outside the surf zone, it will be effective in blocking rip currents (Fig. 7). Field observations of induced-rip currents and sediment transport without a rip current barrier and of rip currents with a rip current barrier carried out at Katagai Fishery Harbor suggest that the rip current barrier is effective only under moderate wave conditions. Rip head bars under storm conditions were still formed after the rip current barrier construction.

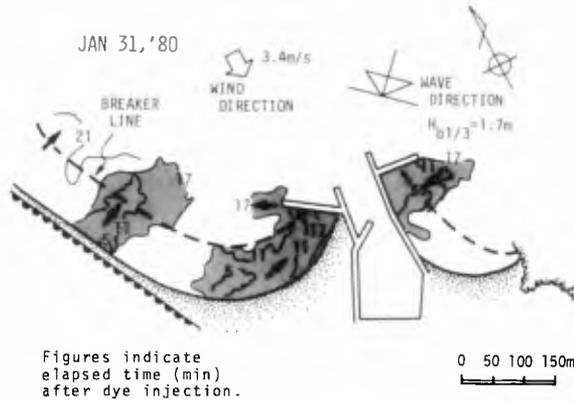
Fig. 8 Dispersion of dye patches around rip current barriers.

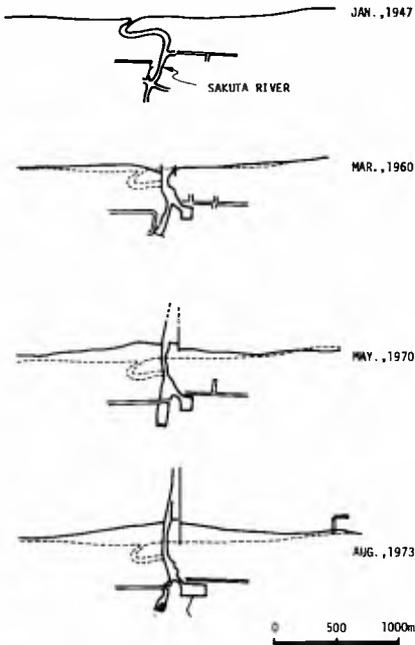
Fig. 9 History of shoreline evolution associated with jetty construction at Katagai Fishery Harbor.

Another example is Katagai Fishery Harbor, located about 30 km north of Taito harbor. Sediment transported alongshore on the neighboring beaches arrives at both sides of the harbor. Therefore, the entrance jetties had to be extended year by year before 1974 due to accretion (Fig. 9). The length of the jetties reached 600 m; the total entrance channel length is about 1 km. This harbor was originally built to have a common entrance with the Sakuta river. The annual rate of shoreline advance was about 6 m/year at both sides of the jetties. The annual rate of accretion estimated by Sunamura and Horikawa (1977) for the central part of the Kujukuri coast is  $494,000 \text{ m}^3/\text{year}$ .

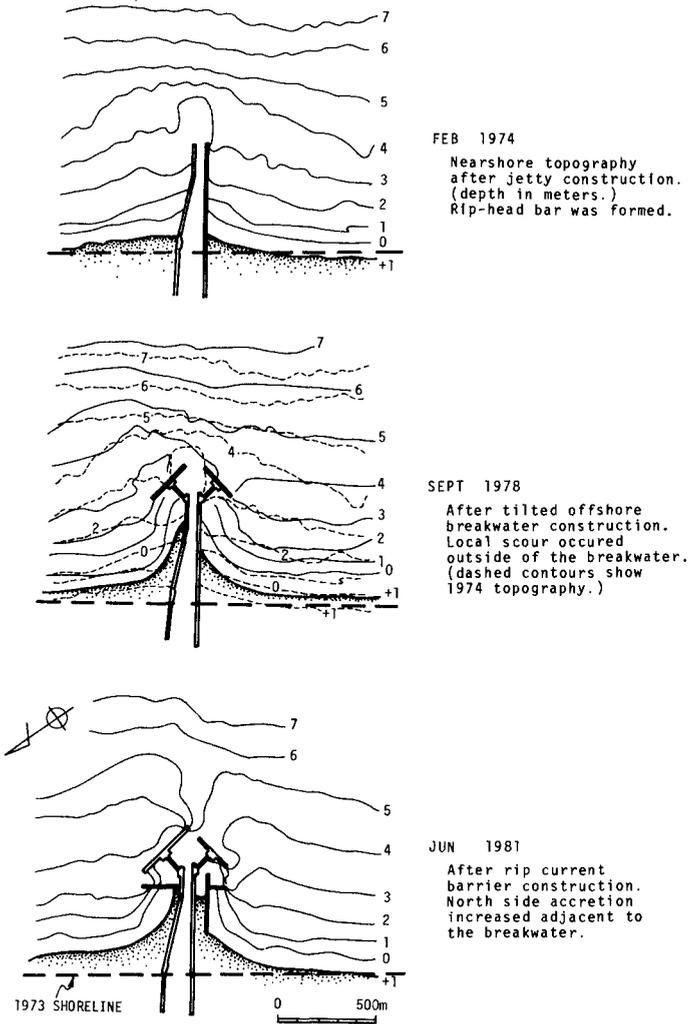
Fig. 10 History of nearshore topography around jetties and breakwaters after 1974.

Figure 10 shows the change in nearshore topography from 1974. Major accretion occurred at depths less than 4 - 5 m; however, significant accretion took place deeper than 6 - 7 m as well. Angled plan shape breakwater construction started in 1975. The breakwaters are connected to the jetties by piers. This structure plan shape was designed based on results of laboratory experiments to maintain the entrance by a flushing. (A similar concept and shape appear in Maza et al. (1977) as a convergent jetty.) This angled breakwater did not give a good solution under prototype conditions. As shown in Fig. 10, large accretion occurred on the lee side of the breakwater and thus the amount of required maintenance dredging increased.

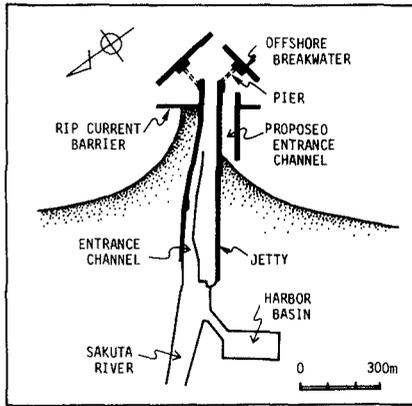
Fig. 11 Plan of Katagai Harbor. Harbor basin is located about 1 km inland from the entrance.

Field observations of the nearshore current and sediment transport were conducted on October 1978 and March 1980 to study the underlying mechanism of the barrier (Table 1) before and after the rip current barrier construction. Several plan shape alternatives were compared by numerical modeling of the nearshore current system (Sasaki, 1975). As a result, rip current barriers as seen in Fig. 11 were finally adopted.

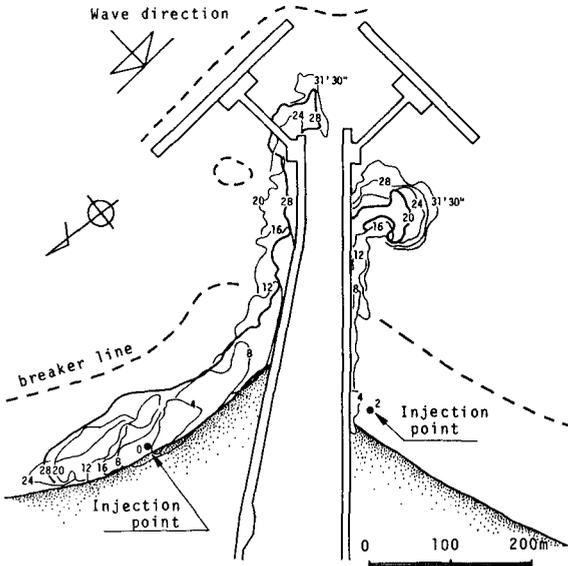
Fig. 12 Dispersion of dye released at the feet of the jetties. Numbers denote elapsed time in min. after injection. Rip heads are outlined.

Rip currents were observed by a tethered balloon system (Sasaki et al., 1976) on 14 Oct. 1978. The dispersion of dye patches was obtained from time-lapse photography (Fig. 12). The associated current velocity is given in Fig. 13. Dye released at the foot of the north jetty moved along the jetty, then reached the harbor entrance. The dye patches on the south side also moved with the rip current then formed rip heads underway to the harbor entrance. The maximum velocity of the rip currents was 40 - 50 cm/s. The dye northward from the injection point dispersed in the bore.

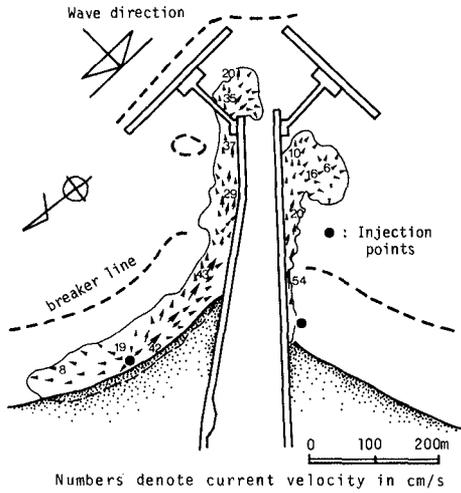
Fig. 13 Velocity distribution of rip currents derived from dye patch movement on 14 Oct. 1978.

Sediment movement was observed with fluorescent tagged sand tracer. One thousand kg of tracer was injected on both sides of the jetties, and samples were taken 2, 4, 6, 8, and 24 hr after injection. The distribution of tracer numbers (Fig. 14) shows very similar patterns to the current (Fig. 13). The tracer study was conducted the day before the current measurement; however, the incident wave directions were almost the same on 13 and 14 October (Table 1). The maximum drift velocities on both sides of the jetties were 7 cm/s and 1 cm/s, respectively.

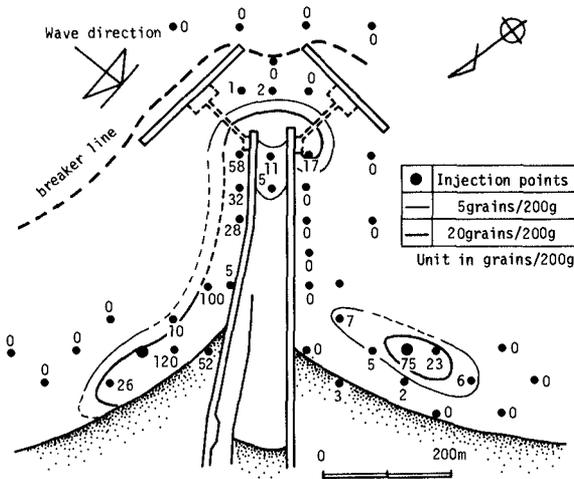
Fig. 14 Tracer movement 6 hr after injection on 13 Oct. 1978. Tracer entered the channel mouth.

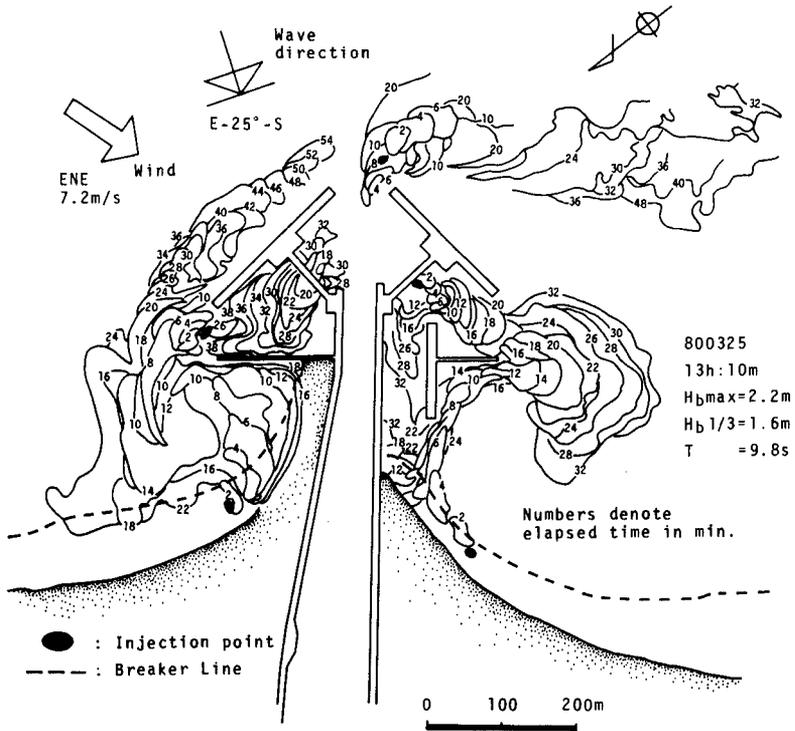
Fig. 15 Dispersion of dye patches around rip current barriers.

Nearshore current measurements were made on 25 March 1980 by using a helicopter-mounted camera instead of the balloon. Fluorescent dye was released at 7 points, 3 kg at each point in the surf zone and 2 kg at each point outside the surf zone. Figure 15 shows the dispersion of the dye patches around the vicinity of the rip current barriers. The rip current barriers block the rip currents effectively and produce forced circulation cells (Fig. 16). The velocity field is given in Fig. 17.

Because the south rip current barrier is short compared with the north barrier, the effectiveness of the barrier is limited. The shore-normal structure attached to the barrier is a portion of the proposed jetty to the separate harbor entrance channel from the Sakuta river.

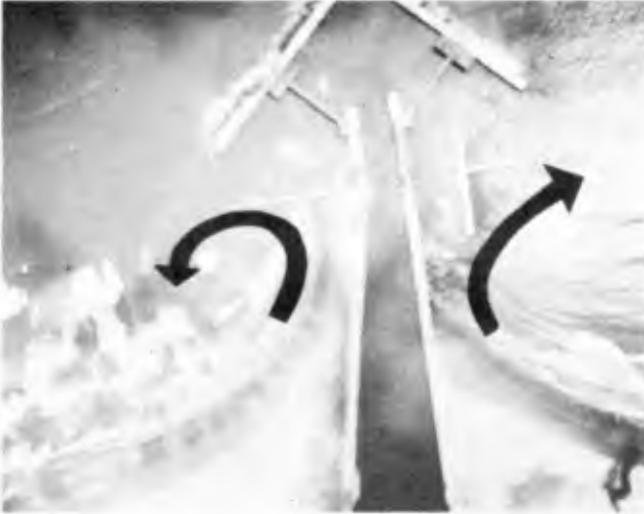
Fig. 16 Rip current barriers at Katagai Fishery Harbor. Arrows show measured rip currents.

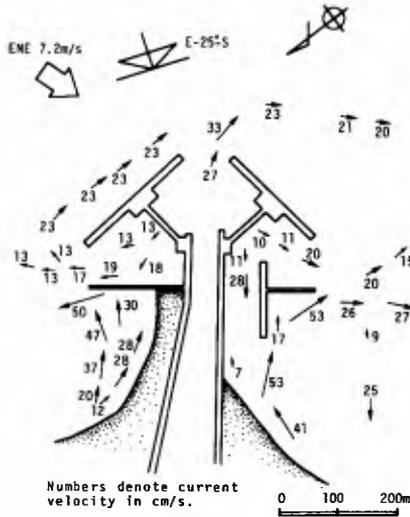
Fig. 17 Flow field derived from dye dispersion.

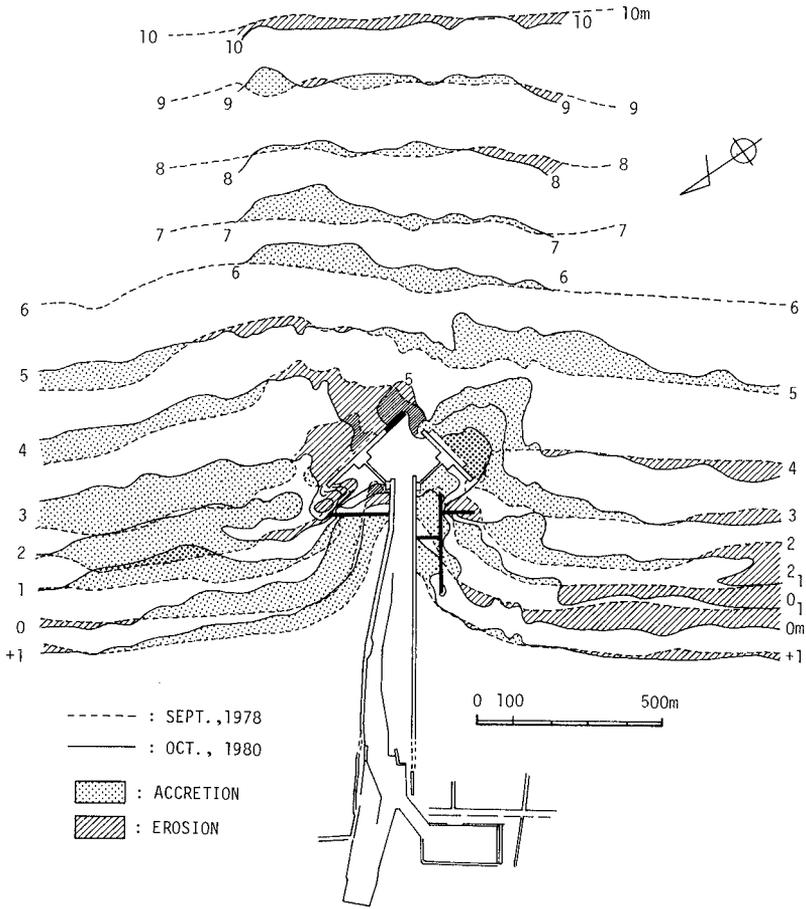
Fig. 18 Comparison of bottom contours before and after rip current barrier construction.

Sounding charts were compared for surveys taken before and after rip current barrier construction (Fig. 18). General accretion is seen offshore and north of the harbor. On the other hand, an eroded area appears on the south side of the harbor. The offshore accretion may be the result of rip head bar formation during storms. Several sounding charts (e.g., bottom of Fig. 10) show huge rip channels. This tendency is consistent with the action of angled breakwaters and indicates that rip current barriers of this size are not effective in storms.

In the lee of the north barrier, accretion continues to take place, and thus the rate of accretion at the harbor entrance is decreasing. At the south, due to the geometry of the barrier, the mitigation effect is imperfect, and further extension of the barrier is deemed necessary.
