## CHAPTER ONE HUNDRED EIGHTY

### ASPHALT STABILIZATION OF RUBBLE SLOPES

E.J.Schmeltz, M.ASCE<sup>1</sup>, M.J.McCarthy, A.M.ASCE<sup>2</sup>, N.Lopez<sup>3</sup>

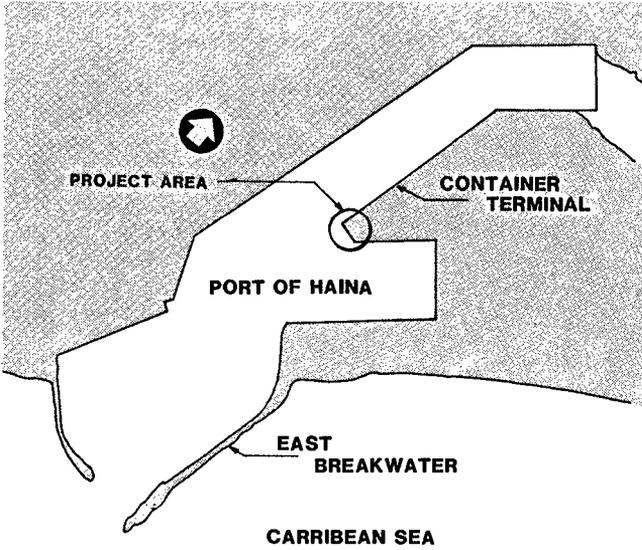
Figure 2  
Site Plan

The harbor is protected against incoming waves by two breakwaters as shown in Figure 2. During the fall of 1979, the site was affected by two hurricanes, Frederick and David, which resulted in considerable damage to the breakwaters. 110 meters of the east breakwater and 65 meters of the west breakwater were essentially destroyed. Since that time, progressive deterioration of the structures has resulted in increased exposure of the south end of the container terminal which was under construction.

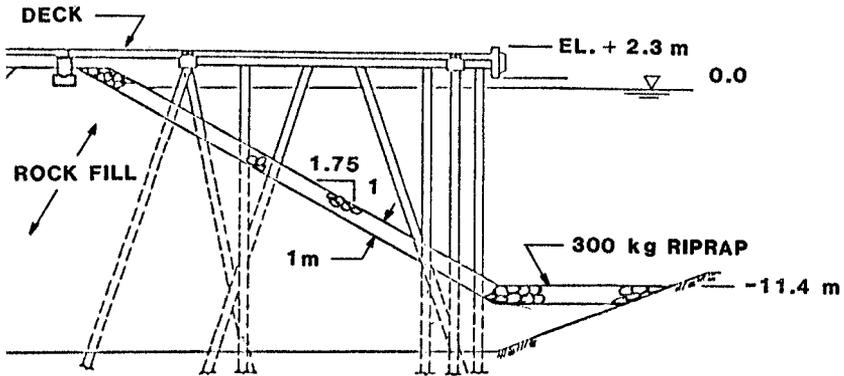
Figure 3  
Typical Section of Container Berth As Designed

The design of the container terminal pier included a pile supported relieving platform constructed over a rock armored dike which surrounded fill material used for the container storage area, as shown in Figure 3. The armor layer consisted of stone with a median weight of 300 kilograms and an average specific gravity of 2.6. Based on Hudson's equation (Reference 1), using a design slope of 1:1.75, this stone was found to be stable for wave heights of up to 1.25 meters. At the time of this study, in April 1983, exposure of the site had increased to a point where the original one meter design wave height could be as high as 2.6 meters. Since this wave height was in excess of the stable wave height for the proposed stone armor layer, a study was initiated to determine alternative methods of temporary reinforcement.

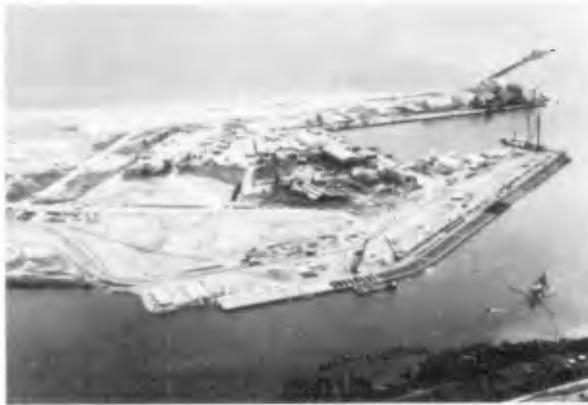
Figure 4  
Container Facility Under Construction  
(View from the north)

It should be noted that at the time of this effort, a substantial amount of construction was completed on the container berth. Piles and pile caps were in place and the majority of the deck was completed. Figure 4 provides an aerial view of the facility around this time. Only the southern end of the structure was of concern since the deterioration of the breakwaters resulted in a high exposure level to southerly waves at this "head" section. A total of approximately 150 linear meters of the structure were involved.

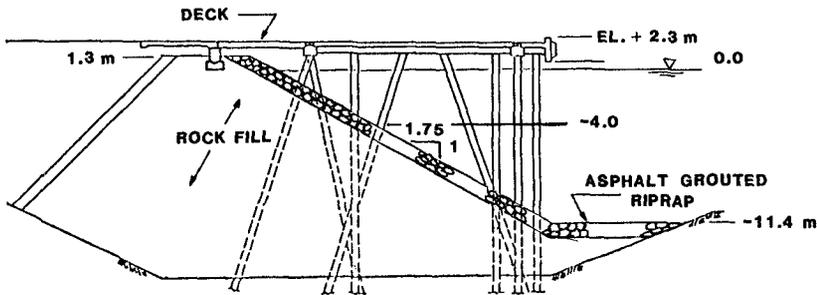
Figure 5  
Revised Cross Section With Asphalt Grout

The basic design for this project consisted of placement of asphalt as a grout to fill the interstices of the existing primary armor. From the top of structure to a level 4.0 meters below the datum, the asphalt would be placed as a continuous cover. The lower level was selected since it is approximately 1.5 times the design wave height below the surface. Below - 4.0 meters, the material would be "pattern"

grouted to result in approximately 50% coverage. The purpose of the pattern grouting was to permit relief of pore pressures in the rock-fill. Penetration of the asphalt to a depth of 0.3 meters was judged to be adequate to bind the primary armor. The design section is shown in Figure 5.

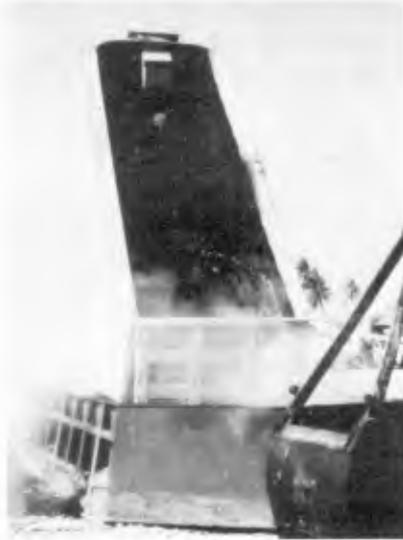
Placement temperatures ranged from a low of 99° C (210 °F) to a high of 215° C (410°F). Both the low and high ends of the temperature range were troublesome since low temperatures resulted in poor flow; high temperatures in a spongy mass in the water and excess steam formation. The majority of the material was placed at approximately 165° C (330° F) which resulted in good flow and reasonable under water placement. The asphalt was supplied from a plant approximately 10 kilometers from the site. Delivered to the site in 15 cubic meter batches by truck, the material was dumped into a rock bin (steel holding box) as shown in Figure 6.

Figure 6  
Asphalt Being Dumped into Rock Bin at the Site

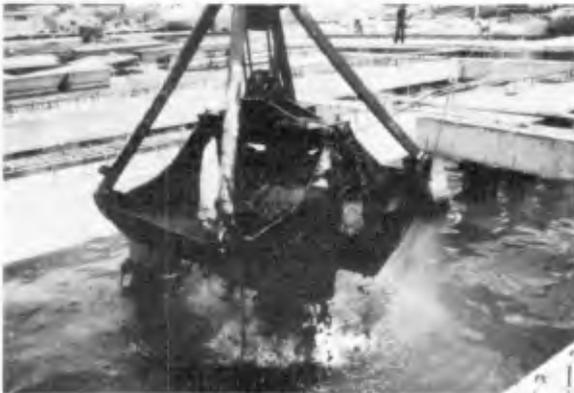
The material was placed on the structure with a 4 cubic yard clamshell as shown in Figure 7. When placed above water workmen utilized shovels and rakes to move the asphalt as required, although on the slopes it flowed well. Below water, the clamshell was opened near the water surface and material was dropped in mass to the rock surface. The pattern was obtained by locating the bucket relative to the pile caps and horizontal members already in place.

Figure 7  
Asphalt Placement With Four Cubic Yard Bucket

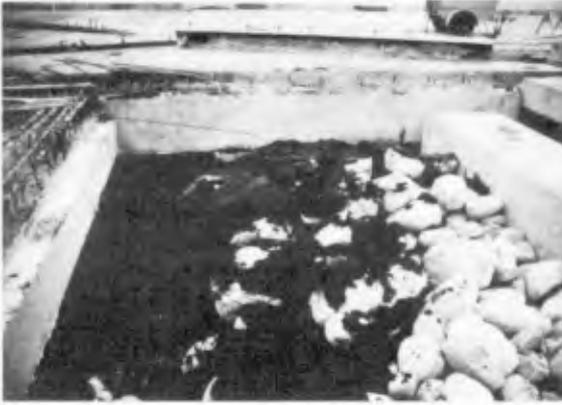
Two hundred and sixty cubic meters of asphalt were delivered and placed on the structure. With an adequate supply, approximately 60 cubic meters were placed in a working day. A total of 1150 square meters of rock protection surface between elevation +1.3 and -4.0 meters were completely grouted; 1450 square meters from -4.0 to -10.8 meters were pattern grouted with approximately 50% coverage achieved. Figures 8 and 9 provide views of the above water section and near the water line, respectively.

Figure 8  
**Asphalt Grout Partially in Place Near the Crest**

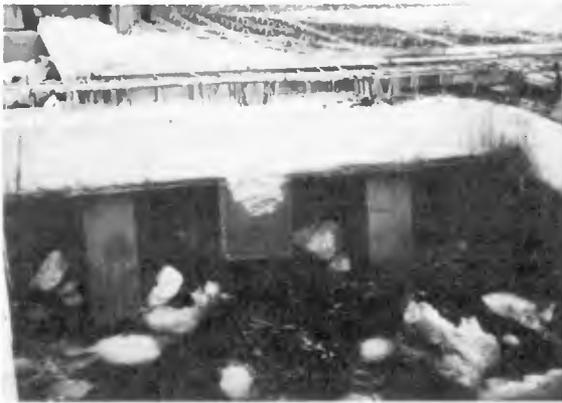
Figure 9  
**Asphalt Grouted Rock Slope Near Water Line**
