## CHAPTER 240

### EMERGENCY SITUATION IN THE SHORELINE REACH OF AN OFFSHORE OILFIELD PIPELINE AND REMEDIAL MEASURES

#### Abstract

This paper describes the critical situation experienced in the northeast coast of Brazil by an oil and a gas pipeline, in their shoreline reach, due to the growth of a spit, and the remedial measures adopted, which avoided an environmental and economical disaster.

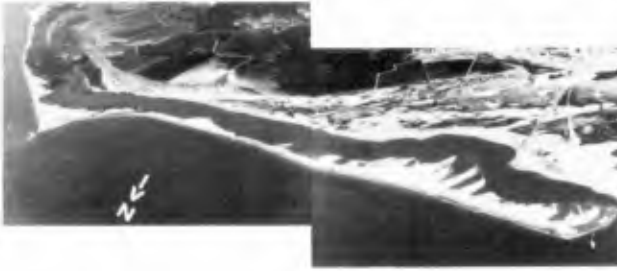
When the pipelines were buried, the shoreline presented no problems. Nevertheless, there existed eastwards a spit, almost parallel to the shoreline, originating in a nearshore island situated in front of Guamaré village. With the growth of this spit (Fig. 5), which defines, between it and the mainland, a double-entrance estuary, the pipelines region, in the shoreline, was submitted to a tidal current that eroded severely the seabottom under the two western pipelines, due to a narrowing of the tidal channel right in their placement, leaving in suspension an extension of about 40m of both lines (Fig. 6, 7, 8 and 9). One of them is a gas and the other an oil pipeline, both with an outside diameter of 0.66m and lined with a concrete coating, 7.6cm thick.

Figure 5. Spit at the Pipelines Region  
Date: 03/16/88 Hour: 15:30 W.L.= +3.1m (H.W.)

but, for environmental reasons and ease of construction it was situated at the narrowest section of the channel, near the mangrove region and west of it, as indicated in Figure 5, which was taken at the high water of a spring tide. In this way there was an increase in the tidal prism flowing through the eastern entrance.

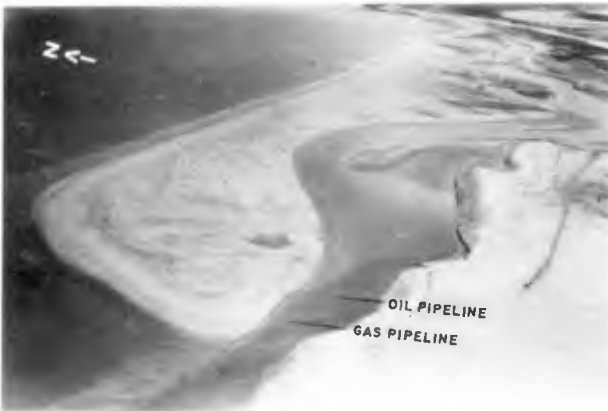
Figure 6. Undermined Pipelines  
Date: 03/02/88 Hour: 10:24 W.L.= +0.7m

a) the oil pipeline was in a situation dangerously close to resonance conditions because: for a free length of the order of 50m its natural frequency of vibration would coincide with the vortex frequency caused by a current of 2.8 knots (1.4m/s) flowing in its surroundings. Indeed, the extremities of the suspended portion of the oil pipeline had already presented deep fissures in the concrete lining;

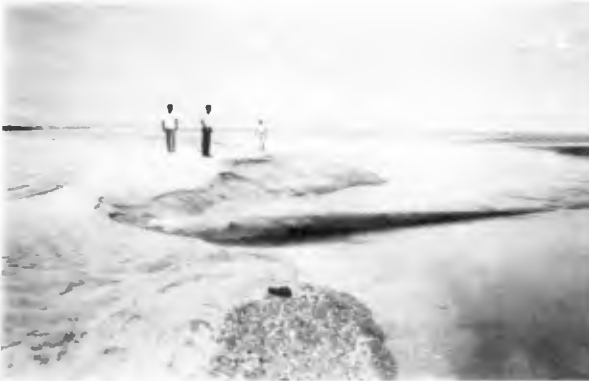
Figure 7. Gas Pipeline  
Date: 03/02/88 Hour: 09:08 W.L.= +0.9m (ebb tide)

b) the gas pipeline, lighter than the oil pipeline and with a higher natural frequency would be in resonance for a free length of 70m and then it was in a situation of lesser risk than the oil pipeline.

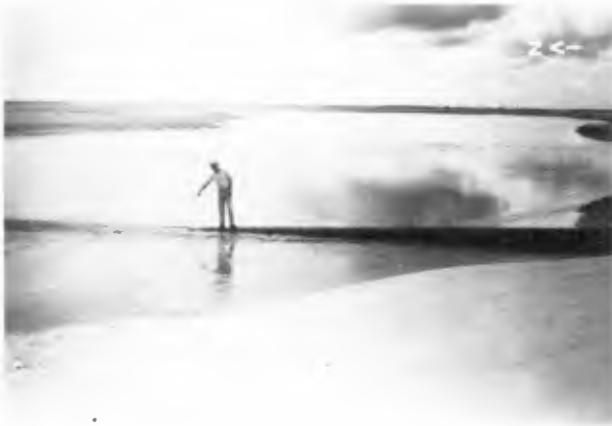
Figure 8. Gas Pipeline

Date: 03/02/88 Hour: 09:10 W.L. = +0.9m (ebb tide)

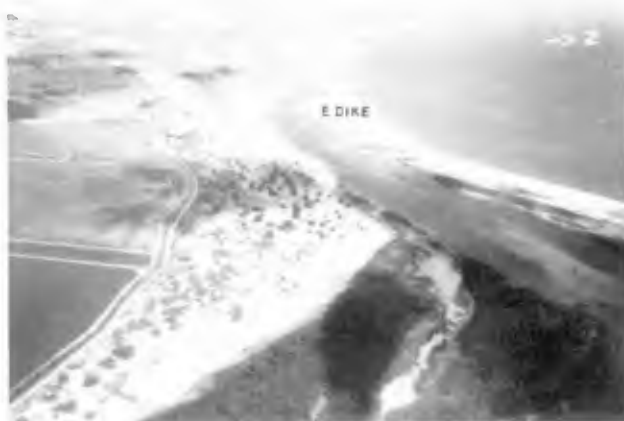
The E dike was not constructed in the region where the tidal waves, entering the channel by both entrance, meet each other (mangrove region in Figure 10)

Figure 10. East Dike and Mangrove Region  
Date: 04/07/88 Hour: 08:25 W.L. = +2.2m

For the construction of the sand dikes, PETROBRAS made use of two bulldozers which piled sand in the two sides of the dike sections, and plastic bags filled with sand. Shortly before the low water of a neap tide, the plastic bags were placed in the deepest part of the channel section and, after that, the bulldozers, simultaneously from both sides, pushed the piled sand over the section, completing the closure.

The E dike (Fig. 10 and 11) was built on March 22, 1988 and the W dike (Fig. 12) three days after. There was a strong sediment deposition westwards of the western dike as expected (Fig. 12, 13 and 14) and on March, 1989, a rupture in the spit portion between the two dikes occurred during an equinoctial tide and is presently being monitored.

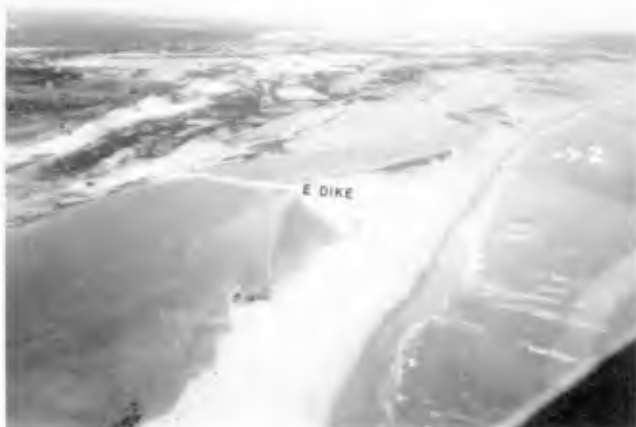
Figure 11. East Dike (Closer View)  
Date: 04/07/88 Hour: 14:23 W.L.= +0.8m

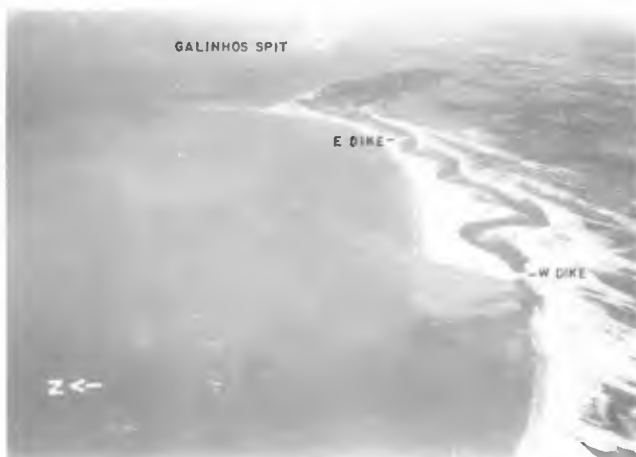
Figure 12. West Dike (13 Days After Closure)  
Date: 04/07/88 Hour: 14:27 W.L.= +0.8m

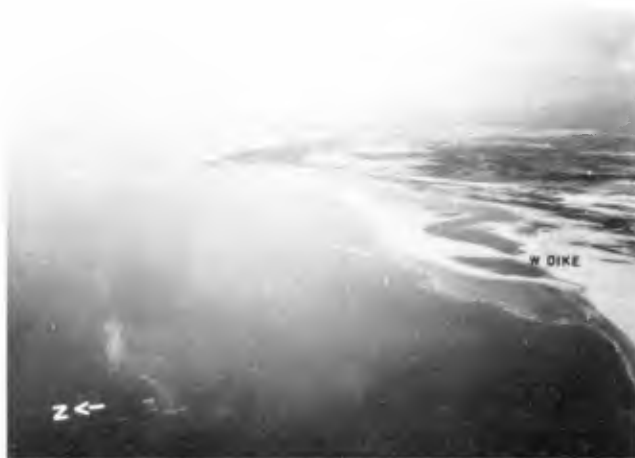
Figure 13. West Dike (10 Months After Closure)  
Date: 01/25/89 Hour: 13:50 W.L.= + 1.1m

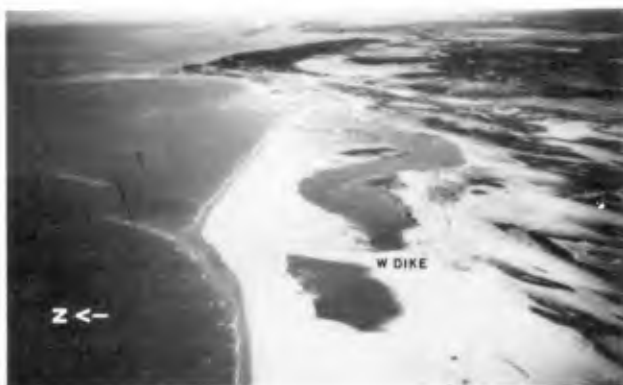
Figure 14. West Dike (27.6 Months After Closure)  
Date: 06/14/90 Hour: 14:00 W.L.= +0,6m

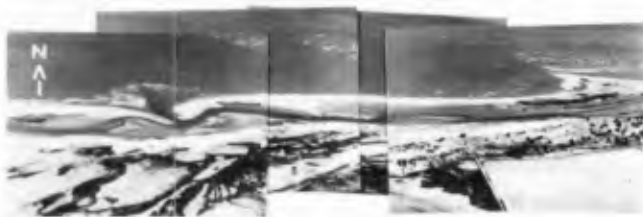
Then, when the rupture of the spit occurred (Fig. 15 and 16), PETROBRAS decided to open the E dike in order to re-establish the original tidal circulation in the mangrove area and in the eastern entrance (e.g. a decrease in the tidal prism flowing through this entrance). This action caused a correspondent increase in the tidal volume flowing through the new western entrance.

Figure 15. Disrupted Spit with the E Dike Opened  
Date: 12/27/89 Hour: 9:55 W.L.= +0.7m

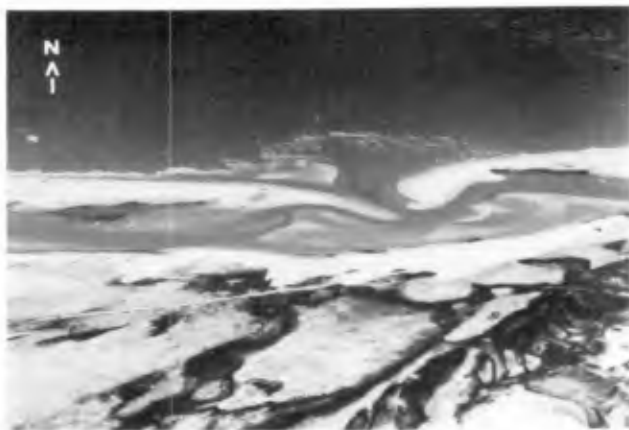
Figure 16. New Western Entrance  
Date: 12/27/89 Hour: 10:00 W.L.= +0.7m

This new western entrance has now a greater tidal volume flowing through it than the original one (which is estimated in  $425,000\text{m}^3$  relatively to the average tide amplitude), when the extremity of the spit was situated in the same region as the entrance. Now, there is a contribution of the tidal prism western of the mouth (in the channel between this mouth and the W dike) which is estimated in  $326,000\text{m}^3$ , giving a total tidal prism of the order of  $751,000\text{m}^3$ . This increased tidal volume flowing through the mouth added to the fact that now the flood flow branches E and W after crossing the mouth and the ebb flow coming from these two directions converges upon the entrance, may have an influence in the rate of advance of the mouth to W, compared to the velocity of migration of the spit when its extremity occupied the same region of the present mouth, from which there is no record.
