## CHAPTER 258

### PROJECTS, WORKS AND MONITORING AT BARCELONA COAST

CARLOS PEÑA<sup>1</sup>  
VICENTE CARRION<sup>1</sup>  
ANA CASTAÑEDA<sup>1</sup>

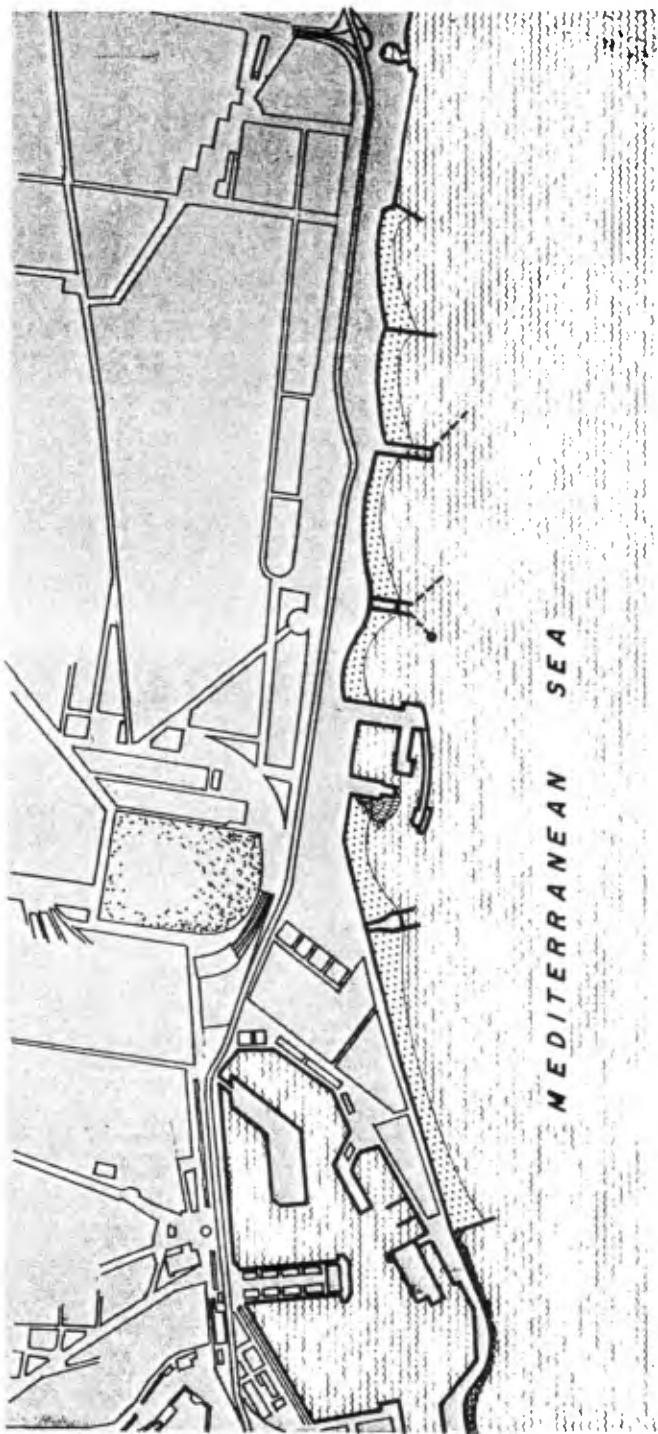
FIG. 16

A schematic plan of the whole segment can be seen in fig. 16.

## BARCELONA CITY SEA-SIDE WORKS

The landscape has deeply changed; a marina has been constructed as part of the Olympic Games infrastructure, beaches can be found instead of previous rubbish tips, and the groins have been rebuilt in order to assure the stability of the beaches.
