## CHAPTER 98

### DESIGN OF BREAKWATERS AND BEACH NOURISHMENT

#### Abstract

The subject of this paper is to compare the design forecast and the actual performance of a coastal protection scheme combining segmented near shore breakwaters and beach nourishment.

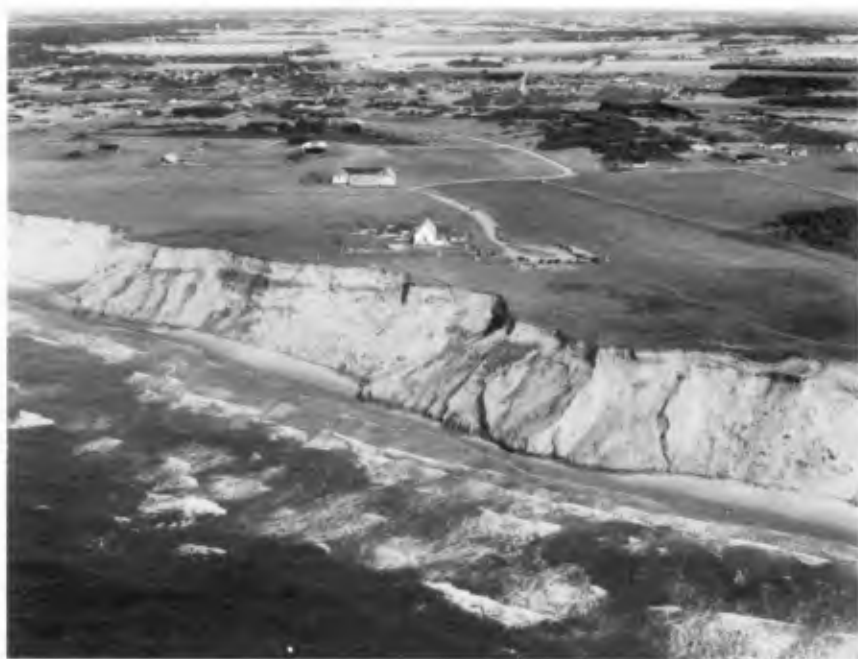
Figure 2. The Beach and the Cliff

During a storm in 1981, 5–15 m of the cliff was eroded and it was decided to protect the town.

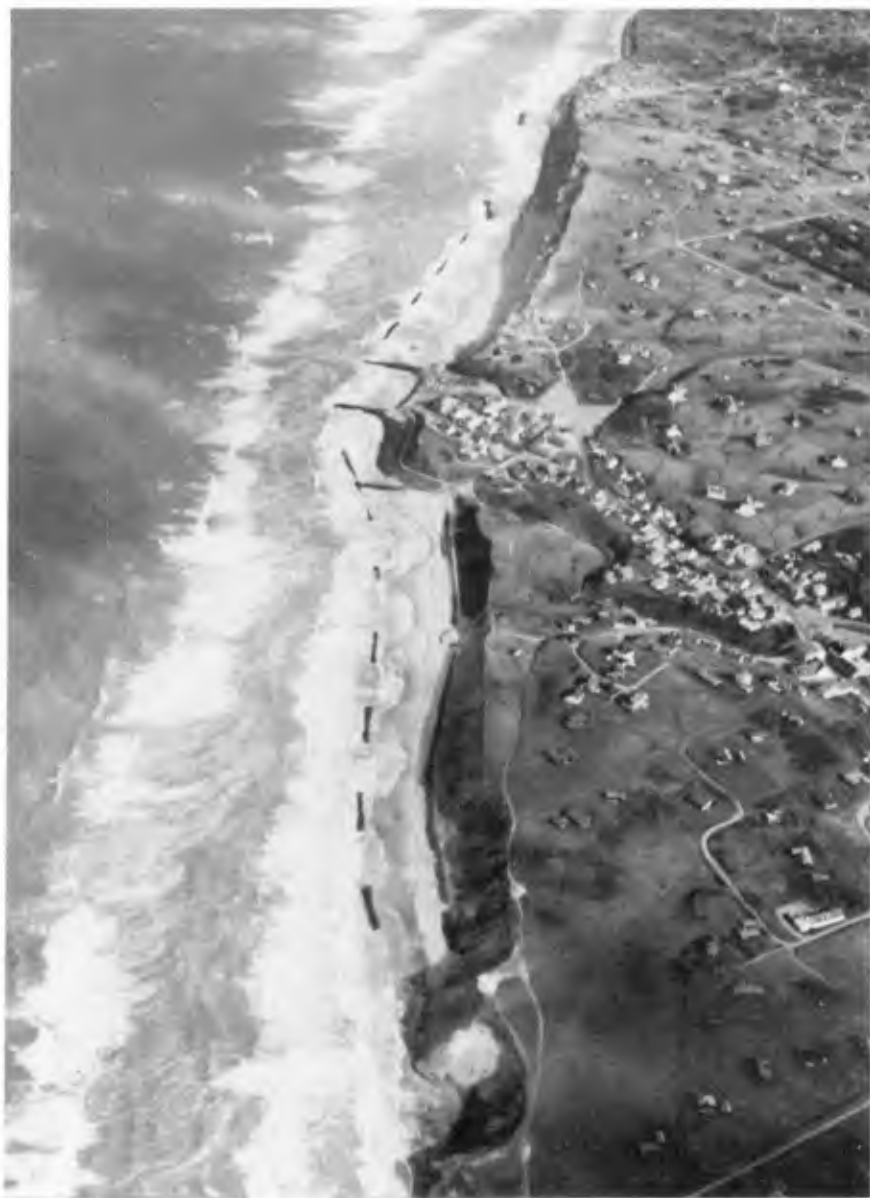
Figure 7. Aerial Photo of Breakwater Group.

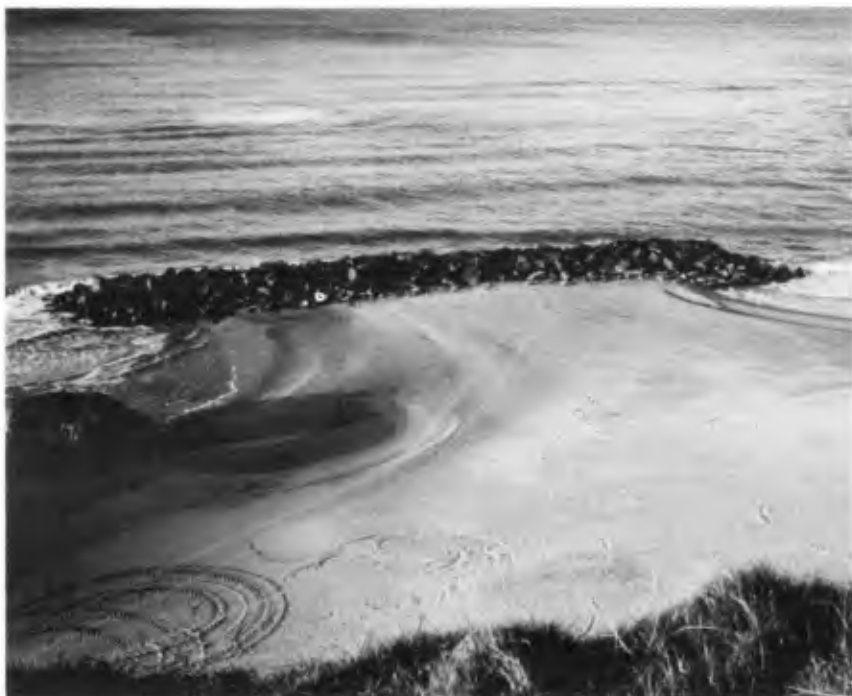
Figure 8. Single Breakwater.
