Field Experiment on the Effect of Gravity Drainage System on Beach Stabilization

Kazumasa KATOH ¹ and Shin-ichi YANAGISHIMA ²

Abstract

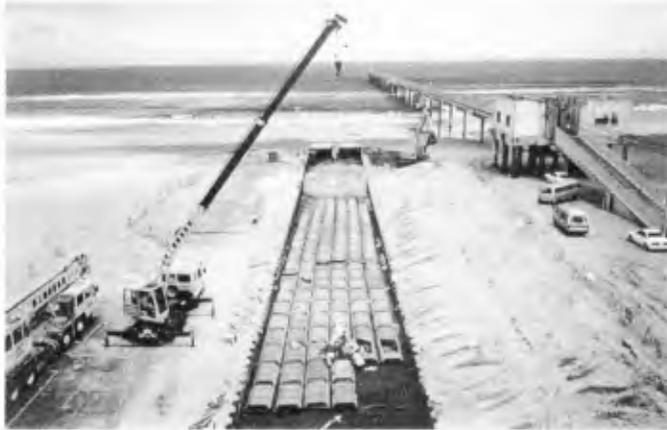
Photo. 1 Execution of Permeable Layer.

diameter has been connected to the sea-side end of permeable layer to drain the ground water into the middle surf zone, 144 meters offshore from the shoreline. The pipe has been buried in the sea bottom with keeping the outlet in the sea. After setting, sand was put on the permeable layer so that we had the same profile as before. The sheet piles at the sea and land sides have been removed. The sheet piles along the longitudinal sides, however, were left without removing in order to make two-dimensional situation in the first experiment. In the second experiment, all the sheet piles were removed.

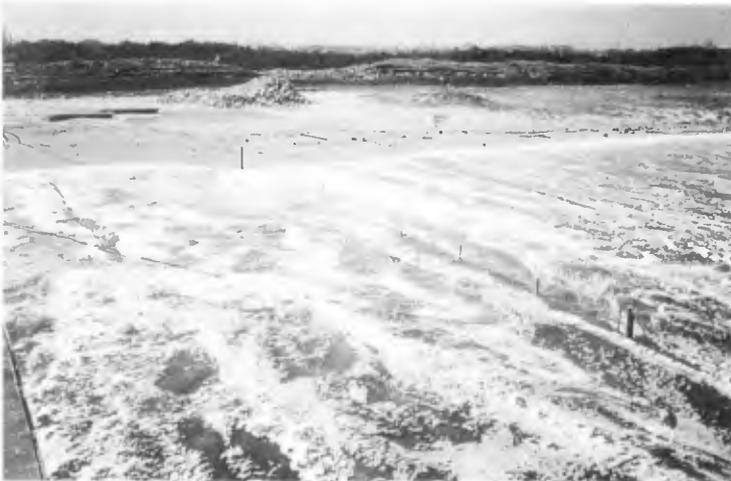
Photo. 2 was taken from the rooftop of laboratory at HORS on 19th September, on the second day of the storm, when an infragravity wave was running up on the drained beach. Small poles dug into the beach at the cross-shore intervals of 5 meters were arranged along a center line of the area where

Photo. 2 Infragravity Waves Running on the Drained Beach.

the permeable layer was set up. Under this situation, sea-water infiltration into the beach was considered to be enhanced in the drained area, because on the drained beach we recognized a very interesting phenomenon that air bubbles came out actively from the ground through the surface of beach, which had never been seen in the laboratory. It is not difficult to infer the situation that the water was infiltrating into the beach because the effusion of air bubbles was a result of being replaced with the infiltrated water into the ground. Photo. 3 is a picture taken about one minute after the situation of Photo. 2, when the infragravity wave was running down to the sea. The beach surface of drained area, of which both sides were cut off by the sheet piles, was already dried up, while the surface of natural beach was still wetted.
