Coastal Erosion Caused by Construction of an Artificial Island and Performance of Beach Nourishment

Ryuichiro Nishi¹, Takaaki Uda², Michio Sato¹,
Masakazu Wakita³, Yasuro Ohtani⁴ and Takahiro Horiguchi⁴

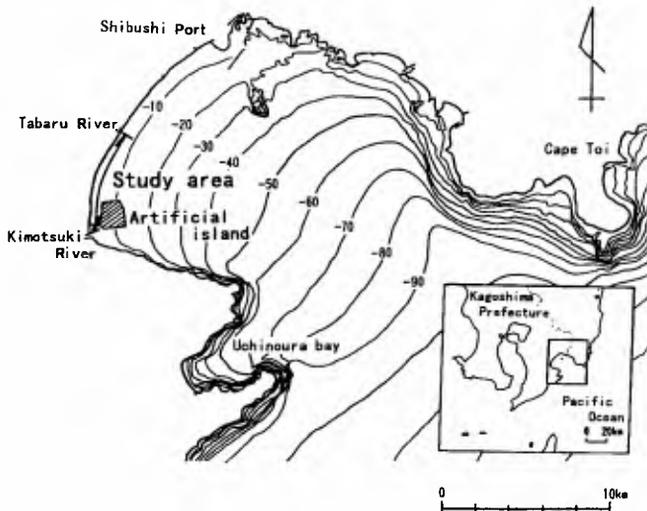
Figure 1 Location of study area.

The Kashiwabara coast is located on the south side of Shibushi Bay which opens to the southeast direction as shown in Figure 1. Shibushi Bay is 16.8 km long and faces to the Pacific Ocean. Shibushi Port and the artificial island lie on the northeast and southwest sides of the bay, respectively. The sandy beach extends nearly 14.2 km along the coast. Five rivers, i.e. Mae, Anraku, Hishida, Tabaru and Kimotsuki Rivers, run into the coast and supply the sediment to the beach. However, the length of each of these rivers is only 14.5, 27.1, 49.3, 14.7 and 34.0 km, respectively, therefore the sand discharge from the river mouths are probably minimal. For instance, the annual mean water discharge of the Kimotsuki River is only 35.12 m³/sec. The Kimotsuki and Tabaru Rivers run into the southwest and northeast side of the study area, respectively.

The entire coast in the bay opens to southeast direction and both sides of the coast are surrounded by the capes as shown in Figure 1. Therefore, the incident wave direction is limited nearly to the southeast direction with some seasonal fluctuation. The incident wave conditions have been monitored by an ultrasonic type of wave gauge which is installed at the -35m water depth and located just off the Birou island. The monthly mean energy wave conditions is shown in Table 1, where as of the highest significant wave since 1980 are shown in Table 2. The incident angles are positive to clockwise from southeast. As can be seen in Table 1, the mean energy wave height during the winter season (December to February) is smaller than that in summer season (July to September). In addition, mean incident wave angle in June, July and August is slightly southward compared to that during the period from September to May, because the mean wind directions in winter and summer are from landward and seaward, respectively. Moreover, high waves generated by typhoons approach to the coast in the summer season.

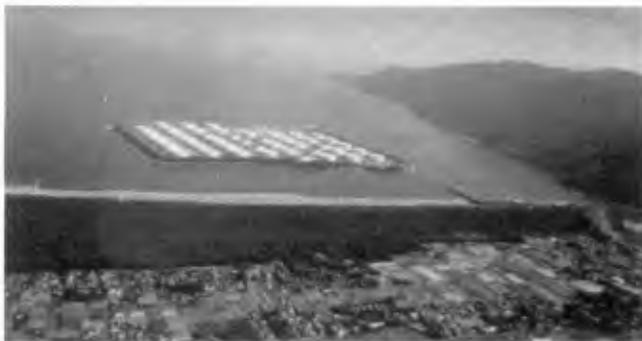
Photograph 1. Aerial view of the artificial island.

An artificial island for storage of crude oil was constructed off the Kashiwabara coast, Shibushi, Kagoshima Prefecture, Japan since 1985 (see Figure 1). The construction of outer facility of the island was completed in 1987 and then the island was reclaimed by dredged material from the nearshore area in front of the island. The island has a rectangular shape roughly 1.5 km long, 1.5 km wide, and the size of

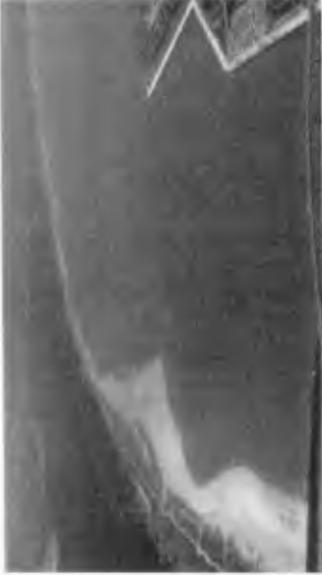
Photo 3. Plan view before the beach nourishment (Sept. 27, 1992).

nearly 7 m at that time. To prevent further coastal erosion and shoreline recession, a beach nourishment project with single groin was carried out. Photograph 3 dated on May 27, 1992 is the situation just before the beach nourishment.

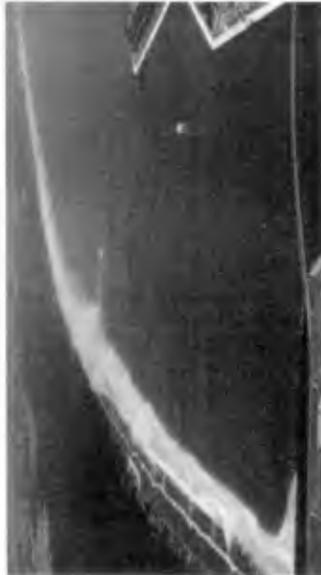
Photo 4. Plan view after the beach nourishment (May 13, 1993).

Photograph 4 shows the plan view just after the beach nourishment. The sand for the nourishment had been taken from two borrow sites between a groin and Hami fishery harbor. Therefore the sandy beach behind the island is somewhat uniform. The non-sheltered beach north to the groin was filled by the sand from the sheltered area, and thus the beach was widened nearly 80 m offshore. As a result, the shoreline configuration became more straight. In addition, a T-shaped single groin was installed between the sheltered and non-sheltered beaches to block the excess southern longshore sediment transport.

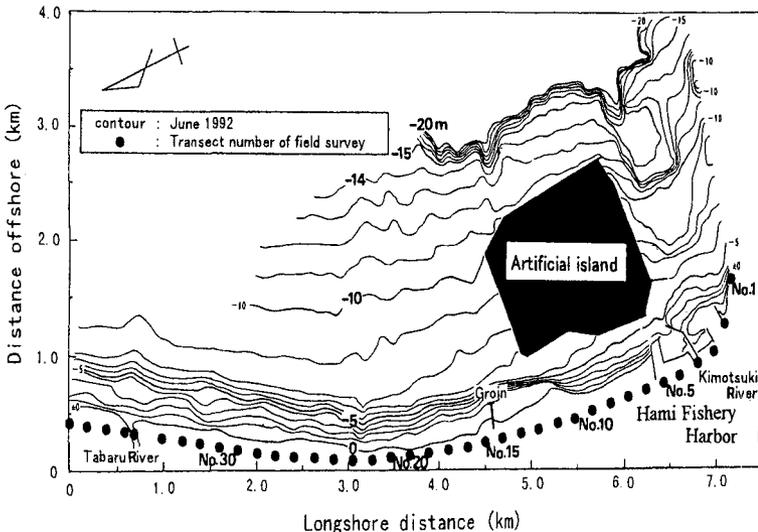
Figure 2. The orientation of coastal structures and transects.

The orientation of artificial island, groin, fishery harbor is shown in Figure 2. The incoming waves are refracted and diffracted by the island and tend to transport much sediment into the sheltered area located just behind the island. The bathymetry and shoreline data have been collected twice a year since 1984, and wave data is collected since 1980. The bathymetry survey covers the region from the southwest end of the bay, where the Kimotsuki River runs into, to beyond the Tabaru River.

The length of this study area extends to 7.5 km. The origin of the x-coordinate for a survey is set to the northeast end of the study area. The number of survey transects increases from the Kimotsuki River to the Tabaru River as shown in Figure 2. The borrow sites for the reclamation sand were in front of the island and the Kimotsuki River mouth.

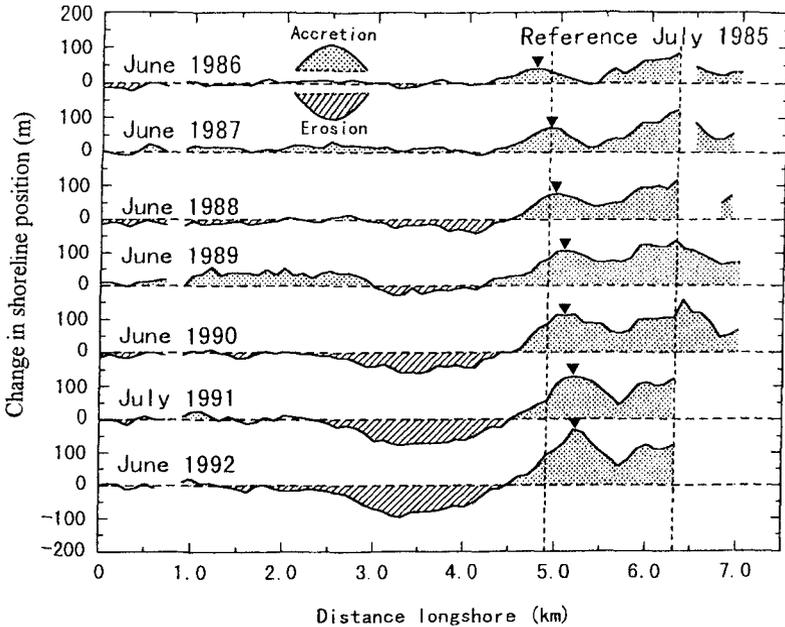
Figure 3. Shoreline change after the construction of the island.

Shoreline configurations of the Kashiwabara coast after the construction of artificial island are shown in Figure 3. The reference shoreline is set to be the shoreline in July 1985. As seen in the shoreline in June 1986, when an outlying facility of the artificial island was being constructed, the wave sheltering effect on the sandy beach had initiated especially in further south area than $x = 4.3$ km. It is clearly seen that sediment had been deposited in the sheltered area, and the shoreline configuration showed quasi-double-tombolo features. The peaks in the shoreline were located at $x = 4.9$ km and $x = 6.3$ km in June 1987. The migration of southern quasi-tombolo along a shore was blocked by an outer facility of the Hami fishery harbor, but the size of this depositional area had continued to grow. The sediment supply from the Kimotsuki River partially contributed to the generation of the south depositional feature. The north tombolo had shifted south along shore and the size of the tombolo had enlarged year by year.

Regarding the growth of the north tombolo, where significant amount of sand had been deposited, the offshore distance of peak of the tombolo had advanced from 40 m in June 1986 to 170 m in June 1992. The maximum shoreline advance in this period was 130 m, resulting the mean advance speed 21.7 m/yr of the shoreline. In addition, the peak of the tombolo was migrated from $x = 4.75$ km in 1986 to $x = 5.25$ km in 1992 to south direction, hence the tombolo had been shifted 500 m in this period. The mean migration speed was 83 m/yr after the construction of island. Once the tombolo generation was initiated by the diffracted waves in the sheltered area, the water depth at the tip of the tombolo was getting deeper according to its offshore growth. As a result, more diffracted waves with higher wave energy flux tend to act toward south direction in the sheltered area. Therefore, the peak of the tombolo migrated southwards while the size of tombolo was increasing in the sheltered area. As seen in the figure, the boundary of northern tombolo and southern quasi-tombolo had been also shifted 270 m to south with an annual mean speed of 45 m/yr. In accordance with the migration of tombolo behind the island, the boundary of depositional and erosional areas of this coast shifted 132 m toward the sheltered area.

The sandy beach in the sheltered area had widened, but the neighboring sandy beach in non-sheltered area had suffered severe coastal erosion after the construction of artificial island. As can be seen in the first and second rows of the figure, there is little shoreline recession in 1988 and 1989. The shoreline recession in non-sheltered area seems to be delayed two years compared to the quick shoreline advance in sheltered area. The shoreline started to retreat over 1360 m stretch from 1988, and then the total length of shoreline recession had become nearly 2.5 km by June 1992. The maximum shoreline recession was nearly 100 m at that time. The northern boundary of erosional area had shifted from $x = 2.8$ km to $x = 1.8$ km in June 1992, while the peak of erosion has shifted from $x = 4.1$ km to $x = 3.2$ km with an annual speed of 200-250 m/yr. The shoreline recession triggered the dune erosion and scarp generation as well. Because the shoreline is located closed to the upper beach face and dune face, the steeper the cross-shore profile, avalanching tends to occur on the steep slope to cause the scarp. Following the severe dune and beach erosion, a beach nourishment project with single groin had been carried out to prevent further coastal erosion. The project was completed in May 1993.

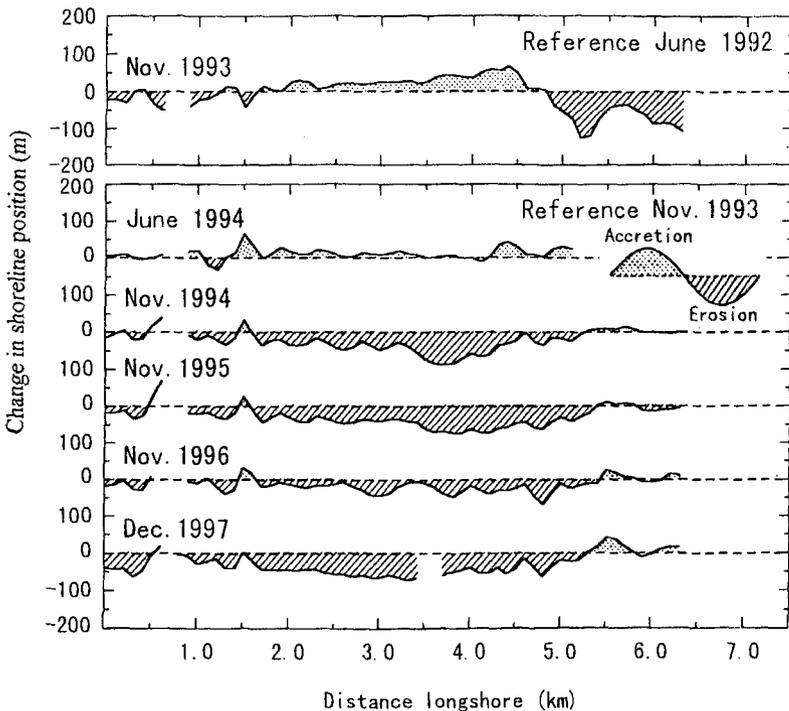
Figure 4. Shoreline change after the beach nourishment.

A volume of $1.15 \times 10^6 \text{ m}^3$ of sand was dredged from two borrow sites just behind the island and filled into the eroded beach. The two borrow sites for the beach nourishment were deployed between $x = 5.3 \text{ km}$ and $x = 6.24 \text{ km}$, respectively. The shoreline changes after the beach nourishment is shown in Figure 4. The reference shoreline is set to be the shoreline in June 1992 when the nourishment project had conducted thereafter. As seen in the figure, the shoreline advanced in a region from $x = 4.94$ to 6.3 km ($= 1.36 \text{ km}$ extension) in June 1992. The maximum shoreline advance was 152 m at $x = 5.34 \text{ km}$. On the other hand, the shoreline receded in the region from $x = 1.43$ to 4.75 km ($= 3.32 \text{ km}$ extension) with a convex plan view in June 1992 before the beach nourishment. This maximum shoreline retreat in November 1992 was nearly 80 m at $x = 3.74 \text{ km}$.

To prevent further erosion and property damage, sand was filled in the non-sheltered area in May, 1993 as shown by the shoreline in Nov. 1993. The nourished shoreline around $x = 2.63 \text{ km}$ was smoothly connected to the natural shoreline at $x = 2.43 \text{ km}$. The shoreline was advanced 80 to 100 m in the eroded section of the beach by the beach nourishment.

Following the beach fill project in May 1993, the largest typhoon since 1980 generated a maximum significant wave with $H_{1/3} = 8.3$ m and $T_{1/3} = 12.8$ sec period on August 10, 1993. Then unfortunately the third largest significant wave caused by Typhoon 9313 approached the shore with 7.72 m wave height and 11.2 sec wave period on September 3, 1993. As a result, the filled shoreline quickly receded nearly 50 m in the first six months just after the beach fill project as shown by solid line in Nov. 1993. Following this shoreline recession in the first six months, successive shoreline recession including a crescentic shoreline configuration between $x = 3.27$ km and $x = 4.68$ km occurred until 1995. In contrast, the shoreline in the non-sheltered area was advanced in Nov. 1996, because the Typhoon wave condition in this year was smaller than previous years. However, Typhoon 9713 which lasted three days (in terms of the significant wave height condition higher than 3.0 m) and Typhoon 9719 caused the shoreline recession in the entire region except the river mouth of the Tabaru River and the sheltered area. Finally, the shoreline configuration became as shown by the solid line in December 1997.

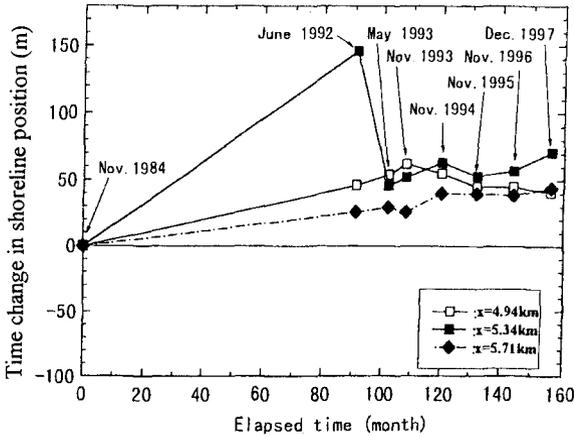
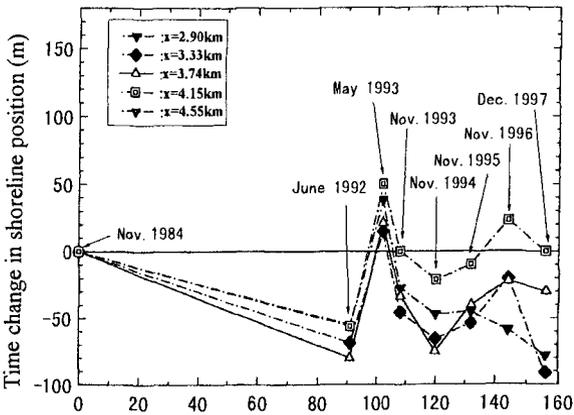
(a) Time change in shoreline position in the sheltered area.

(b) Time change in shoreline position in the non-sheltered area.

Figure 5. Shoreline changes of each transect.

Figs. 5 (a), and (b) show the time series of shoreline position at representative transects. The mean shoreline changes at $x = 5.34$ km and $x = 3.74$ km were nearly $+19.3$ m/yr and -10.5 m/yr, respectively. In contrast, the shoreline

The shoreline changes on the nourished beach were accelerated during the first 2.5 years after the nourishment due to attack of two of the three largest typhoons in the wave record in 1993 and profile adjustment relating to the overfill. For instance, an annual rate of shoreline change at transect $x = 3.74$ km was 60.2 m/yr. Following this period, the shoreline change seems to have stabilized or shows some positive trend except the shoreline position in Dec. 1997.

The inverse exponential behavior of the shoreline changes on the nourished beach (on non-sheltered beach) clearly means that a single groin installed between sheltered and non-sheltered beaches functions to block an excess longshore sediment transport into the sheltered area.

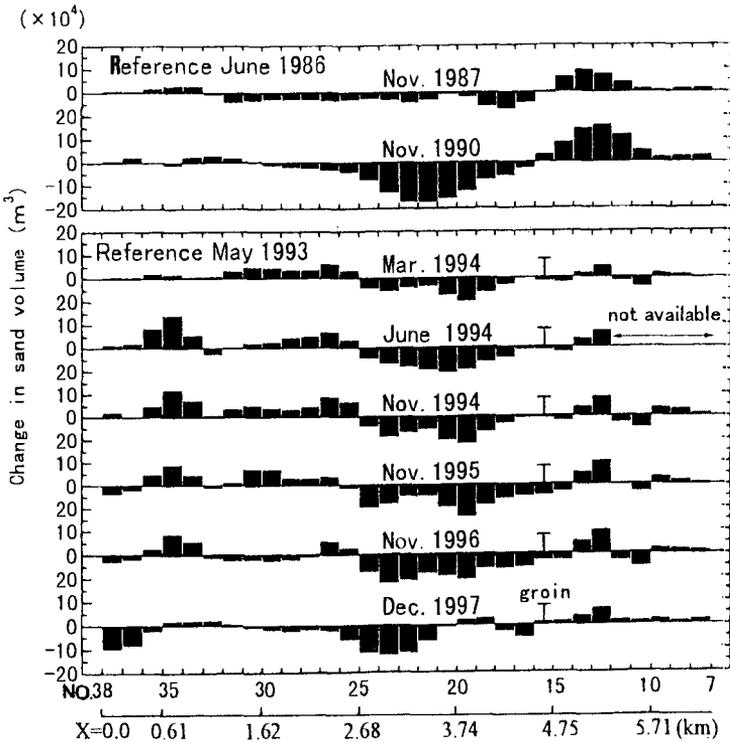
Figure 6. Change in sand volume in the study area.

A time series of the change in sand volume over the entire Kashiwabara coast is shown in Figure 6. The change in sand volume along the shore is calculated by multiplying the cross-sectional change by the transect spacing. The volumetric change beyond the -9 m water depth was not taken into account for the estimation, since the sounding survey was conducted to this water depth. The profile analysis which will be shown later and the cross-shore distribution of sediment diameter show that the critical water depth for profile change in this study area is nearly -8 m. Therefore the change in sand volume in Figure 6 can be used as the first approximation. The change in total sand volume in the sheltered area $x=4.55$ to 6.30 km was nearly $600 \times 10^3 \text{ m}^3$, thus the annual depositional rate in this area was $160 \times 10^3 \text{ m}^3/\text{yr}$ after the construction of the island (June 1986 to November 1990). On the other hand the change in total sand volume in the erosional area from $x = 2.68$ to 4.55 km was roughly $970 \times 10^3 \text{ m}^3$. Thus, the annual erosional rate in this area was $-220 \times 10^3 \text{ m}^3/\text{yr}$.

The beach nourishment project with the single groin was completed in May 1993. The change in sand volume in the area from $x = 4.75$ to 5.71 km was $+220 \times 10^3 \text{ m}^3$ after the beach nourishment, and thus the annual depositional rate in this area is $50 \times 10^3 \text{ m}^3/\text{yr}$. This means that the transmission rate of this groin for longshore sediment transport is estimated by comparison of depositional rate before and after the beach nourishment as follows;

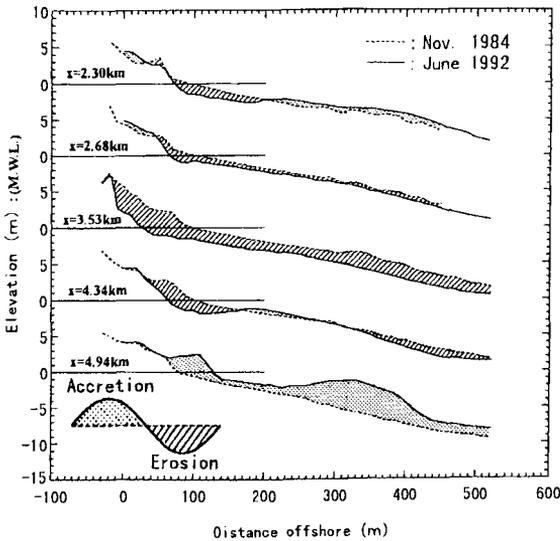
Figure 7. Profile change along the shore after the construction of the island.

The profile variations in space during the post-construction period, beach nourishment period, and post-nourishment period are examined here. Figure 7 shows the change in profile along shore from November 1984 to June 1992. The coordinate $x = 4.94$ km is located in the sheltered area and $x = 3.53$ km is located in the middle of erosional area. In addition, an entire profile at $x = 3.53$ km is lowered by more than 1.4 m.

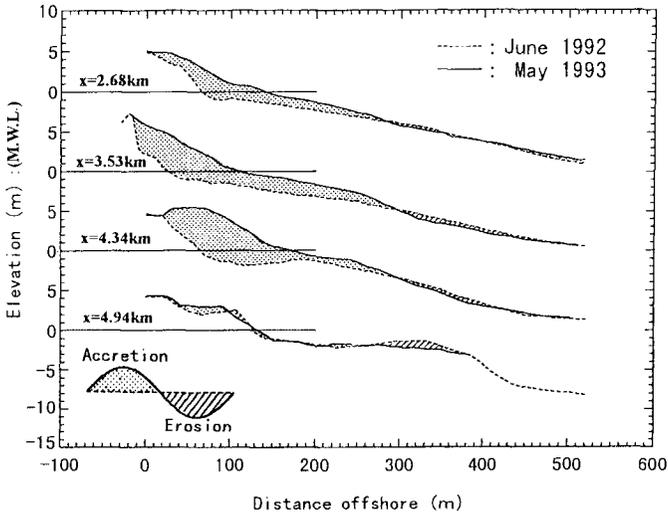
Figure 8. Profile change along the shore during the beach nourishment.

Figure 8 shows the profile change along the coast before and after the beach nourishment. The nourished sand was filled from a landward boundary of erosional area to -4 m water depth. As can be seen in the figure, the profile was designed to have composite slopes. The beach slopes higher than 1m elevation are 1/25, 1/29, 1/27 and the offshore slopes are 1/60, 1/59 and 1/51 at $x = 2.68, 3.53$ and 4.34 km, respectively.

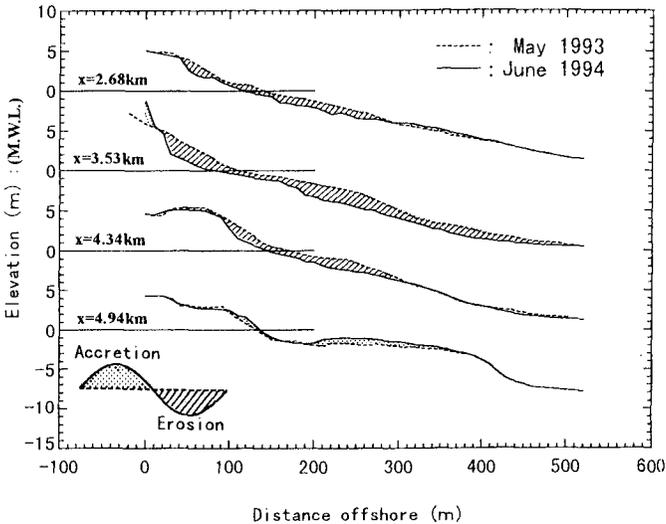
Figure 9. Profile change along the shore after the beach nourishment

Figure 9 shows that the profile changes along the coast in the first typhoon season after the beach nourishment. Because two of the three largest typhoons since 1980

struck on the shore during this period, the nourished beach had been extensively damaged and scarp generation has commenced again. Typhoons 9307 and 9313 produced 8.3 m and 7.72 m significant wave height, respectively. The elevation of the scarp base is nearly 2 m along the shore.
