## THE FIRST CORE-LOC BREAKWATER

Anton H Holtzhausen<sup>1</sup>

*The first project in which Core-Locs were used as the main breakwater armour unit, is a small craft harbour on the south east coast of South Africa named Port St Francis. The Core-Loc was selected based on economic advantages over other units. Stability of 15 t units was confirmed in a full three-dimensional model study. Construction of the harbour commenced in early 1996 and was successfully completed towards the end of 1997. Practical construction issues are discussed in detail. Core-Loc performance under construction stage storms was excellent and virtually no damage has taken place under design storm conditions subsequent to the completion of the structure.*

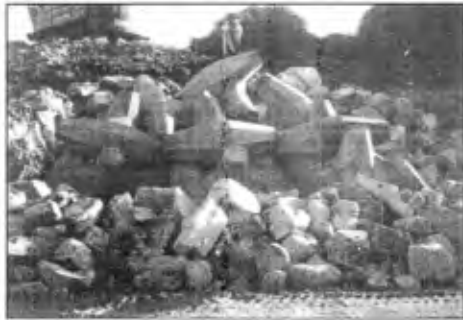
Figure 5. Completed test section

shows the completed test section in which toe units were placed according to this orientation. In general the rock profiles and Core-Loc placement achieved on the

test section was found to be acceptable. This, together with a specification based on CIRIA (1991), would form the basis for approving actual breakwater sections.

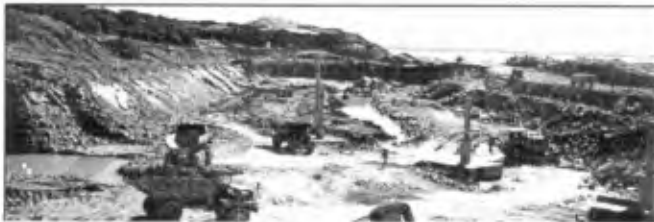
Figure 8. Harbour basin after excavation. Armour rock yielded ~6%

Figure 8 shows the excavated harbour basin (quarry) which only yielded approximately 6 percent armour rock. This required the opening of a new quarry some 11 km away from the site, causing extensive delays to the breakwater construction.

In addition to the low yield in armour rock, the basin excavation also produced fines and clay that fell outside specifications for breakwater core material and fill material for the peninsula. In spite of the specification, some of this material was used for breakwater construction, leading to the rejection of these sections of breakwater. A compromise was reached where areas containing fines were excavated and sluiced before being replaced.

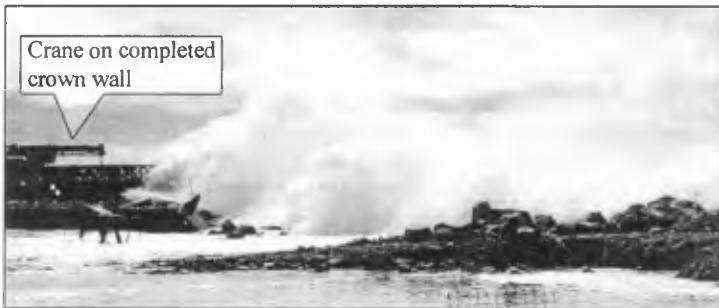
Figure 10. Largest storm that hit the breakwater during construction

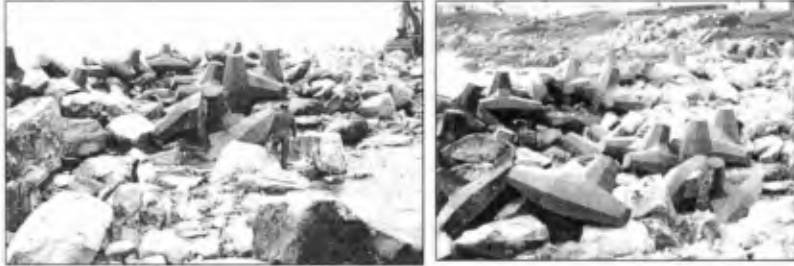
Figure 11. Construction stage damage mainly due to erosion of breakwater crest. Some Core-Locs rolled further than 10 m without any breakage.

Over the section where the crown wall had been completed, almost no damage took place. However, the section from the bend in the breakwater to the root sustained significant damage. The damage was caused mainly by erosion of the breakwater crest to a level that caused top row Core-Locs to roll toward the lee of the breakwater. This is illustrated in Figure 11 where some Core-Locs rolled over a distance of more than 10 m without breaking.

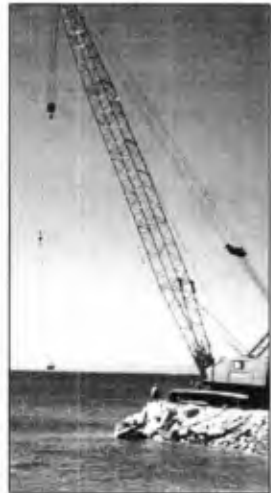
Figure 12. Crane and ball survey equipment

Construction of the first section of breakwater in relatively shallow water, proceeded without many problems. However, the crane and ball survey method that was used for surveying core and underlayer rock, had obvious limitations that gave rise to differences between the Contractor and Engineer. The survey was done using the breakwater crane shown in Figure 12. The height of the crane coupled with wave action made horizontal

positioning of the ball very difficult so that surveys often took very long to complete. This was especially frustrating when rising wave conditions made it urgent to protect breakwater sections where under layers had been placed. Before placement of Core-Locs could proceed, under layers had to be surveyed, plotted and approved by the engineer.
