## Evaluation of the Effect of 20 Years of Nourishment

Christian Lastrup<sup>1</sup> and Holger Toxvig Madsen<sup>2</sup>

Since 1982, large-scale coastal protection works have taken place on the Danish North Sea coast. The subject of the first part of this paper is the coastal protection policy, the engineering approaches to erosion and flood control and the results achieved. An important tool for coastal protection has always been and still is nourishment. In the second part of the paper, the effect of the nourishment will be evaluated with focus on the positioning of the nourishment in the profile and on the use of coarse materials.

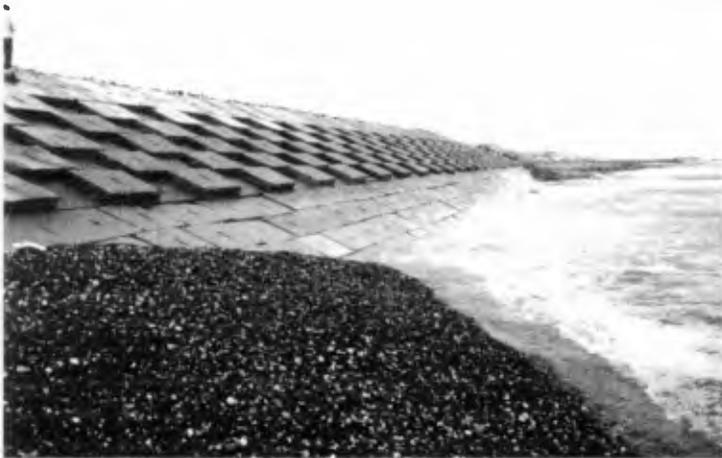
The dunes were reinforced and new dunes were built to re-establish the safety against flooding to a 100-year return period. However, in many cases it was not possible to reach the safety level required because there was not enough land between the beach and the houses or the road to build a sufficient dune volume. In this case, the dunes were protected by a revetment.

Placed concrete block revetment

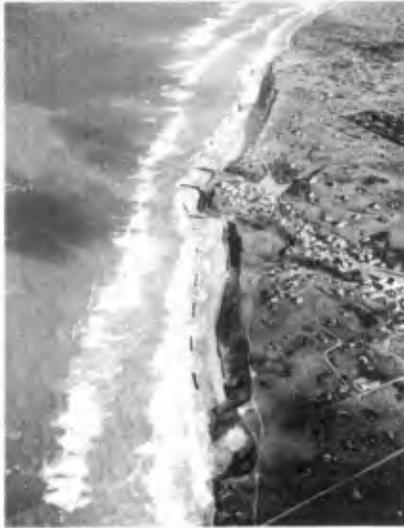
- On highly exposed stretches where erosion should be stopped, low detached breakwaters were used in combination with nourishment. One reason for the use of breakwaters was that for historical reasons, local politicians trusted in hard structures like groynes and breakwaters. Another reason was the high price of the nourishment sand.
- Nourishment was applied but on a small scale. The main reason for this was that the principle of beach nourishment was new to the politicians. It was difficult to convince the politicians that “the erosion of the nourishment sand during storms is part of the plan”. This meant that volumes were small and unit costs were high which was one reason for stabilizing the nourishment by means of breakwaters.

Detached breakwaters, beach nourishment and revetment
