#### 2011 TOHOKU TSUNAMI RUNUP AND DEVASTATING DAMAGES AROUND YAMADA BAY, IWATE: SURVEYS AND NUMERICAL SIMULATION

Distributions of inundation and runup height for the 2011 off the Pacific coast of Tohoku Earthquake Tsunami were measured in and outside Yamada Bay located at the center of lwate Prefecture, Japan. Numerical simulations were conducted to reproduce flow, inundation and runup height distributions. Surface elevation profiles recorded by the GPS wave gauges were used as the offshore boundary condition. In order to investigate characteristics of tsunami response to different geomorphological features, frequency separation was tried for the tsunami incident wave. It was found that the high frequency component was responsible for large tsunami height at narrow inlets and open bays, whereas the low frequency component had significant influence for inundation in closed bays.

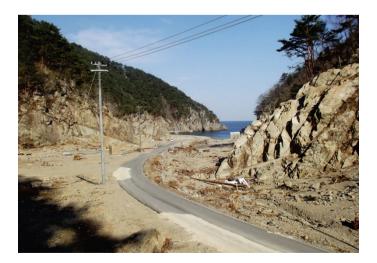
Photograph 1. Small valley at the end of a funnel-shape inlet of Aneyoshi. The electric posts seen in the photograph were built after the tsunami. Note the erosion down to bedrock. (Photograph taken on April 13, 2011)

On the exposed east coast of the Omoe Peninsula the average tsunami height was 15 to 20m at the shoreline as shown in Figure 2. All villages there were impacted by extreme runup heights of more than 25m and residential houses at lower elevation were completely washed away. The highest runup, approaching 40m with an inundation distance of 500 m, was measured at the inlet of Aneyoshi. It locates at the bottom of a small funnel-shape inlet which concentrates the energy of tsunami and amplifies its height (Photograph 1).

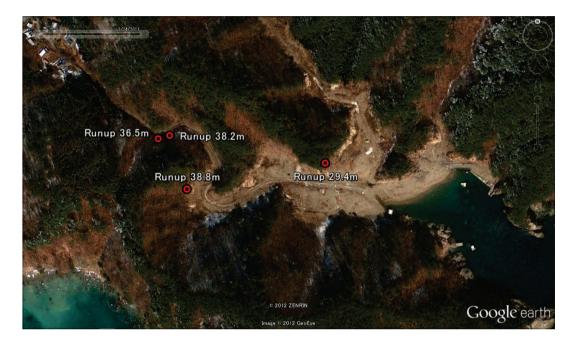
Figure 3. Satellite image of Aneyoshi Valley (Image processed by Google Earth). The markers show measured tsunami heights. The houses at the upper-left corner form Aneyoshi Village which had been relocated to the present location after Showa Sanriku Tsunami in 1933.

Figure 3 shows an overview of the Aneyoshi valley with the tsunami height exceeding 20 m at the mouth of the gulch along the coastline of Aneyoshi Inlet. The small white rectangles in the satellite image are concrete caissons that formed the inlet breakwaters of Aneyoshi Fishery Port. The tsunami penetrated upstream along the winding gulch of Aneyoshi reaching up to runup heights of 38m at an inundation limit located about 200m downstream of the Aneyoshi village visible at the upper-left corner of the satellite image.

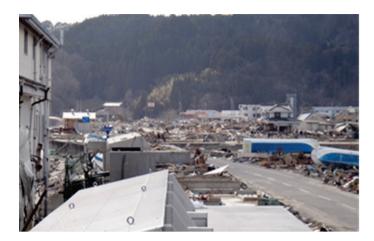
Photograph 2. View from top of the new seawall overlooking the Osawa Area of Yamada Town toward the old seawall section to the west. The old section was significantly lower with a height of 4.0m above MSL compared to the new 6.6m high section.

Yamada Town located at the head of Yamada Bay however suffered significant loss of life. Photograph 2 shows the devastating damage in the Osawa Area of Yamada Town at the north side of the Yamada Bay. The ratio of dead or missing to its population is around 4%, which is high among the cities and towns along the Sanriku Coast. Yamada Town had moderately large lowland areas along the bay and was protected by a non-uniform combination of old and new tsunami seawalls. The height of the old seawall was 4.0m, whereas the design height of the new one was 6.6m above the local mean sea level. It should be noticed that the effective heights of the seawalls may be tens of centimeters lower than their design heights because of the coseismic landlevel subsidence. The tsunami height marginally overflowed the new seawall sections. Unfortunately the lateral old seawall segments allowed massive overtopping and flooding into the town resulting in property damages and loss of life (Photographs 3 and 4).

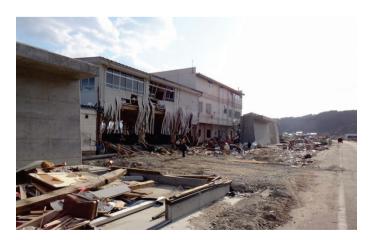
Photograph 3. Gap between new seawall segments at Osawa Fishery Port of Yamada Town. The tsunami flowed into the residential Osawa Area through the buildings of Osawa Fishery Port.

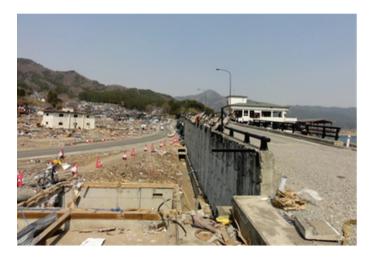
Photograph 8. Kirikiri Town flushed by the tsunami at the left. A tsunami trace at 16.2m was found on the roof of the seaward RC 4-story building.

The exposed areas south of Funakoshi Bay such as Kirikiri also experienced tsunami runup of more than 15m. Photograph 8 gives an idea how large and strong the tsunami was in Kirikiri Town. The measured elevation of the road surface of the overpass in the photograph and the base elevation of it were 8.8 m and 5.1 m from the mean sea level, respectively. A trace found on the roof of a four-story reinforced concrete building in the right of the photograph was 16.2 m above the sea level. At the top of the overpass, the parapets were bent toward the land side (Photograph 9), whereas they were bent toward the sea side at the lower part of the overpass (Photograph 8). These alternating bending directions suggest that the landward tsunami inflow during the runup phase was dominant at high locations, while the seaward outflow during the drawback phase was channelized in low lying areas. Extreme outflow current velocities have been reported at other locations such as Kesennuma (Fritz et al., 2012).

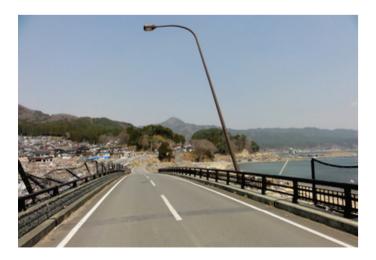
Photograph 9. At the top of the overpass, the lighting post and parapets were bent landwards, which is attributed to dominant inflow during the runup phase.
