ANALYSIS OF WIND DRIVEN CURRENT IN ISHIKARI BAY AND NEARSHORE CURRENT AT ISHIKARI-HAMA BEACH, JAPAN

Naoyuki Inukai¹ and Keita Shinada²

Keywords: Ishikari bay; rip current; wind driven current.

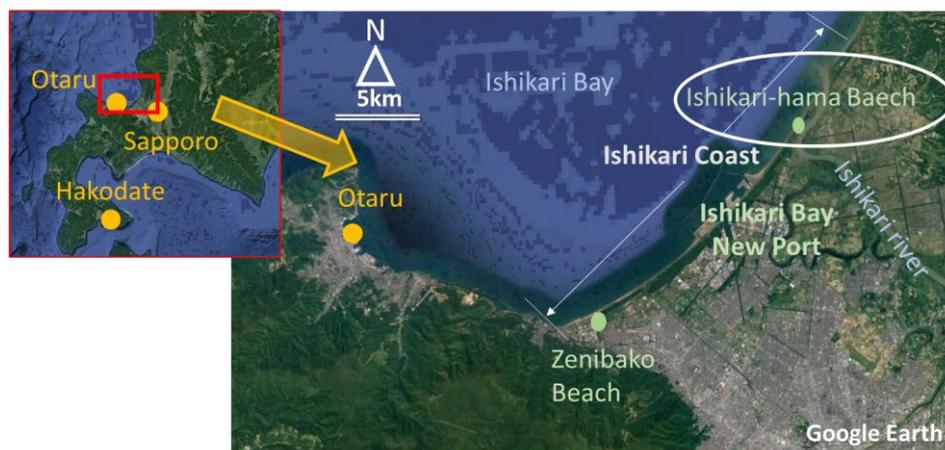
Figure 1. Location of the field

Ishikari coast in Hokkaido has a sandy beach which is located in the back of Ishikari Bay. The total length of the coast is about 27 km. Ishikari New Port is located the center of Ishikari coast, and the estuary of Ishikari River is located the northeast extremity of the coast (see Figure 1).

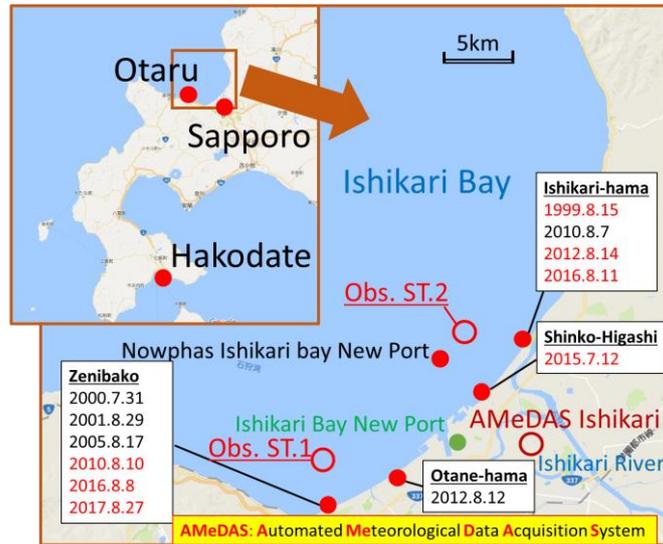
Figure 2. Location of the field, wave observed and wind observed points

Figure 2 shows the accident location and the date of occurrence. The figure shows that many accidents occurred on Ishikari coast. Expressly, many accidents occurred at Zenibako beach (South-West of the coast) and Ishikari-hama beach (North-East of the coast).

In order to grasp the occurrence situation of drowning accident at the target coast, we searched the on-line database of Asahi Shinbun newspaper and Hokkaido newspaper etc. As the results, 12 accidents were extracted (see Figure 2). Furthermore, 7 of 12 accidents were “flowed” accidents.

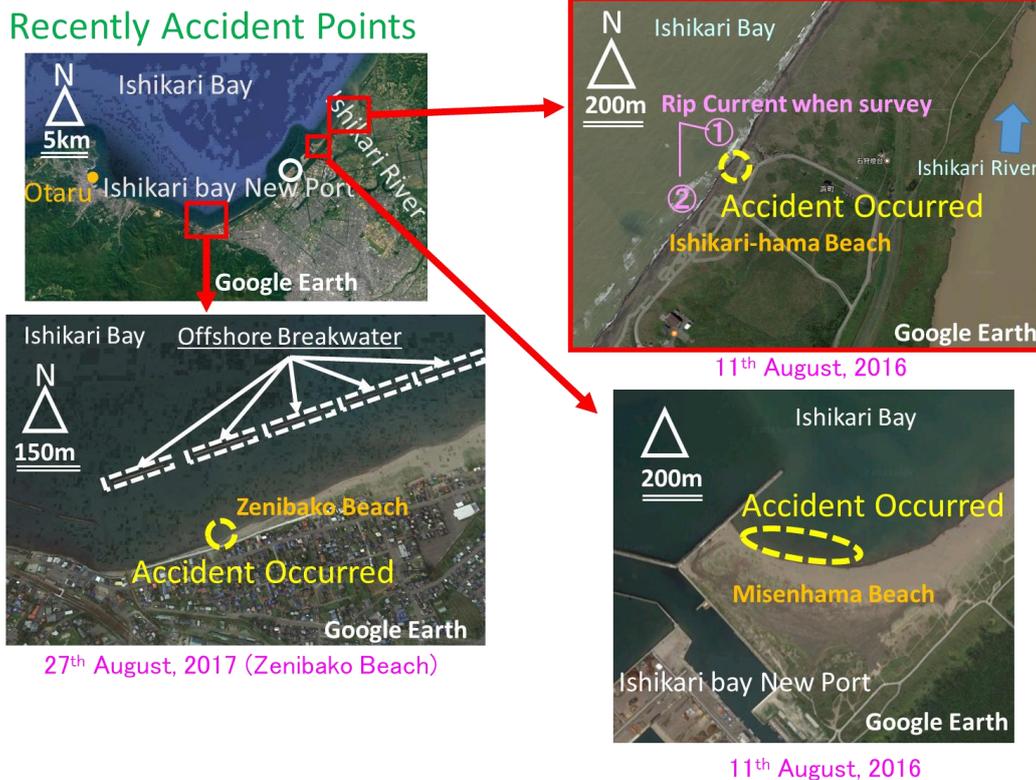
Figure 3. Satellite Image of Ishikari-hama Beach (cusp topography) and Zenibako Beach (cusp topography+breakwater)

Figure 3 shows the satellite photographs of Ishikari-hama beach and Zenibako beach. According to the photographs, Ishikari-hama beach is the sandy coast that has the cusp topography. The wavelength of the cups is about 200 m. Furthermore, Zenibako beach is the sandy coast that has the 200m wavelength cusp topography, and the several offshore breakwaters are set at off the beach. The past our research (Inukai, 2015 and 2017) confirmed that such cusp topography was formed by waves, and the nearshore current (include the rip current) occurs at these beaches.

A field survey was conducted on Ishikarihama beach (Figure 1) where the accident occurred on August 11, 2016. The enforced date was on July 8, 2017. During conducting the survey, we confirmed the occurrence of a rip current at point ① and point ② (Figure 3). We visualized the rip current by Inukai's method (Inukai, 2015, 2017). In this method, we pigmented the current by the water colorant, and we got the aerial photograph by Unmanned Aerial Vehicle (UAV). We also installed the weather station on site. Furthermore, we measured the water depth along the measure line from the shoreline to 100m off the coast. The lines were set at every 50m along the shoreline.

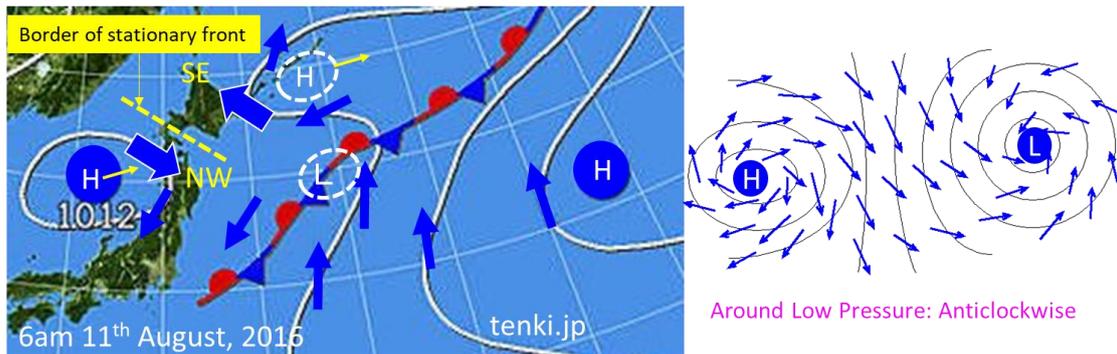
Figure 4. Weather Chart (6am 11th August, 2016)

Figure 4 shows the weather chart at 6 am on August 11, 2016, and Figure 5 shows the time variation of the wind speed and the wind direction at around Ishikari Bay. According to Figure 4, the high pressure moved to eastward on the south side of the field, and the wind direction at the field changed from SE to NW. Furthermore, Figure 5 shows that the wind direction changed from SE to N since 12am. It was 2 hours before the accident occurred. And the wind velocity also increased at the same time.

occurred, the wind direction fluctuated counterclockwise as shown in Figure 4. Because the high pressure moved to east and it passed the south side.

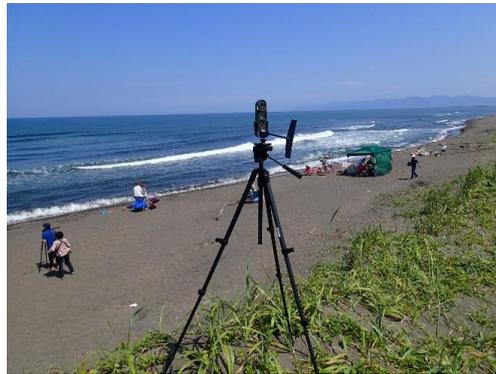
Figure 6. Weather Station (8th July, 2017)

At the field, we set the weather station when we conducted the field survey (Figure 6). Figure 7 and Figure 8 show the time fluctuation of the wind direction and the wind velocity at AMeDAS Ishikari and the survey field. Figures show that the wind directions of the weather station and AMeDAS during the field survey were almost N. According to Figure 1, the site of AMeDAS Ishikari is opened to the north direction on the sea. Therefore, when the wind direction is N, the wind direction of the weather station and AMeDAS were almost same. However, although the wind speed gradually increased, the difference between the weather station data and AMeDAS was about twice as large. As the cause, the AMeDAS was influenced by the land friction. When the wind direction fluctuated to N on August 11, 2016, AMeDAS wind velocity increased from about 1 m/s to about 3.4 m/s. Therefore,

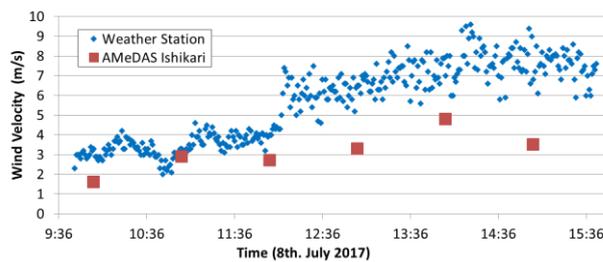
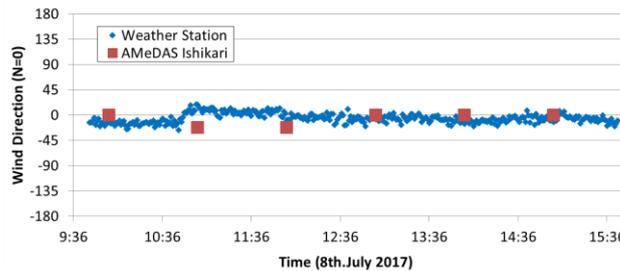
we considered that the real local wind velocity increased from about 2 m/s to 8 m /s on the accident date.

Figure 7. Time change of wind velocity (8th July, 2017)

Figure 8. Time change of wind direction (8th July, 2017)

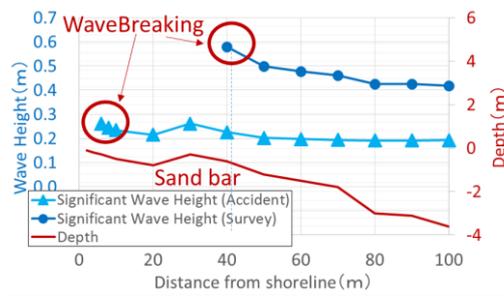
When the field survey was conducted, the significant wave height was 0.43 m and the period was 5.1 seconds at Nowphas Ishikari Bay New Port (MIG, 2012) where is located near the field (Figure 1). The wave height at the shoreline always increases due to the influence of the water depth, therefore, we calculated the wave height at the shoreline, and the breaking wave height H_b . The breaking wave height has the relationship with the wave height and the depth (Horikawa, 1991). Figure 9 shows the change of water depth and the change of wave height in the offshore direction. According to Figure 9, when the field survey was conducted, the breaking wave height was about 0.6 m, and the wave broke at the sandbar on the offshore side. However, when the accident occurred, the breaking wave height was 0.26 m. Therefore, we considered that the wave broke at near the shoreline.

Figure 9. Shallow water deformation of Ishikari-hama beach (Accident and Field Survey)

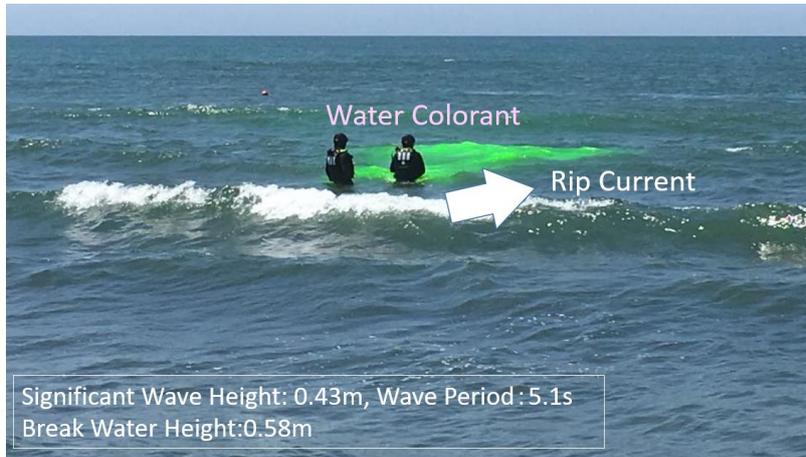
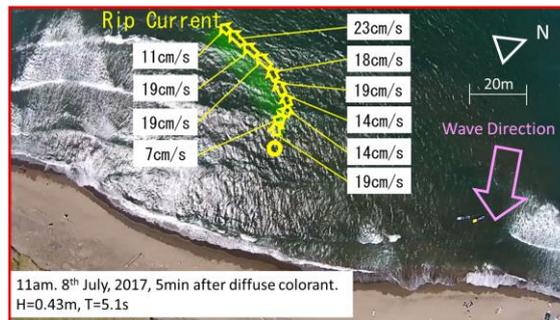
Figure 10 shows the visualized rip current by the water colorant at point ① in Figure 3. And, Figure 11 shows the average current speed which was calculated by the average moving distance in every 30 seconds. Figures show that the rip current generated at the point ①, and the current velocity was about 0.15 m/s. The occurrence situation of the rip current about the wave height was similar to the other example (Inukai, 2015 and 2017). However, after flowing out to the offshore, the current velocity changed to about 0.19 m/s, and the current direction changed to SW. This direction means, the current flowed parallel to the coast. It seems that this current was influenced by the coastal current (include the wind driven current).

Figure 10. Visualized Rip Current

Figure 11. Velocity profiles of Rip Current (at point 1 in Figure 2)

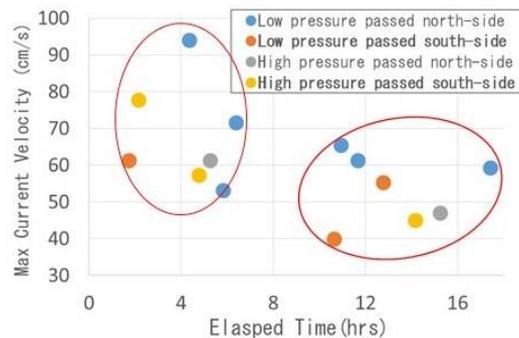
Figure 12. Relationship between maximum velocity and reach time after starting wind direction changed

Figure 12 shows the relationship between the time after starting the fluctuation of the wind direction and the maximum velocity of the current. Figure shows that the current became in 3 to 5 hours after starting the fluctuation, and the current velocity became about 70 cm/s.

Furthermore, it was classified into two groups by the time to reach the maximum velocity of the current after starting the fluctuation of the wind direction. As the reason, the move speed of the low pressure/ the high pressure and the magnitude of the pressure gradient were different. When the move speed or the magnitude of the pressure gradient was high, the fluctuation time became be short.

Incidentally, the high pressure passed fast the south side of the field in the accident day. Therefore, the trend fluctuated in a short time.

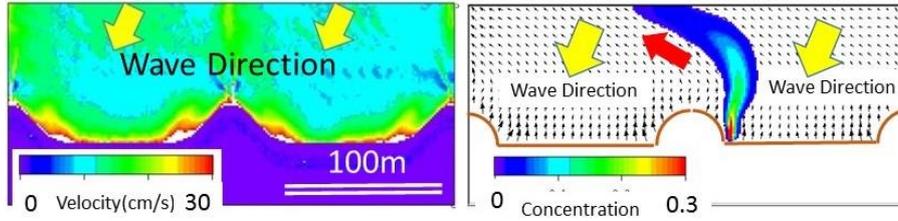
Figure 13. Profile of current velocity and diffusion of virtual water colorant

where, u : the flow velocity in the x direction, v : the flow velocity in the y direction, C : the concentration, and A_h : the horizontal vortex viscosity coefficient. In this case, the concentration was set as 1 of the number at the point source, and the result of the simulation shows the profile of the relative concentration in the simulation area. Therefore, the unit of Figure 13 has not the unit.

The simulation area was 250 m in the shoreline direction and 500 m in the offshore direction. The grid space was 1 m and the wavelength of the cusp topography was set to 100 m. The interval time of the simulation was set to 0.1 second. The seabed gradient was set to 1/40 gradient by the depth information in Figure 9. In the simulation, the wave condition was set to be same condition of the field survey in July 8, 2017. Specifically, the wave height was set to 0.5m and the period was set to 5 seconds, and the wave was entered at the outer boundary, and the wave direction was set to 78 degree to shoreline. Furthermore, when the field survey was conducted, the current after flowing out from the shoreline moved to the left direction in 20 cm/s. Therefore, the uniform current was set in 20 cm/s at the outer boundary of the perpendicular direction to the coast. In the diffusion simulation, the vortex viscosity coefficient was set to 4 cm² /s. The calculation result is shown in Figure 13. Figure shows that the pigment water flowed out to the offshore by the rip current from the side of the cusp topography. After flowing out, the current diffused to the left due to the coastal current. Furthermore, the current velocity at the near shoreline was about 15 cm/s and the velocity at the offshore was about 20cm/s. These results were qualitatively reproduced the results of the field survey.

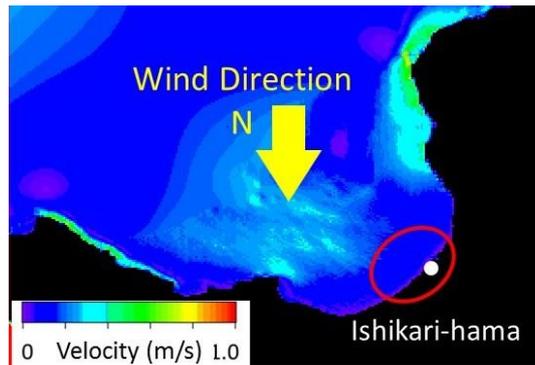
Figure 14. Profile of current velocity when field survey

Figure 14 shows the profile of the current velocity when the field survey was conducted. Figure shows that the current velocity was about 20cm/s at Ishikari-hama. This result was same with the result of the field survey. Therefore, we considered that this model qualitatively reproduced the current.

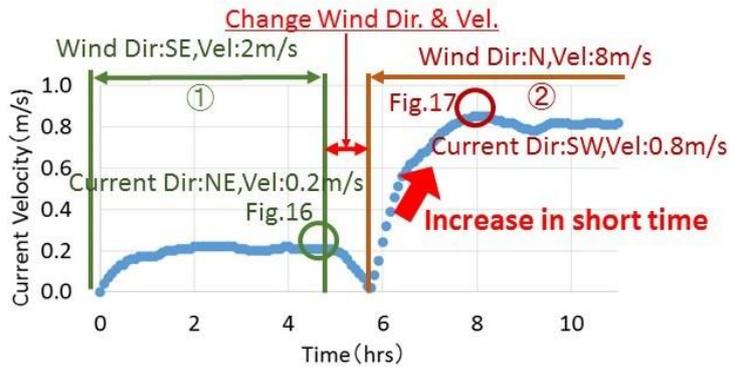
Figure 15. Simulation result of time change of current velocity due to change of wind condition (Ishikari-hama, 11th August, 2016)

Figure 15 shows the time change of current velocity of surface layer, and the inflection of the wind condition at Ishikari-hama when the accident occurred in 11th August, 2016. The figure shows when the wind direction changed, the current direction changed for 1 hour and the velocity increased to 0.8m/s for 2 hours.

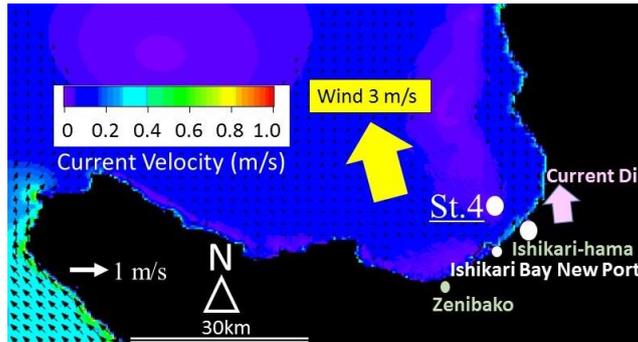
Figure 16. Profile of current velocity when wind direction was SE (5 hours after starting simulation)

Figure 16 shows the current velocity of the surface layer when wind direction was SE (5hours after staring simulation). The figure shows that the current velocity at Ishikari-hama was about 0.2m/s and the wind direction was N.

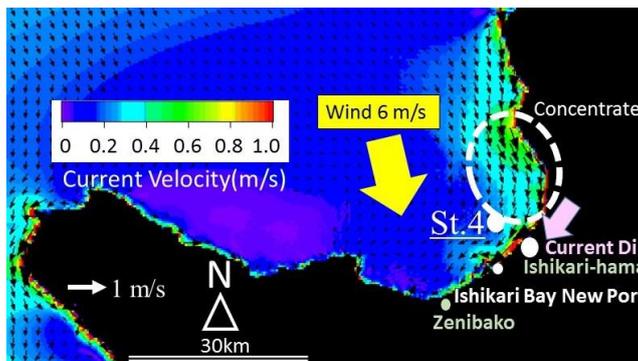
Figure 17. Profile of current velocity when wind direction was NNW (8 hours after starting simulation)

Figure 17 shows the current velocity of the surface layer when the wind direction was NNW (8hours after staring simulation). The figure shows that the current velocity at Ishikari-hama was about 1m/s due to concentrate the current. Furthermore, the wind direction was SW. This direction was parallel to the coast. According to above results, we confirmed that the current at inner Ishikari Bay area increase rapidly for 2 hours after the wind direction fluctuates.
