DESIGN OF A COASTAL PROTECTION SCHEME FOR ADA AT THE VOLTA-RIVER MOUTH (GHANA)

The coastal town Ada in Ghana is threatened by a severe coastal erosion. A protection scheme has to be designed to protect the town. Since the area is ecologically important, e.a. due to the presence of turtles, both during the design process and during the construction phase actions to diminish possible negative effects have to be considered. The design is supported by measuring campaigns and numerical modeling of the currents, waves and morphology.

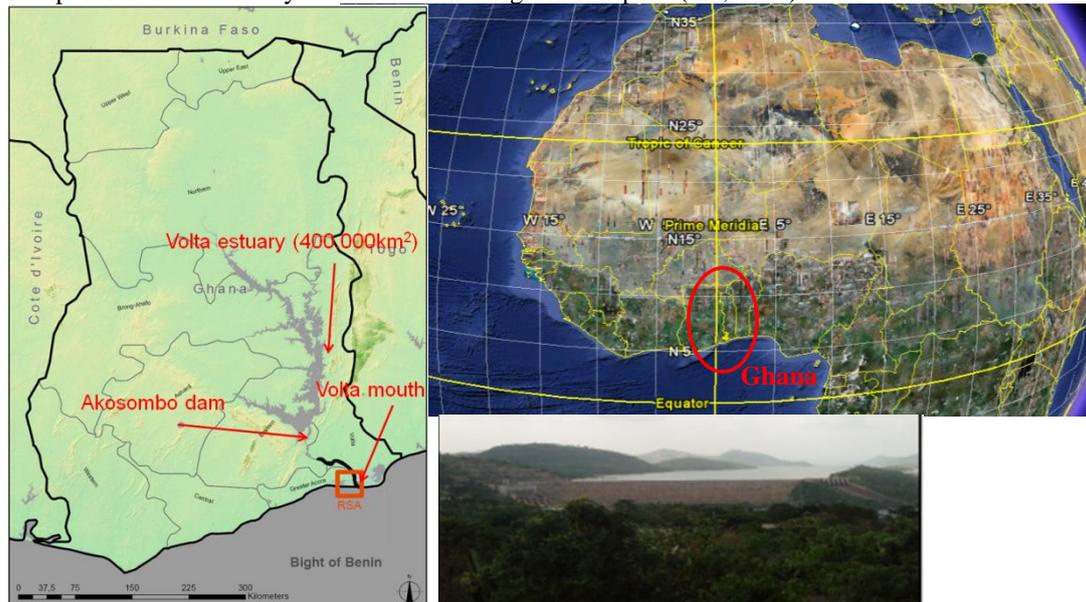
Ada is situated at the mouth of the Volta estuary (Figure 1). The Volta estuary has a catchment area of 400.000km². In 1963 the Akosombo dam was completed. The dam was constructed for the generation of electricity. Before the construction of the dam, the mean water discharge was about 1000m³/s, with peaks of 6000 m³/s. The yearly sediment transport was estimated at 7.5 million m³/s (of which about 20% sand). Since the construction no peaks in flow discharge occur anymore and the sediment transport is reduced to only a fraction of the original transport. (EC, 1989)

Figure 1 Location of project area with view on the Akosombo dam

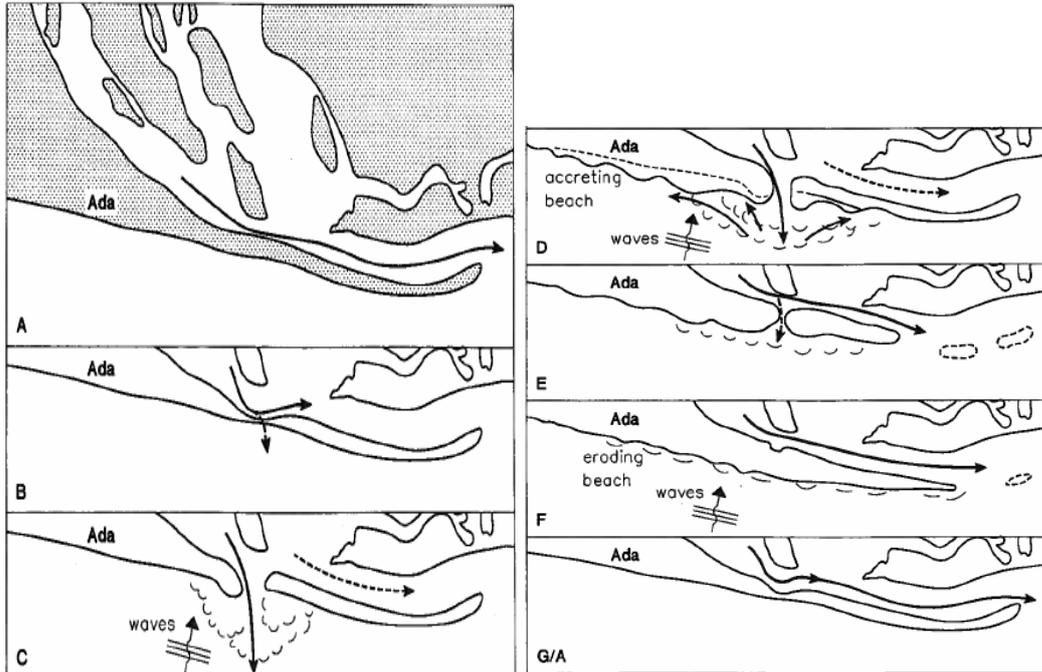
Due to the large sediment transport and the occurrence of peak discharges the Volta River delta was very dynamic before 1963. The sand spit was breached during peak flow discharges (storms) resulting in a cut off of the sand spit and hence erosion of the sand spit. Once the breach closed up again, sand supply to the sand spit resulted in growth again. This dynamic cycle is observed by Alkyon (1998) based on historical bathymetrical charts (Figure 2).

Figure 2 Dynamic evolution of the river mouth before 1963 (Alkyon, 1998, based on historical maps)

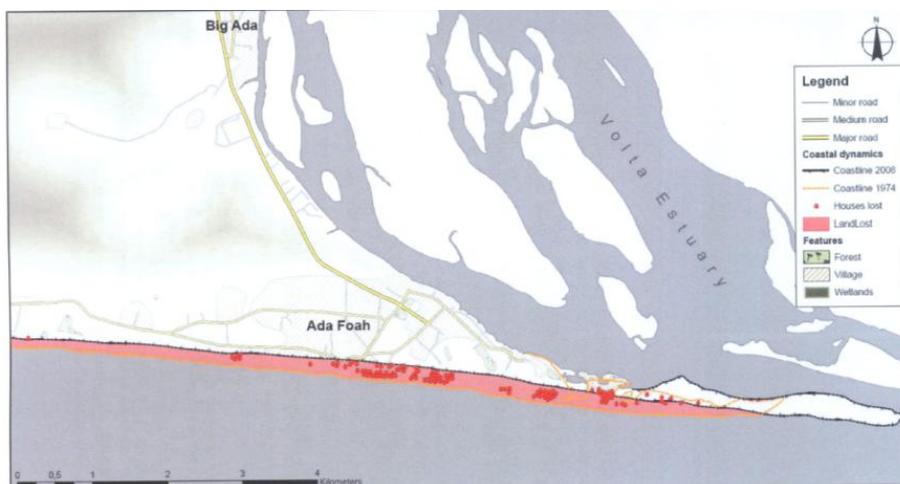
Since the construction of the dam it is observed that the coastal erosion increased significantly, also at locations upstream the mean alongshore (wave driven) current (=west of the Volta-river mouth). Figure 2 shows the coastline of 1974 (orange) and 2008 (black), the eroded area is indicated in red and the disappeared houses with red dots. The yearly retreat of the coastline is about 6 m/year and destroyed a lot of buildings. The severe erosion has also other negative effects like disappearing roads, abandoned housing near the retreating coastline, steep erosion cliffs, ...

Figure 3 Coastal erosion over the last decades with loss of buildings and growth of the sand spit in the river mouth

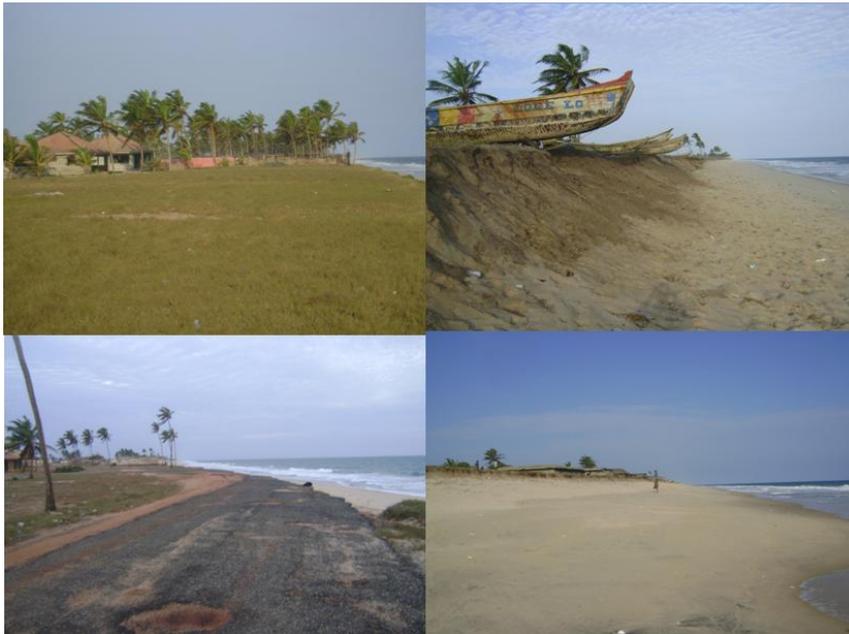
Figure 4 Negative effects of coastal erosion

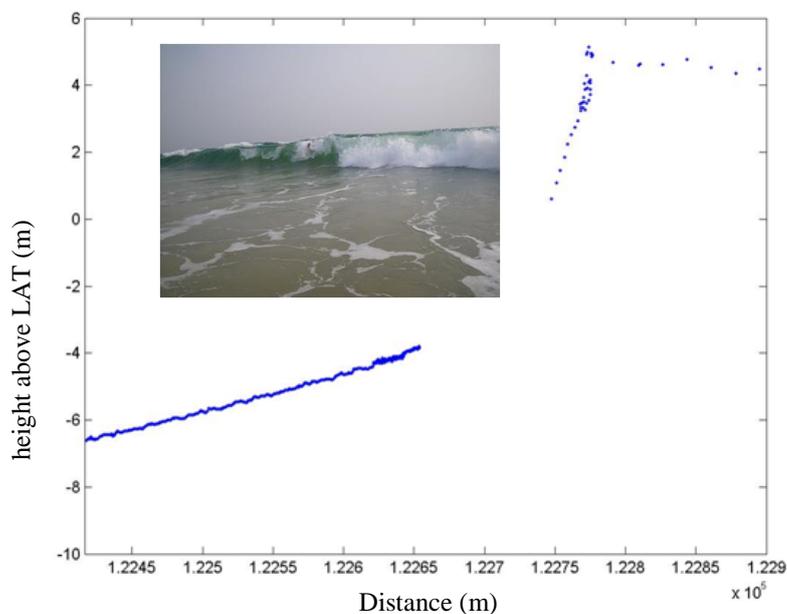
A bathymetry survey was performed in the estuary and at near-shore locations along the coastline (up to -10m LAT). A beach profile is shown in Figure 5. The beach is steep (up to 1:8) above 0 LAT and rather flat (1:100) below -4m LAT. Surveying the surf zone was impossible due to the persistent wave climate.

Figure 5 Cross shore profile – measuring conditions in the critical zone

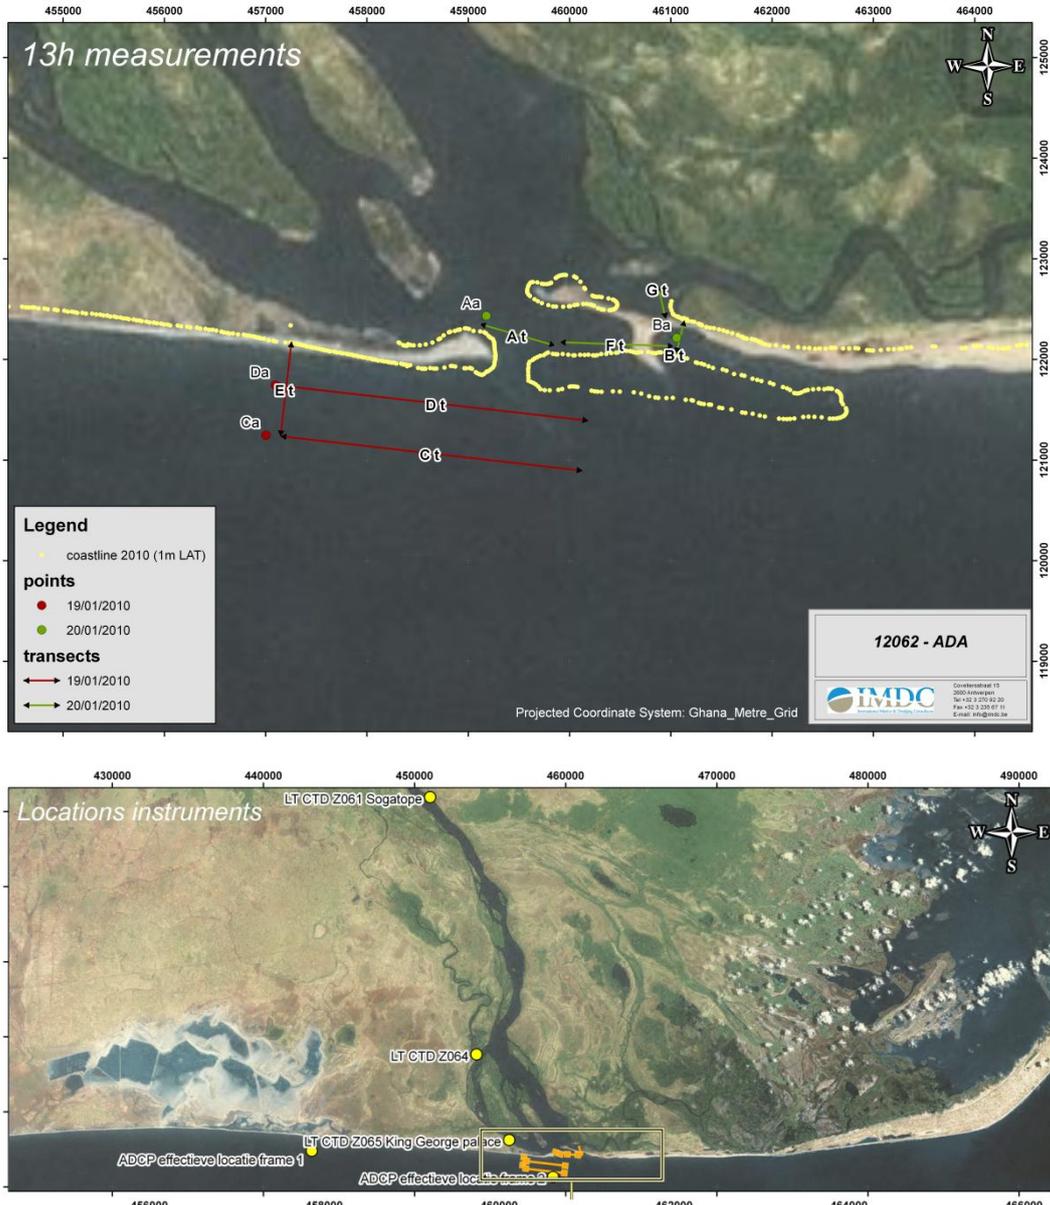
Throughout measurement campaigns of the discharge and flow rates at the tidal inlets were also executed (measuring locations are shown in Figure 6). This data gave an indication of the tidal prism, which is difficult to estimate since it is hardly known how much water flows in the mangrove areas. The

Figure 6 Locations of long term measurements (yellow dots) and through tide measurements (orange lines) and detail of the through tide measurements above

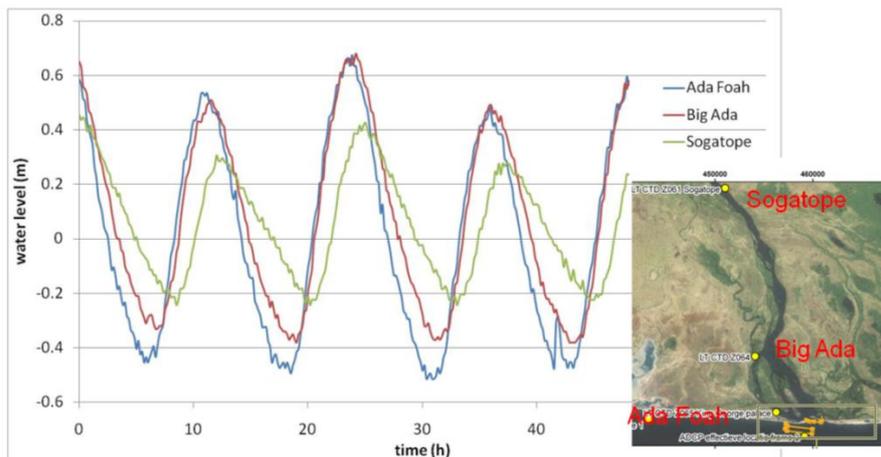
water level measurements (Figure 7) show that over the first 5km, where the estuary is very wide, the tidal amplitude hardly decrease (only 10cm), but in the river itself, the amplitude decreases fast (60cm over 20km).

Figure 7 Water levels in the Volta estuary

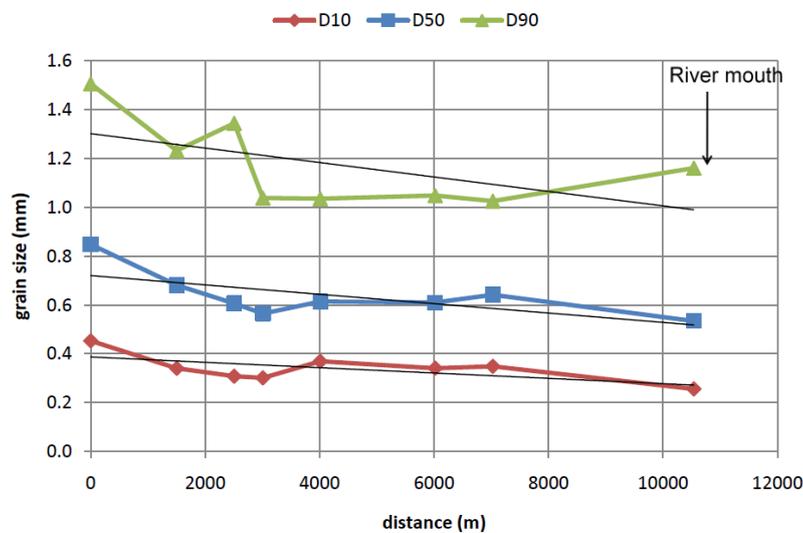
The analysis of the grain sizes (Figure 8) shows well sorted coarse sediments, with the finest sediments at the river mouth.

Figure 8 Grain sizes west of the Volta mouth

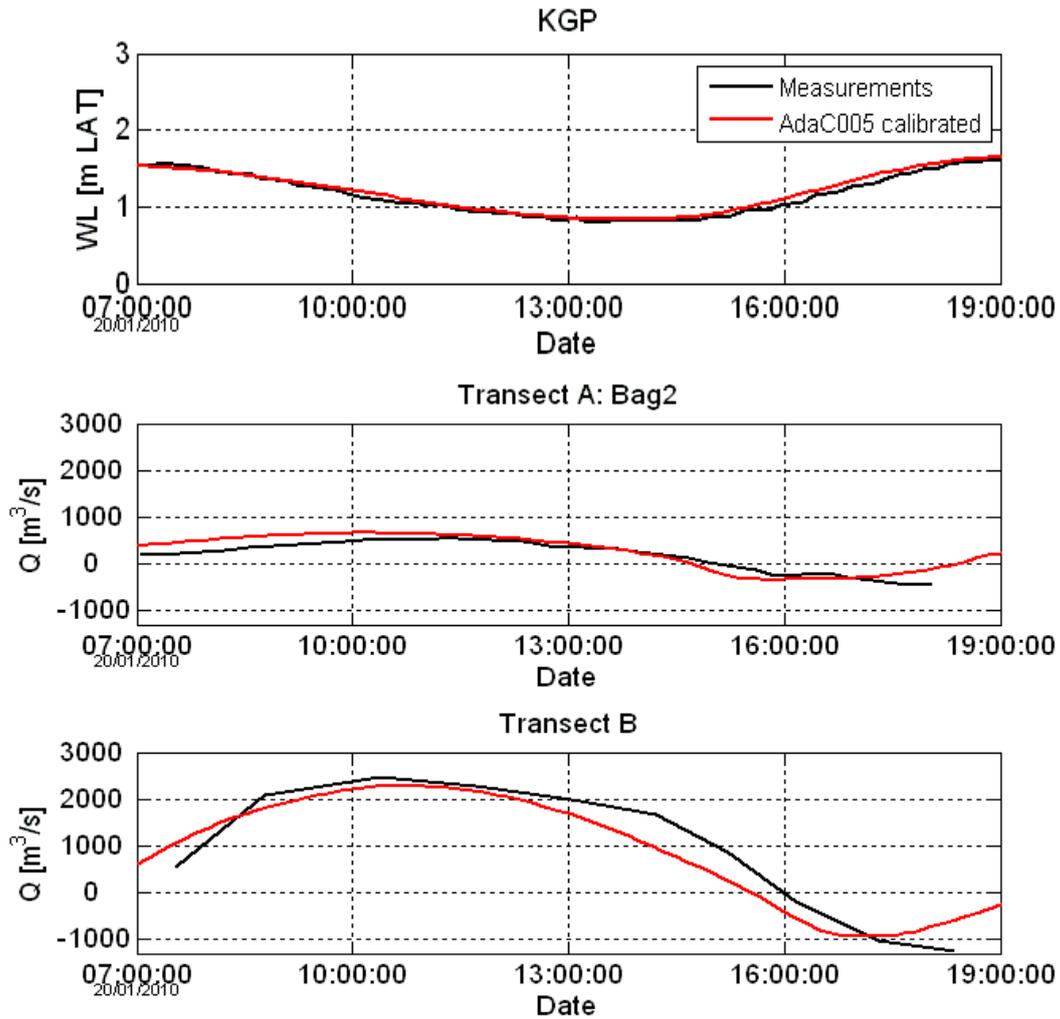
Delft3D is set up to investigate the (effect of) currents along the coast and to investigate the behaviour of the mouth. For the calibration, the different measurements are used: comparison of discharges, water levels in the estuary and the velocities at sea.

Figure 9 Calibration with the discharge at the mouth

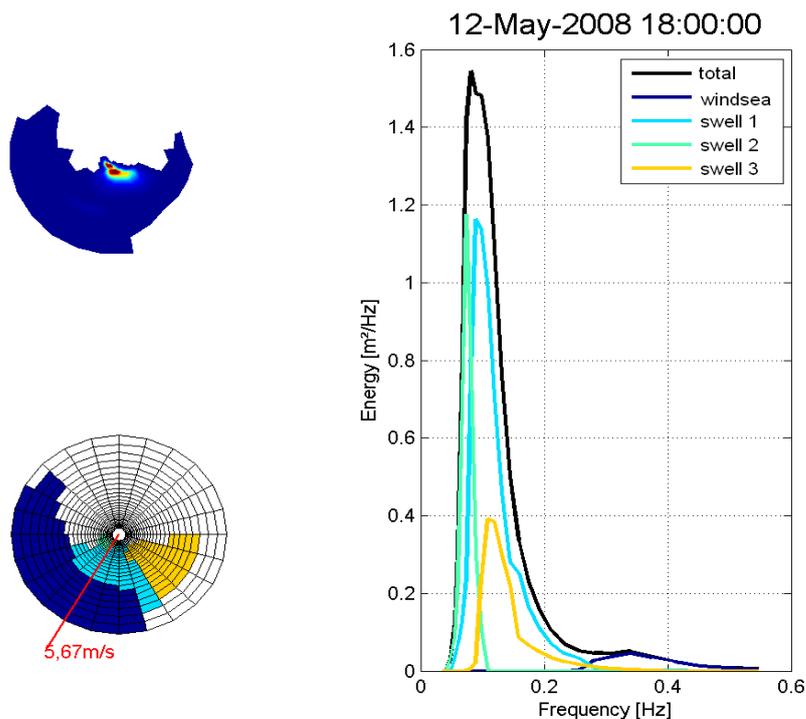
A time series of 16 years of hindcasted wave data (derived from ECMWF wave spectra calibrated by Oceanor with satellite altimeter measurements) are transformed from offshore to nearshore by means of a transformation matrix put up with SWAN. Because the wave energy is almost always composed of wind sea and swell, with different wave periods, the wave spectra first had to be split into different components (e.g. Figure 10). It was found that the offshore wave climate is dominated by swell originating from southern directions and that multiple swell components are often present, with peak wave periods of 10 s and even up to 20 s.

Figure 10 Example of the separation of the wave spectra into the different wave components

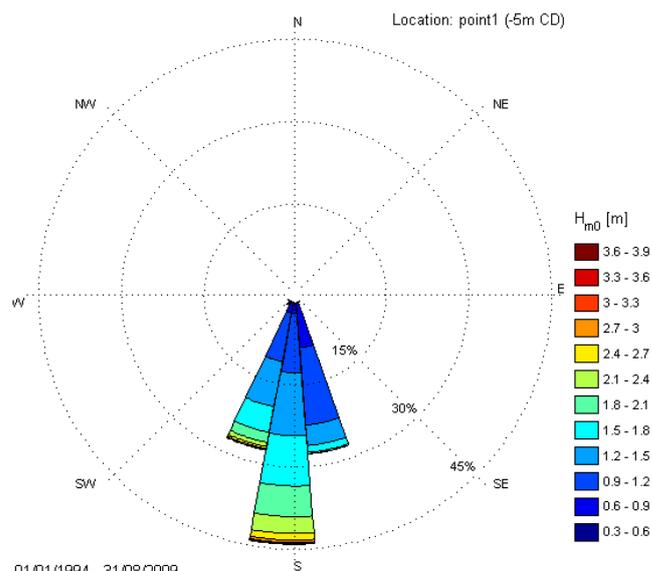
The different components are transformed separately to nearshore with the transformation matrix. For a certain nearshore output location, time series for each component are obtained, which can be superposed to obtain one time series of wave heights, wave periods and directions. With this information, wave roses are constructed. The nearshore wave direction was almost always situated between SW and SSE (Figure 11).

Figure 11 Wave rose at a nearshore location close to Ada. Peak wave directions per sector of 15°, centered around the coast normal (=183°N).

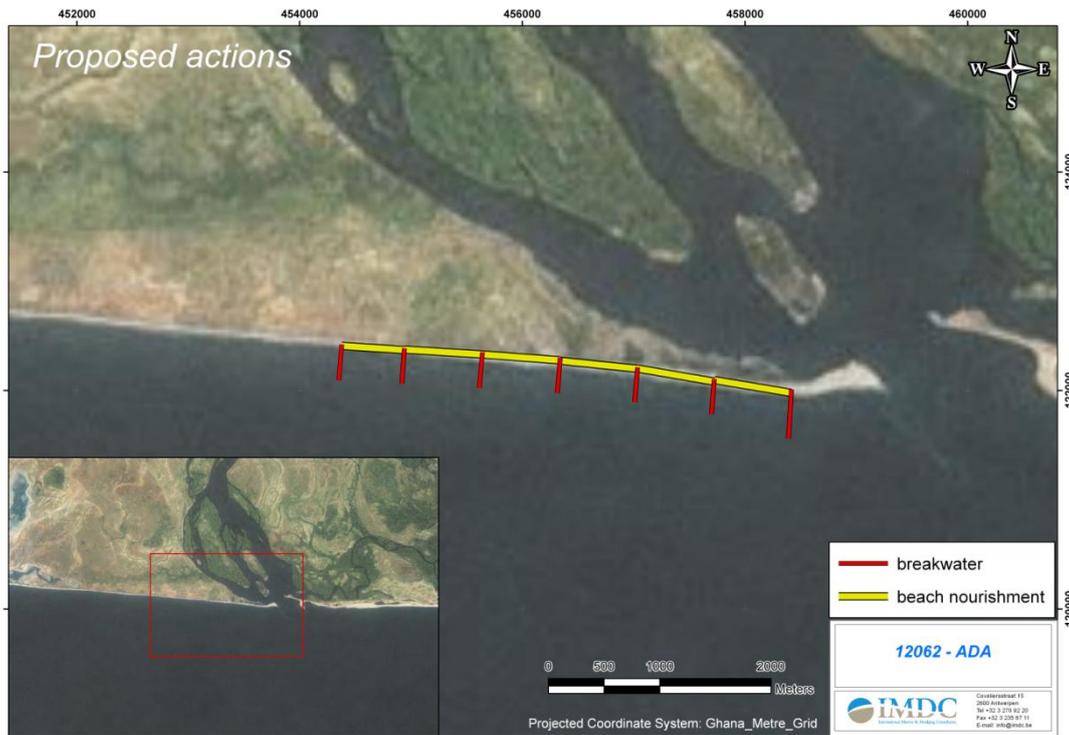
The proposed structures and beach nourishment in the preliminary design are shown in Figure 12.

Figure 12 Proposed structures, beach nourishments and sand mining zone

For the design of the groynes, beside theoretical rules, following practical aspects had to be considered: Availability of sufficient big stones (8-10 ton), taking into account the high abrasion values of the material in nearby quarries which are normally only supplying the building industry; The very long swell (peak wave periods of 10 s and up to 20 s) which makes working at sea very difficult; Occurrence of high waves and undertow which results in high losses during the construction of the core. The beach had to be designed to provide sufficient protection against flooding, while avoiding very steep beaches which might cause issues for boat landing and turtle nesting.

Increasing the length of the groyne near the estuary traps more sediment in the project area but could increase erosion of the sand spit (turtles) and the other side of the mouth (also villages), so an optimisation is necessary. The length of the other groynes has to be long enough to get a “maintenance free” solution. For the nourishment the profile should not be too steep (fishermen, turtles) and available sand from the estuary will be used.

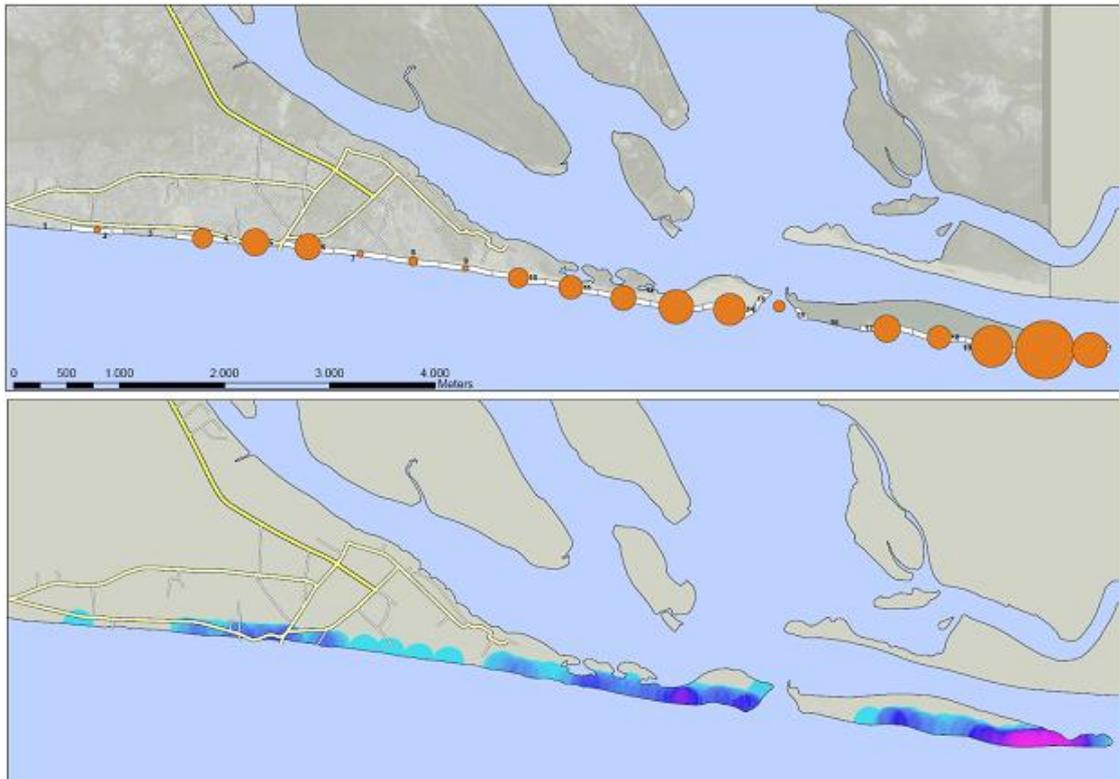
During the Ecorem field visit campaign in early December 2009, turtle activity in the entire project area was mapped using GPS (Figure 13 and 14). All sea turtle tracks, nests, sightings, poached and hatched nests were recorded for each species separately. This inventory provided a highly detailed snapshot of the sea turtle activity during the peak of the nesting season. Also, the relative density of the nests was calculated in a GIS, providing a quantitative insight in nesting density at any given point on the coastline in early December 2009. Again, the heterogeneity of nesting activity is striking. With the newly dredged access channel in place, the coastline in the project area could be said to exhibit two sandspits, both of which are significantly more popular for turtles to nest on.

Figure 13: Observed turtle activity during the Ecorem field visit (early December 2009): point results (top) and density calculation (bottom). (c) **Frederik Lerouge**

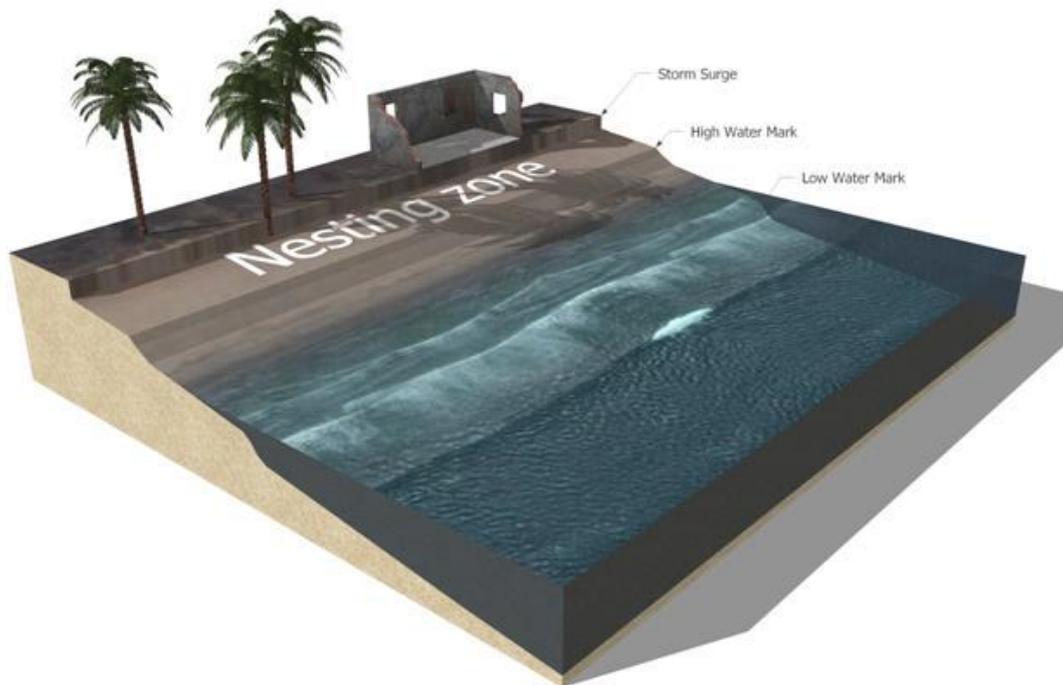
Figure 14 : Simplified diagram showing relative location of the nesting zone in Ada Foah (not to scale).(c) Frederik Lerouge

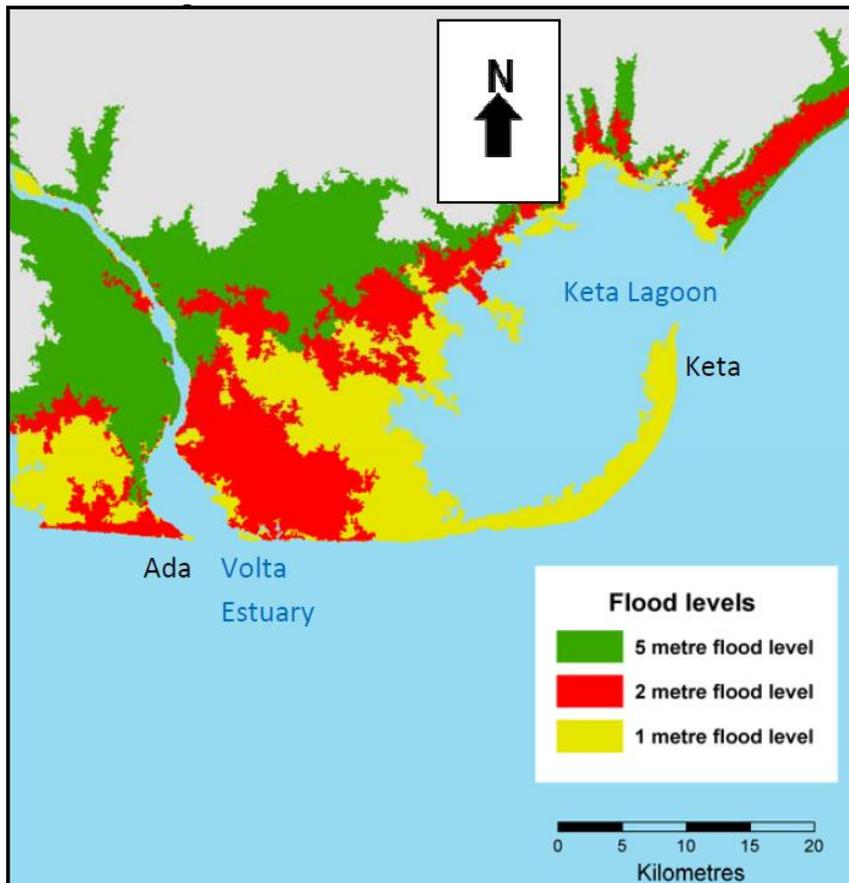
The whole Volta delta is threatened by floodings due to further erosion and sea level rise (cf. Figure 15, Boateng, (2009). Protecting the whole coastline is probably too expensive. For Ada a cost benefit analysis indicates that it is economically unviable to protect the houses, but by taking into account reduced (economical) growth (or worse) if uncertainty due to erosion remains, the analysis becomes positive. But this will not be the case for the whole area, and at most locations adaptive measures will be necessary.

Figure 15: Flood levels in the Volta estuary with regards to sea level rise.
