## CHAPTER 11

# MEASURES AGAINST EROSION AT GROINS AND JETTIES

Technical University of Denmark  
Copenhagen, Denmark  
Per Brunn

**Abstract.** One of the difficult problems on a littoral drift coast is the erosion on the leeside of groins and jetties. This paper will deal with the problem giving special consideration to the conditions on the Danish North Sea coast where many interesting problems of littoral drift and coastal protection are found. They are discussed as an introduction to the main part of the paper which is principally concerned with leeside erosion and measures for its prevention.

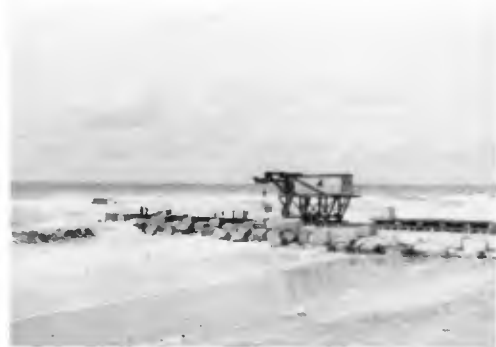
Fig. 6. The crane at work, the Lime Inlet Barriers, 1948.

The 4 tons blocks are taken to the groin on trolleys and put in place by means of specially designed self-propelled cranes running on 100 lb. rails laid out on sleepers attached to the block-hooks. The cranes are designed to carry 10 tons, so that they may also be used for handling 8 tons blocks, which are used only in the exposed places of the groin. Fig. 6 shows the crane in function. The 'land-ends' of the groins consist of three 'crown-blocks' only, and the block is often cast in the groin itself.

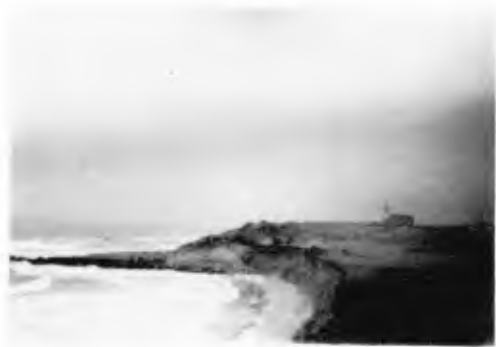
Fig. 7. Groin K, leeside-erosion, 1949.

Since the groin breaks off the beach drift from the up-drift side, the result must be erosion on the leeside. In Fig. 7 is shown the groin K, photographed from the leeside. This groin is the last on the leeside of a group consisting of 5 groins constructed in 1933-1937 south of the

The shoreline has retired 20 to 25-ft. each year for the past 10 years. It has, therefore, been constantly necessary to lengthen the land-end of groin K. The groin was in 1937 465-ft. long, in 1950 650-ft., which means it has had to be lengthened 185-ft. in only 13 years.

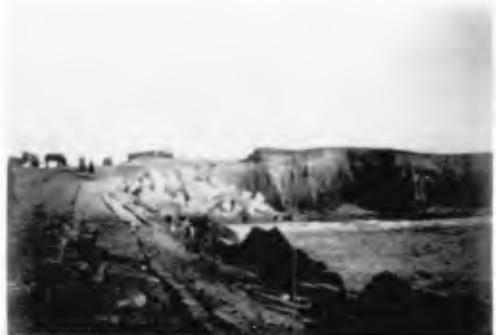
Fig. 9. Erosion on the leeside of groin I, Bovbjerg, 1895.

This measure is the most primitive, but it is often used, and it is effective when the coast retrogradation is not so strong that the shoreline moves quickly behind the end of the lateral work. Fig. 9 shows the lateral work of concrete blocks at groin 1 at Bovbjerg, photographed in 1895.

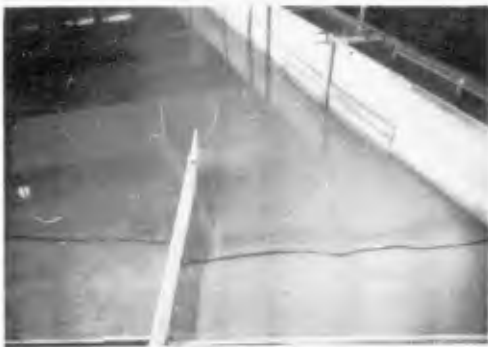
Fig. 24. Laboratory experiment, normal groin, erosion on the lee-side.

Fig. 24 shows the normal influence of a groin, accumulation on the up-drift side and erosion on the down-drift side. In Fig. 25 the groin is provided with an angle of 2-ft. as well as a rubble mound, and it can be seen that the shoreline has prograded on the leeside. Fig. 26 shows the groin with a 6-in. angle, and here the shoreline has almost the same position on both sides of the groin.

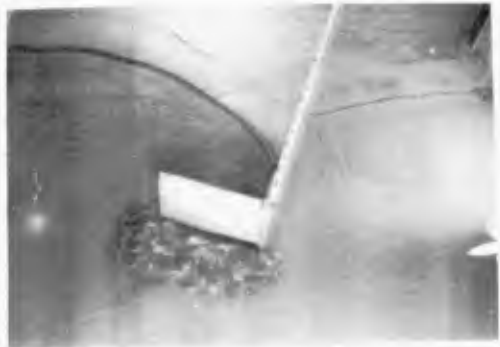
Fig. 25. Laboratory experiment, angular groin, 24-in. angle.

The angle may be a wall of sheet piling, supported by sloping piles on the inside and provided with a rubble mound in front, cf. Fig. 25; it may also consist of two rows of scattered piles with rubble. In the latter case one must make sure, by computation or experiment (see (6)) that the waves passing through the construction do not interfere with the diffracted waves so that they will be of the destructive type. The steepness ratio, therefore, must be  $<$  about 0.02. In the usual groin-heads, built of piles with rubble, the loss of energy is, however, generally so great that one may completely disregard the wave-energy penetrating the construction.

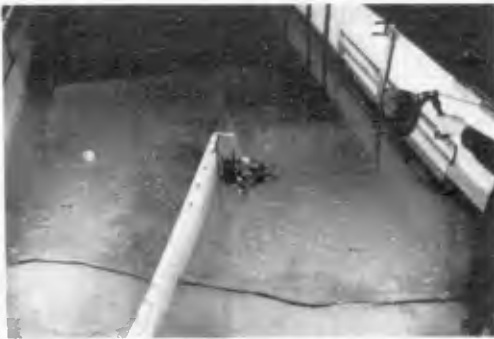
Fig. 26. Laboratory experiment, angular groin, 6-in. angle.

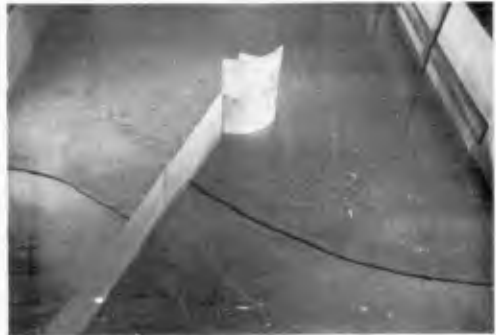
Fig. 27. Laboratory experiment, angular groin, inward-turned groin-head.

The erosion is avoided by turning the angle-end outward, so that the trajectories actually move upwards, cf. Fig. 27. It is also important that reflection from the outside of the angle is reduced as much as possible.

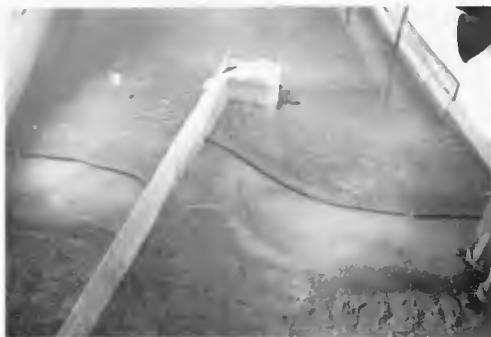
Fig. 28. Laboratory experiment, angular groin, the angle-end turned inward.

Fig. 28 shows a groin with its angle-end turned outward, radius 5-in.; when the angle-end is made in this way, no erosion will occur at the bottom. But if the angle is turned so that the end bends inward, erosion will start at once.

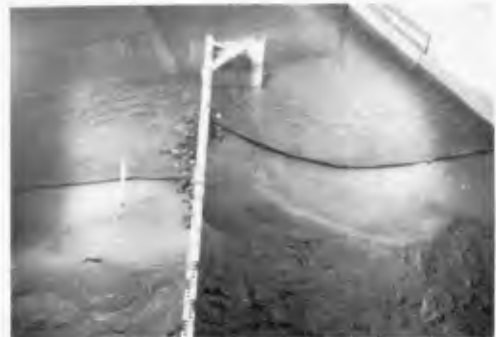
Fig. 29. Laboratory experiment, angular groin with a rubble mound along the stem.

In order to neutralize the tendency of retrogradation along the stem of the groin, the up-drift side and part of the leeside, cf. Fig. 29, are supplied with a rubble mound 1-2 in., which is especially satisfactory on the up-drift side.

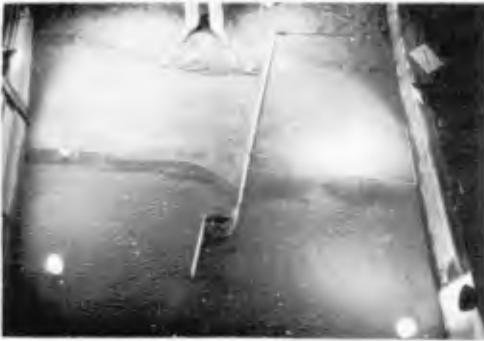
Fig. 30. Laboratory experiment, Z-groin, smooth.

Laboratory-investigations with a Z-groin. - Fig. 30 shows an experiment with a Z-groin. Similar experiments with the corresponding angular groin proved that the Z-groin in conformity with the diffraction accumulates better than the angular groin on the leeside, and the danger of erosion on the up-drift side is less than with a smooth-stemmed angular groin, as part of the wave-energy otherwise running along the groin, is now destroyed by the part parallel with the coast. In Fig. 31 the Z-groin is made rough by the use of piles; (1 x 1-in., space 4-in) this proved to be effective.

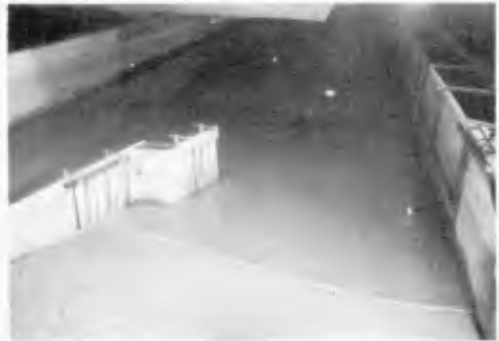
Fig. 31. Laboratory experiment, Z-groin, rough.

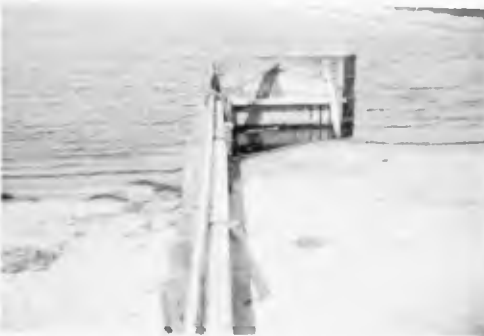
Fig. 32. Practical experiment, angular groin, Thorsminde.

Fig. 32 shows a small angular groin built by the Board of Marine Works in the Nisum Inlet, cf. Fig. 2. This groin is 50-ft. long, the length of the angle 7-ft. including the rounding at the angle-end, radius 1-ft. The wave height and wave length in heavy gales are about 1-ft. and 9-ft. respectively. The up-drift side of the groin is to the left, and

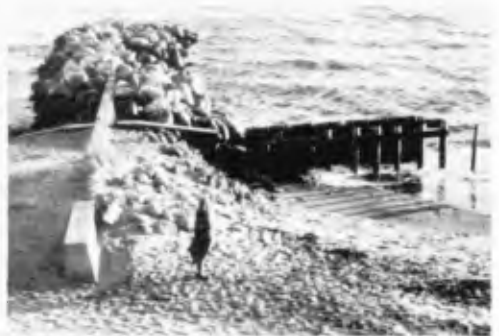
Fig. 33. Practical experiment, groin with an angle, the Scaw.

materials (sand 0.2 mm) are accumulated on the down-drift side quite as in the laboratory. The picture shows the groin at low water, but levelings on both sides of the groin show the greatest deposit on the leeside. Fig. 33 shows an angle on a groin at the Scaw, cf. Fig. 2.

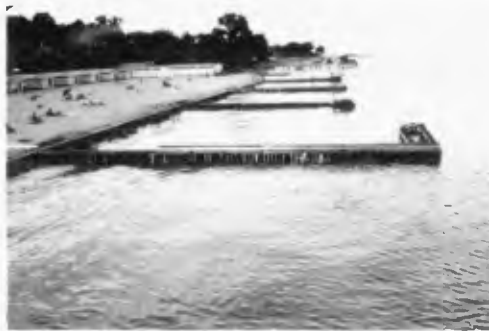
Fig. 34. Practical experiment, angular groin at Belle-Vue Beach, Copenhagen.

Fig. 34 shows an angular groin constructed at Belle-Vue Beach, the famous seaside-resort near Copenhagen. The stem of the groin is 80-ft., the length of the angle 33-ft. It was built by Gentofte municipality.
