# CHAPTER 47

## SUCCESS AND FAILURE OF COAST PROTECTION WORKS IN CEYLON

W.E.Paranathala  
Ministry of Local Government, Ceylon.

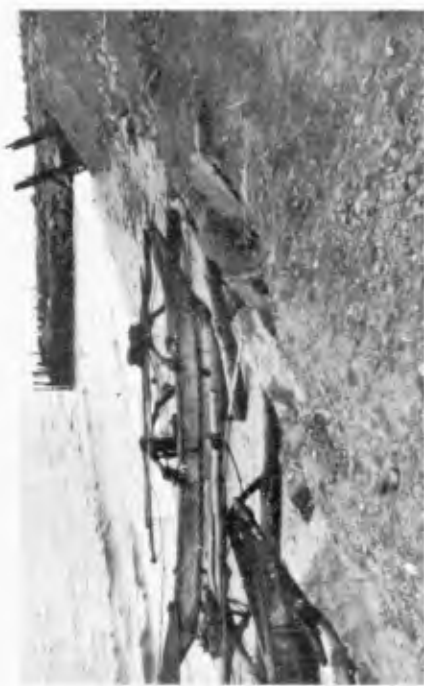
Fig. 2. Southern jetty at Wellawatta Canal outlet in the process of construction. Note the absence of a sandy beach.

In 1952, two experimental jetties, each 325 feet in length, were constructed at Wellawatta Canal out-let, in the vicinity of Colombo, (fig. 3) primarily with the object of preventing the blockade of this important flood out-let with a sand bar. Whilst these jetties now provide a bar-free out-let for the canal, the southern jetty has, incidentally, acted as a groyne in reclaiming a vast beach which was lost several years ago due to sea erosion. (fig. 3). It is significant, however, that groynes as structures for beach reclamation and coast protection have not yet been tried out in this country. In the future planning of coastal works the provision of groynes on sandy coasts will receive important consideration.

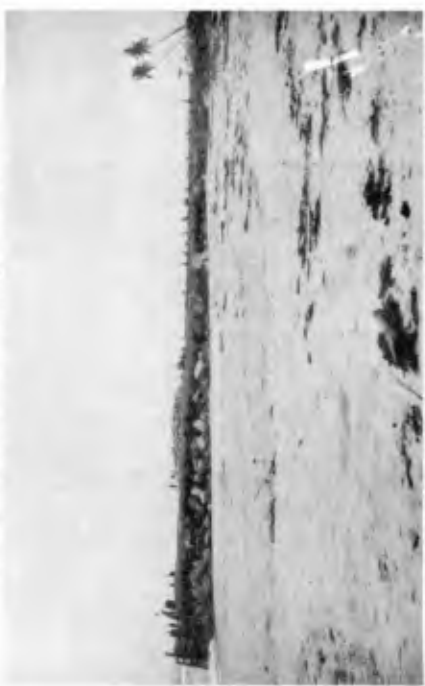
Fig. 3. Southern jetty at Wellawatta Canal outlet after completion. Note the beach re-claimed on the southern side.

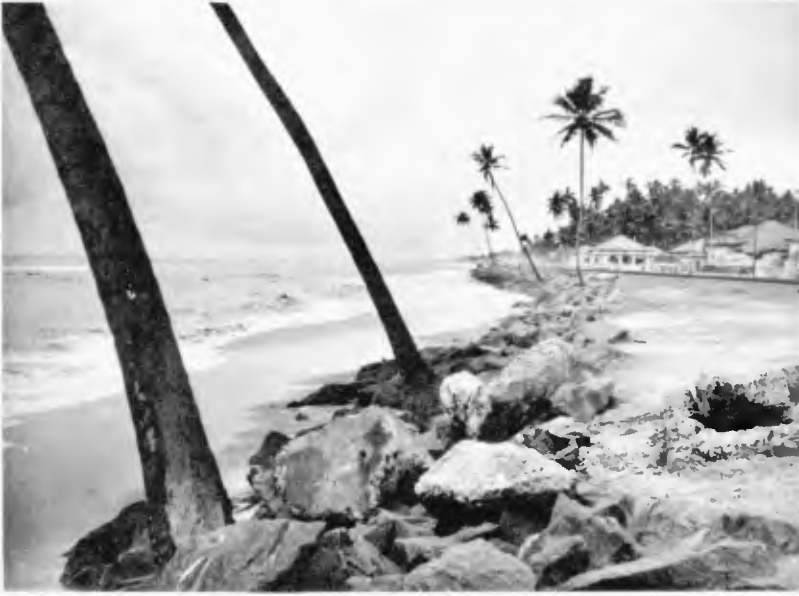
Fig. 4. Coast lined with rock stones supported at the bottom by a coral reef.

In certain sections where this type of protection has been provided, as for instance, along the coast-line railway from Kollupitiya to Wellawatta, a distance of about three miles, it has been effective in checking the advance of the sea, (fig. 4). The rock stones in this reach have been placed to a maximum height of about ten feet and are supported at the bottom by a coral reef. Storms sometimes displace the stones. The displaced stones are then replaced with new ones. There are a few other sections along the western coast-line where this type of protection has been effective. In all these sections the rock stones are resting on coral reefs. Of the total length of about 30 miles of coast lines provided with rock stone protection only a total length of about 8 miles can be said to be effectively protected.

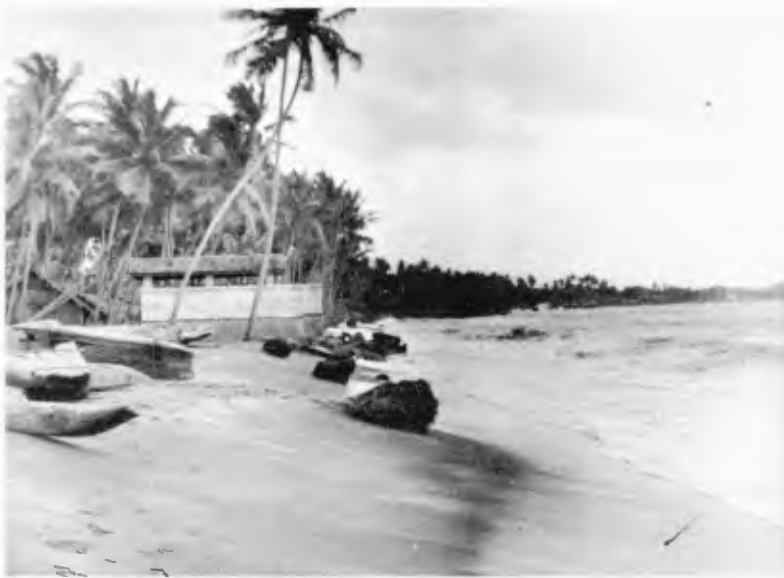
Fig. 5. Coast lined with rock stones supported at the bottom by a sandy beach. Most of the stones have disappeared under the sand.

In all other places where the rock stones are resting on the sandy beach this form of protection has proved ineffective. (fig.5). Not long after the stones are placed on a sandy foundation the pummeling action of waves undermines the sea bed. This scour being greatly induced by the stones themselves they are gradually lost in the sand by a continuous process of sinking. With the disappearance of these stones the waves advance inland. When due notice is taken of this incursion a second line of defence is erected behind the first. Ultimately, this too disappears as before, leaving the problem of coast protection to an indefinite solution of dumping rock stones.
