CHAPTER 50
SHORELINE ADVANCEMENT BY SEA WALL
AND GROYNES AT COCHIN

M. G. Hiranandani
and

C. V. Gole
Central Water & Power Research Station
Poona, India

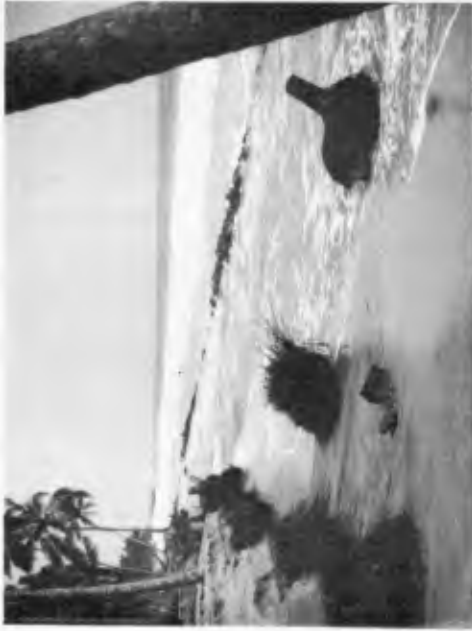
Fig. 5. Recession of the coast with sea wall alone.

One mile long experimental sea wall with groynes has proved to be effective in giving protection to the coast under erosion. Protective measures are, therefore, being extended to the south of this reach for a length of 10 miles. In order to give immediate protection to the coast and due to availability of limited funds sea walls alone are constructed in 8 mile length of the coast. Considerable damage has taken place to these sea walls. Prototype experience has thus clearly shown that without groynes sea walls are ineffective in affording protection to the coast. Figure 5 shows the recession of the coastline with the sea wall alone. In the remaining two mile stretch of the coast, sea walls supplemented with the groynes are constructed. Though some damage has taken place to the sea wall itself, sand has accreted in the groyne field and the conditions are much better than those obtained with sea walls alone (Fig. No. 6). The results with sea walls and groynes have been found encouraging in these reaches also, and 200 ft long groynes are being immediately added to the sea wall.

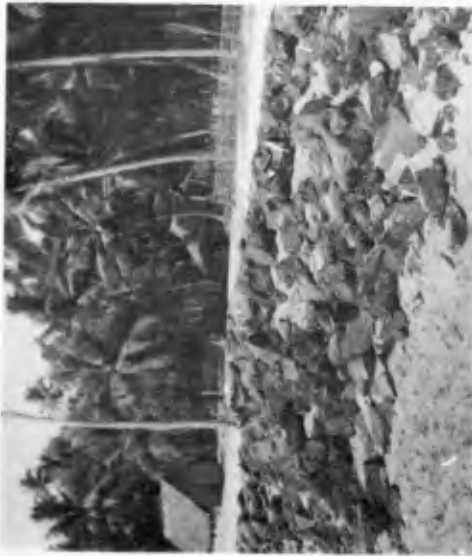
Fig. 4. Damage to sea wall constructed with bituminous grouting.

The sea wall could not withstand the wave attack though waves were only 3 to 4 ft in height. It was considerably damaged within a month and a half after its construction. Fig. 4 shows the damaged conditions of the bituminous grouted sea wall. This type of sea wall did not give satisfactory results in this particular case. It has been, therefore, decided not to use such type of construction for the protection of the remaining coast.

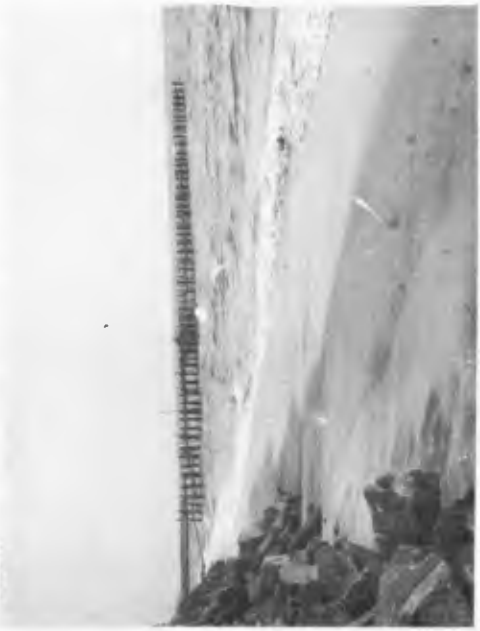
Fig. 7. Groyne being constructed with coconut piles.

The cost of rubble groynes has been found to be high and an alternative type of semi-permeable groyne is, therefore, being tested in the prototype. This consists of two rows of coconut piles which are driven to 7 ft below bed level. Space between the piles is being filled with fascines. The results would be available by the end of August 1960. Figure No. 7 shows the semi-permeable groynes under construction.

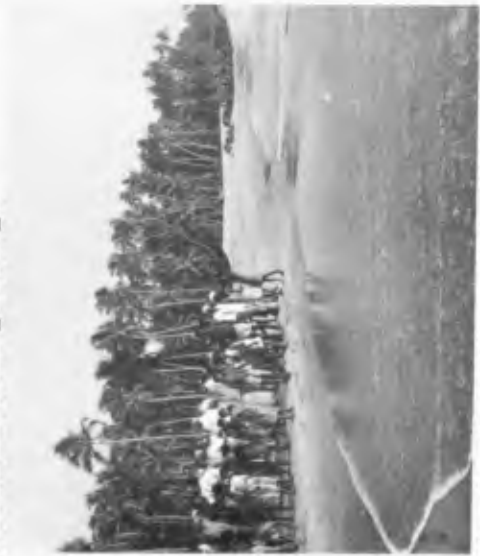
Fig. 6. Accretion taking place in the groyne field. Notice also the damage to the sea wall.
