CHAPTER 57
THE DAMAGES OF COASTAL DIKES AND RIVER LEVEES
AND THEIR RESTORATION

Masanobu Hosoi, Yasuteru Tominaga
and Hiroshi Mitsui,
Coastal Engineering section, the Public
Works Research Institute, Ministry of
Construction, Japan

STORM SURGES DUE TO THE TYPHOON NO.13, 1953 AND RESTORATION OF THE
COASTAL-DIKES

DAMAGES OF COASTAL-DIKES AND RIVER LEVELS DUE TO THE ISE BAY TYPHOON AND THEIR COUNTER PLAN

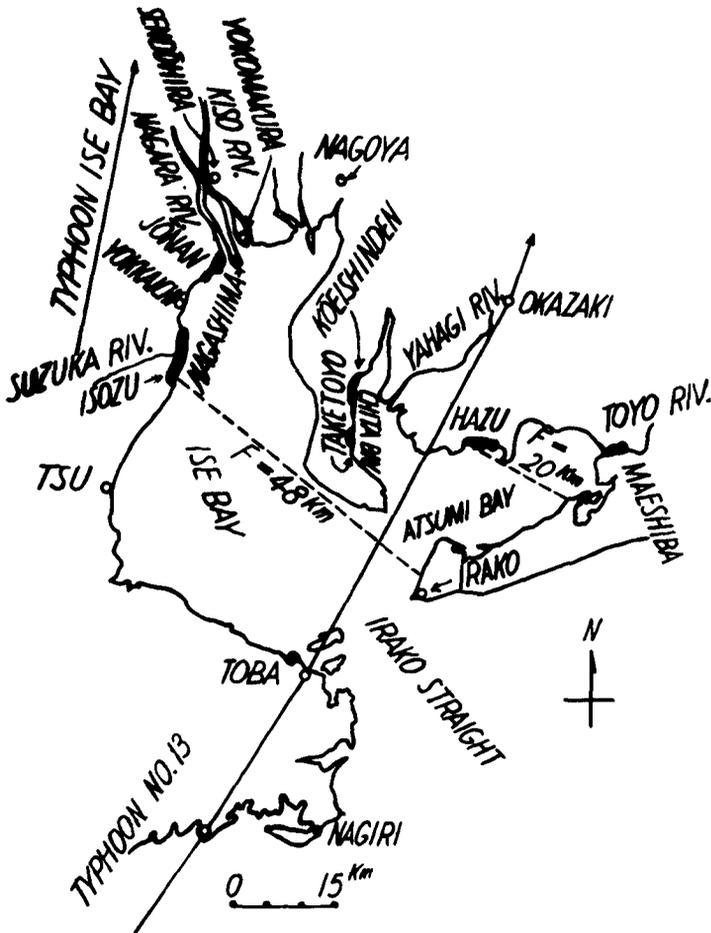
Fig.4.1 Outline map of Ise, Atsumi and Chita Bay.

In Table 4.2, the dimensions of coastal-dikes along each coast (see Fig.4.1), the highest tidal level at the time of Ise Bay Typhoon, the

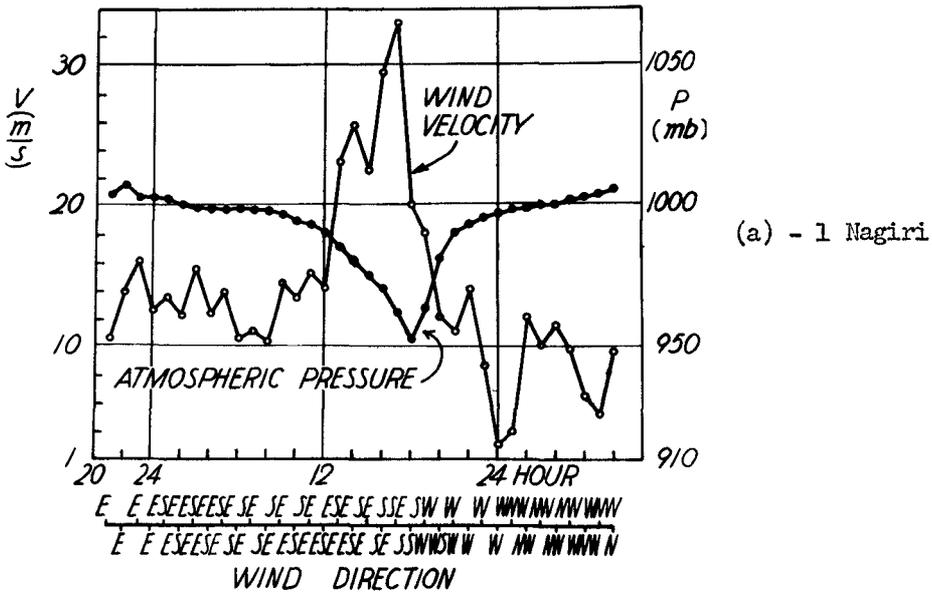
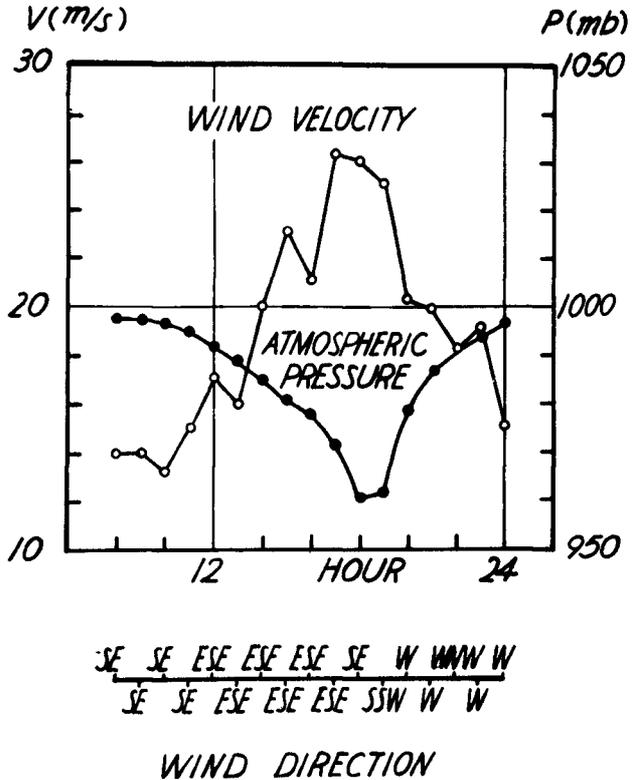
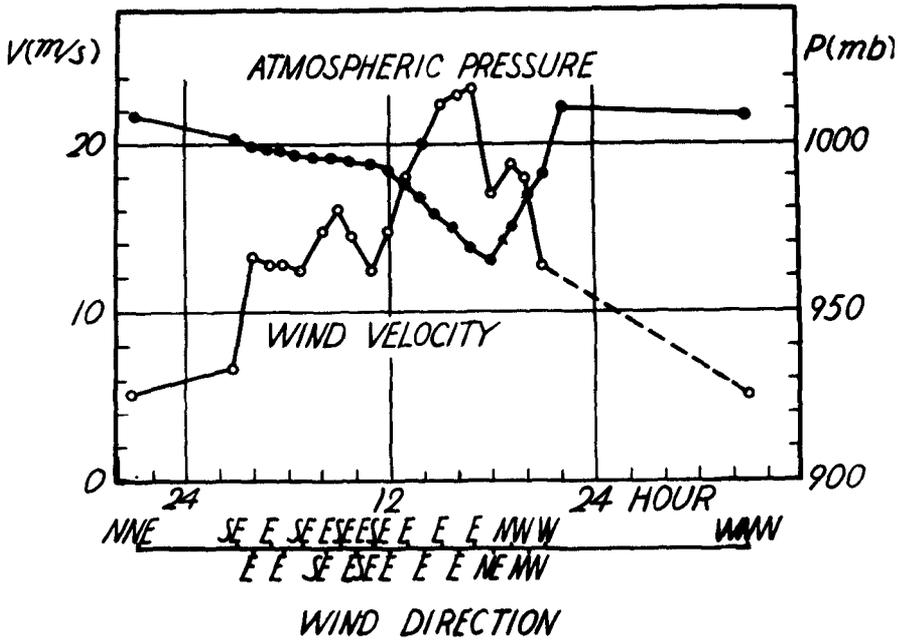
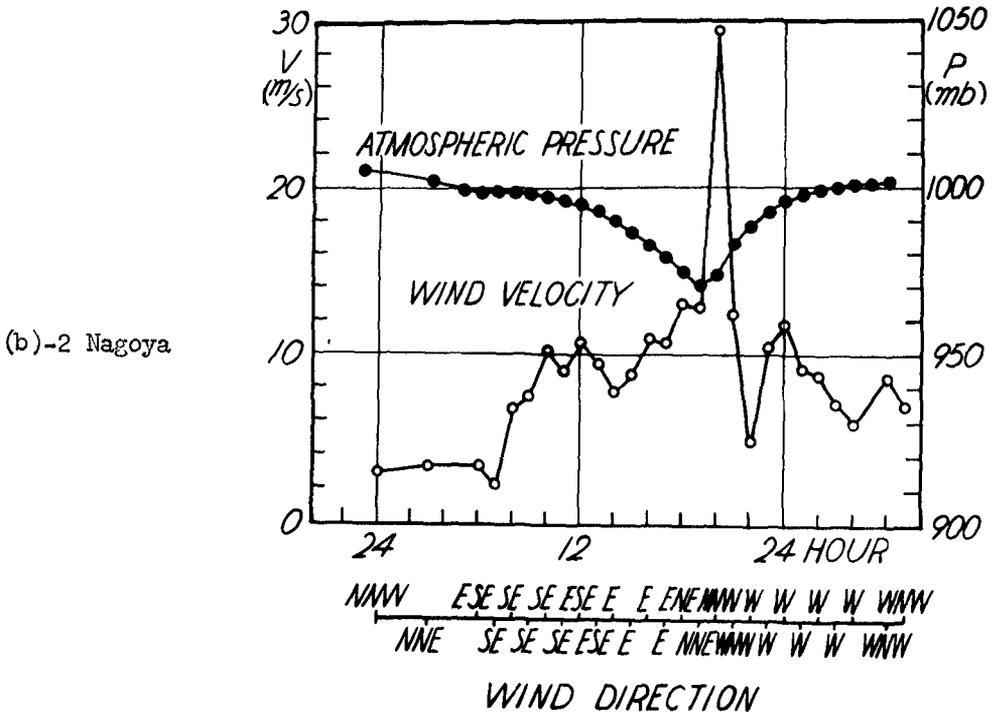
In Fig.4.2 the records of the wind directions, wind velocities and atmospheric pressures at several places are shown. In Fig.4.2-a those on right side of its course, and in Fig.4.2-b, those on left side on its course are indicated. On the right side of its course the wind directions at the maximum wind speed were SE - ESE, while on the left side of its course were E - WNW.

Fig.4.2 Weather Condition at each place on the occasion of the Typhoon No.13.

Fig.4.2 Weather condition at each place on the occasion of the Typhoon No.13.

As shown in Fig.4.2 the lowest atmospheric pressure was about 970 mb. which occurred about 0.4 m statical rise of sea surfaces. Judging from Fig.4.3, we can estimate that in the first place the

To estimate the waves in bay at the time of Typhoon, we investigated the relationships between the wind velocity of E - ESE and the wind duration from wind records shown in Fig.4.2, and those were tabulated in Table 1. The longest fetch in the Ise Bay and Atsumi Bay is about 60 km, and the wind speed is 20 - 25 m/s, so the minimum duration is calculated at 3.5 - 4.0 hrs by S.M.B. method. From Table 1, it is considered that the waves at the time of Typhoon No.13 reached at stational condition at the wind velocity of 25 m/s.

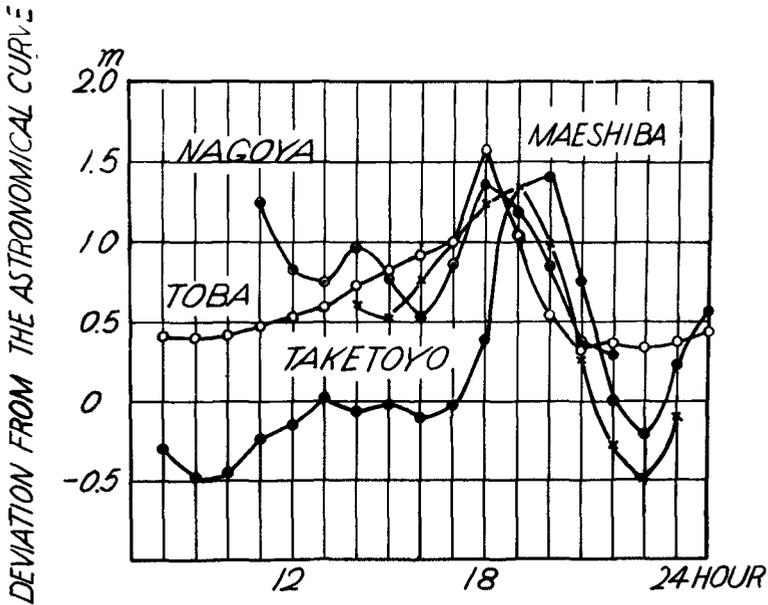
In Fig.4.3, deviations from the astronomical tide at each place within the bay are shown, and we see that its maximum value of 1.6 m was recorded at Toba at 18 o'clock, and 1.4 m - 1.5 m at other places.

Fig.4.3 Deviation from the astronomical tide at each place on the occasion of the typhoon No.13.

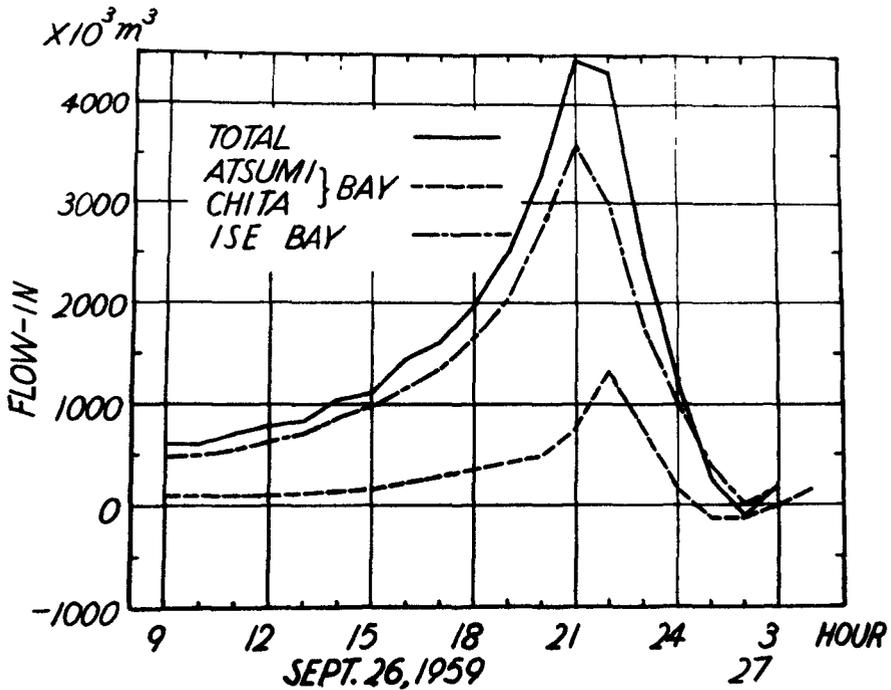
Fig.4.4 Sea water volume flowing into each bay on the occasion of the typhoon No.13.

Such a phenomenon also occurred in the attack of the Ise Bay Typhoon. Fig.4.4 shows the total volume of inflow into the bay which was calculated by using the simultaneous deviations of water level from the astronomical tide at several points in the attack of Ise Bay Typhoon. From this figure, we find out that there already was extraordinary flow into the bay at 9 o'clock. So it is considered that at this time there was extraordinary inflow due to the wind set up near the entrance of the bay and that the inflow was transported in the shape of long wave due to the disturbance near the typhoon center. After this initial time, the inflow increased exponentially up to its maximum value of 450 million tons (cumulative volume) which occurred at 21 o'clock. Fig.4.5 indicated the change of SE, SSE and SW components of wind force observed at Irako Weather Station near the bay entrance. Then it is considered that the water flew into the bay from open sea by the SSE - SE component of wind force because the bay opens towards SSE - SE.

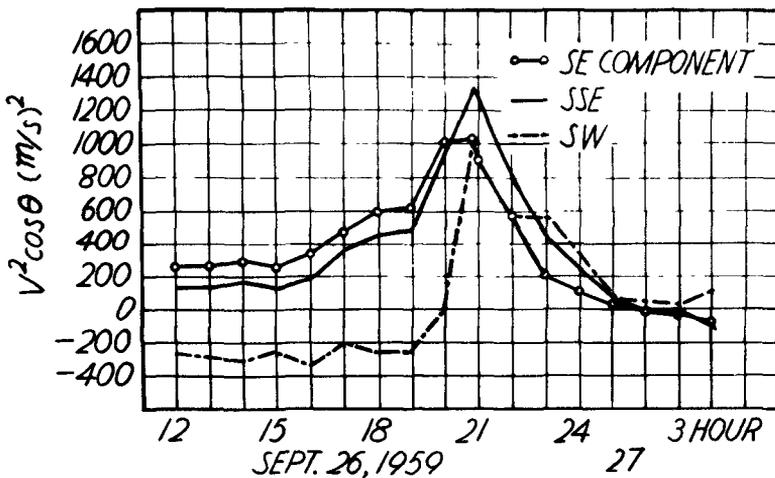
Fig.4.5 Wind force at Irako on the occasion of the Typhoon No.13.

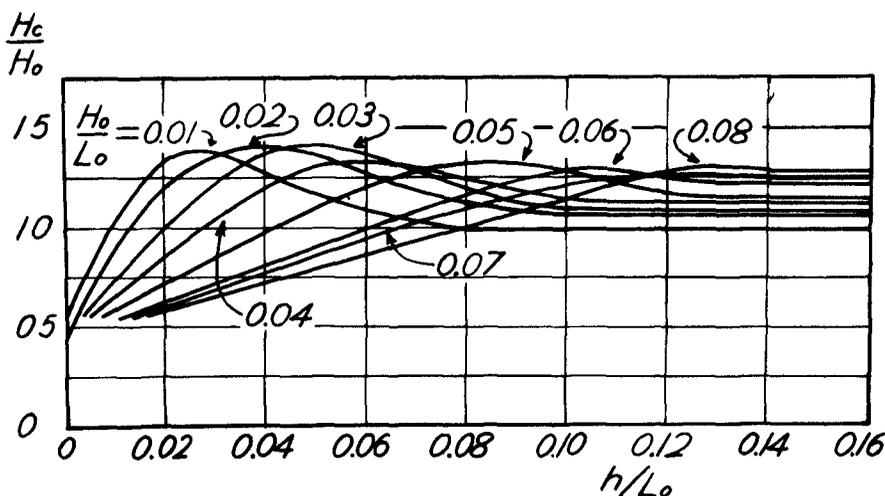
The wave run-up on coastal-dikes of which slope are vertical to 1 on 1 was determined by Fig.4.6. These curves were proposed by the Public Works Research Institute, Ministry of Construction, combining experimental results of wave run-up with the highest wave theory in shallow waters.

Fig.4.6 Wave run-up as a function of structure depth and wave steepness.

As the heights of dikes determined by Fig.4.6 are not always sufficient to prevent wave overtopping in the strong wind, it is also necessary to cover the back slope of dikes with solid material. Making comparative study of the design method mentioned above and the aspect of damages of coastal-dikes, we conducted the revised design.

- 1) When the dike height is lower than the height of wave run-up as shown in Fig.4.6 and the back slope has no solid covering, the damages of dikes are inevitable.
- 2) When the dike height is as much as the height of run-up as shown in Fig.4.6, the thickness of concrete covering of back slope should be more than 10 cm.

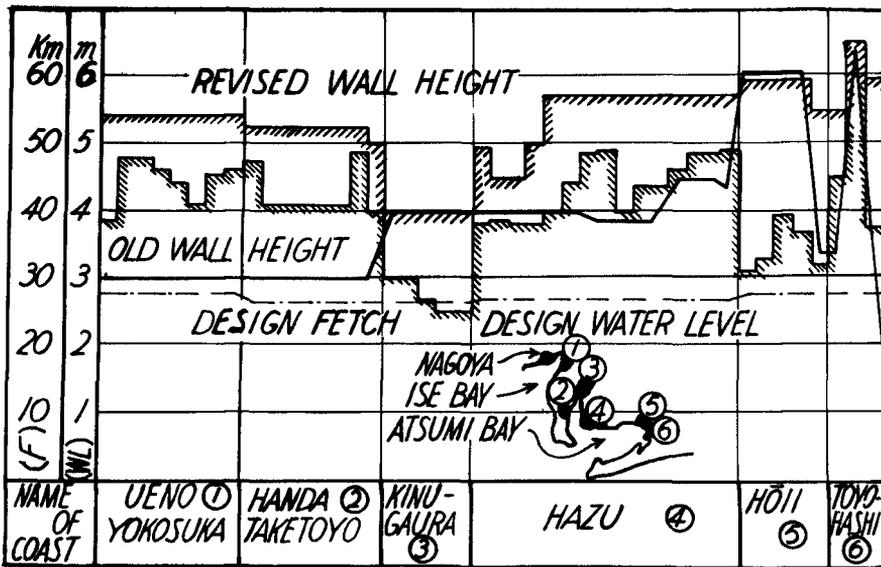
The heights of restoration coastal-dikes designed in such a steps are compared with that of original coastal-dike and are shown in Fig.4.7.

Fig.4.7 The height of restoration coastal-dike and established one.

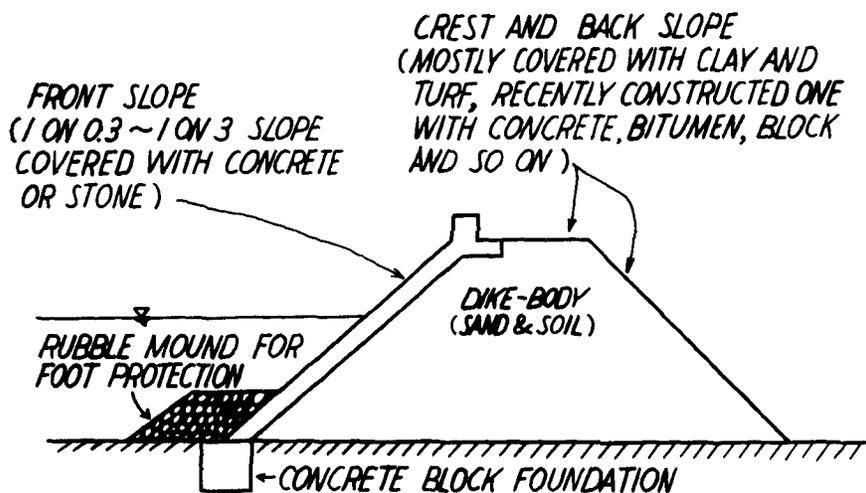
Fig.4.9 Typical cross section of coastal dike with embankment type.

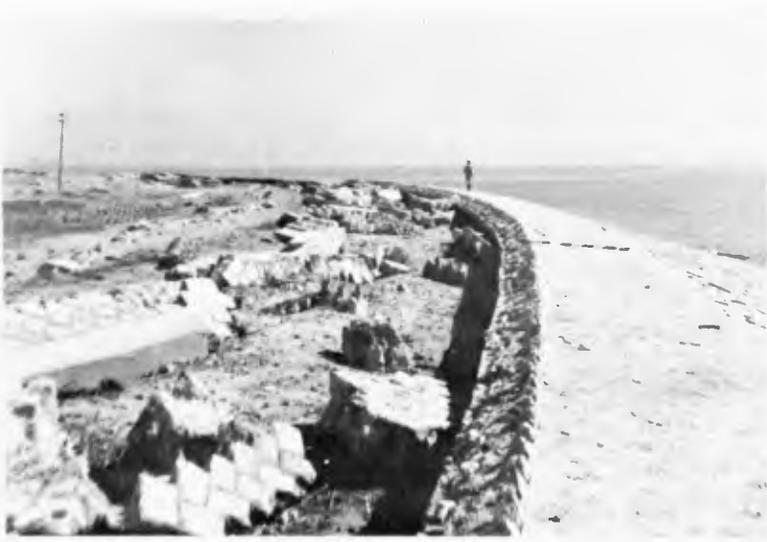
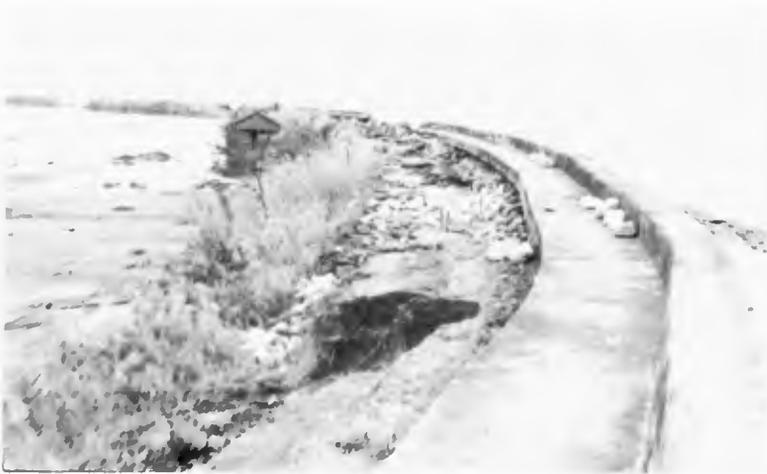
There are Nagashima and Jonan coastal-dikes at the left and right sides of Nagara River respectively. Their cross sections are almost the same, and only their heights are different in about 1 m. Since the shape of sea bottom in front of coastal-dikes are almost coincided with each other, it can be supposed that the tidal levels and waves are almost the same. Nevertheless Jonan coastal-dike were broken down almost over the whole area as shown in photo.4.1-a, while Nagashima coastal-dike were broken down only 200 m of the 1.5 km length as shown in photo.4.1-b, although the dike body was scoured considerably by wave overtopping and situated in a dangerous condition. This is an example to show the difference of damages due to the difference of dike heights. As shown in Table 4.2, the tidal level near this coast is T.P. 3.5 m and wave height is 2 m. Under the condition that slope is 1 : 3, water depth at the toe of coastal-dikes is 4 - 5 m, and steepness is about 0.05, wave run-up become about 1.5 times of wave height. Calculating the maximum height of wave crest from these values mentioned above, we obtain T.P. 6.5 m. Therefore, we suppose that although the Jonan coastal-dike was always attacked by wave overtopping, the rate of wave overtopping at Nagashima coastal dike was very small, and the coastal-dike was only attacked by some extent of spray. This is an example to show that if the height of coastal dikes is taken the maximum crest height of significant wave, there will be a considerable strength of the coastal-dike to resist the waves without any covering on the dike crest and the back slope.

Photo.4.1 The damages of coastal dikes near the mouth of Nagara River.

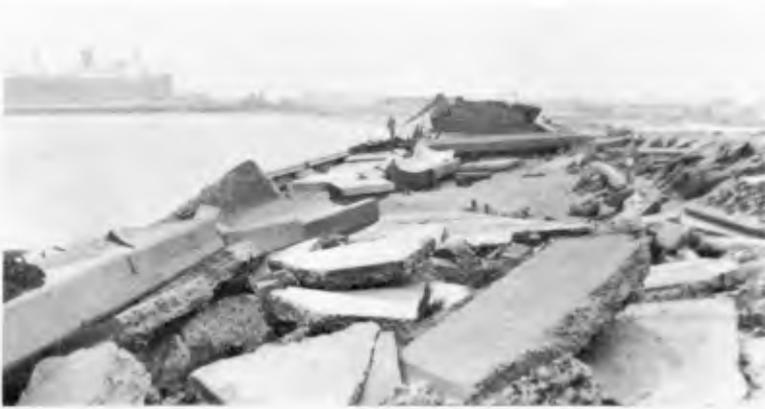
In photo 4.3, the aspect of damages of coastal-dikes at Isozu coast which located at the right side of Suzuka River is shown. These coastal-dikes were constructed after the disaster suffered from Typhoon No.13 in 1953.

Photo.4.3 The damage of Isozu coastal dike.

The reasons why the whole body of coastal-dike destroyed can presumably be interpreted as follows. Some voids were formed in the parts of joints by wave pressure. Consequently a large quantity of soil flew out through the void and at last the dike body was broken down.

The water depth in front of coastal-dike is 3.4 m, and the ratio of water depth to wave height is about 1.2, so it is just in a condition for wave breaking, then we may say that there existed considerably large pressure exerted on the dike body.

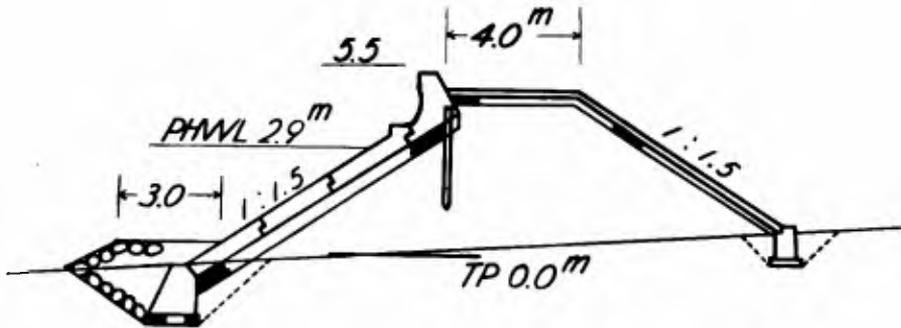
The cross section of the dike is shown in Fig.4.11.

Fig.4.11 Typical cross section of Isozu coastal dike.

The front slope is 1 : 1.5 and the front slope, crest, and back slope are all covered with the concrete. The design water level was T.P. 2.9 m, the design wave height was about 2 m and the crest height was 5.5 m. For the Ise Bay Typhoon, the tidal level was T.P. 3 m, the wave height was 3.4 m, and the latter was considerably higher than designed wave height.

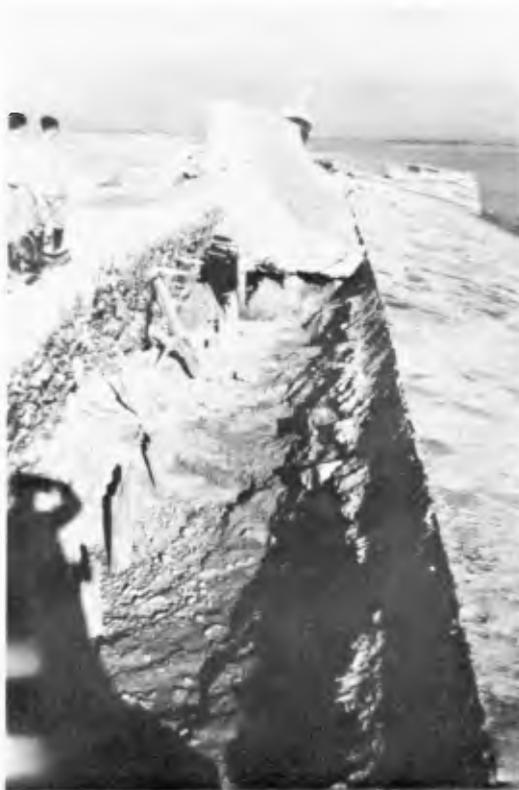
The damage aspect of coastal-dike in Koeishinden at Handa, located at the inner part of Chita Bay, is shown in photo.4.4. The covering of these crest was not yet constructed.

Photo.4.4 The damage of Koeishinden coastal dike at Handa.

The aspect of the overturning of parapet is also seen in this photograph, and this phenomenon was seen everywhere in this disaster. The front surface of the usual coastal dikes in this district is constructed from two parts, one of which is a flat concrete slab and the other is a heavy concrete parapet.

Such a heavy parapet will be easily overturned by wave pressure, if the dike soil near the crest flows out due to wave overtopping. In Koeishinden the parapets were supported by wood piles, but these piles were not so effective to support them against the lateral force.

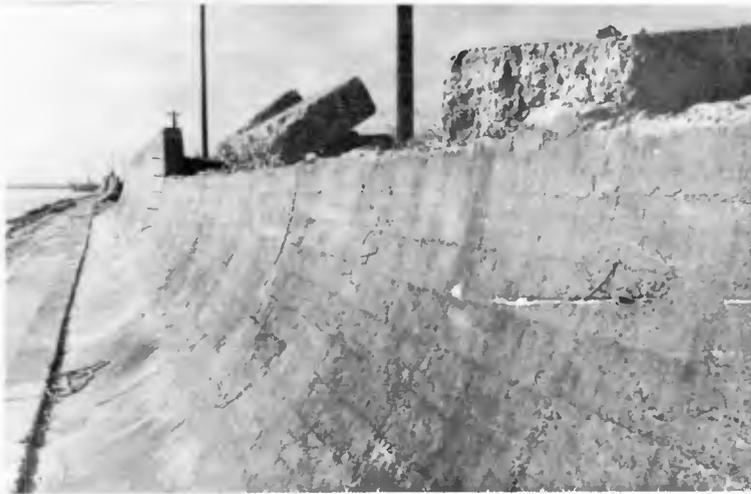
The overturning of parapet could be also seen everywhere in the inner part of Ise Bay (photo.4.5). The tidal level in the Ise Bay Typhoon was fairly higher than the designed level, so the wave energy was concentrated about the parapet. This might be a reason of many overturning in the region.

Photo.4.5 The overturning of parapet in the coastal dike at the left side of Nikko River.

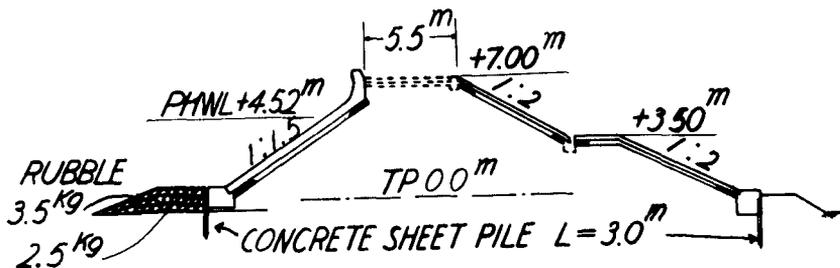
The cross sections of coastal-dikes were so-called the type of embankment as shown in Fig.4.12, and were determined by taking consideration of the aspect of damages mentioned above. In designing of that we specially stressed subjects as follows:

(i) Parapet was lightened as much as possible, and reinforced bar inserted so that it could resist both the wave pressure and earth pressure.

Fig.4.12 Typical cross section of restoration coastal dike.

(ii) The covering of front slope was connected to the foundation block by reinforced bar in order to resist the uplift pressure of sea water.

(iii) Sheet piles were driven in at the toe of foundation blocks in order to protect from creating the hole at the down part of the covering of front slope due to penetrating water.

(iv) In order to commence the covering of crest and back slope soon after banking, the condensation of dike soil was accelerated by vibrofloatation method.

(v) Sheet piles were driven in at the foundation of back slope in order to stop the outflow of penetrating water and to protect the outflow of dike soil.

(vi) The foundation of back slope was constructed not to contact with directly channels behind coastal-dike in order to increase the transverse resistance of the foundation.

(vii) Porous concrete was used at the lower part of covering of back slope in order to decrease the uplift pressure due to penetrating water.

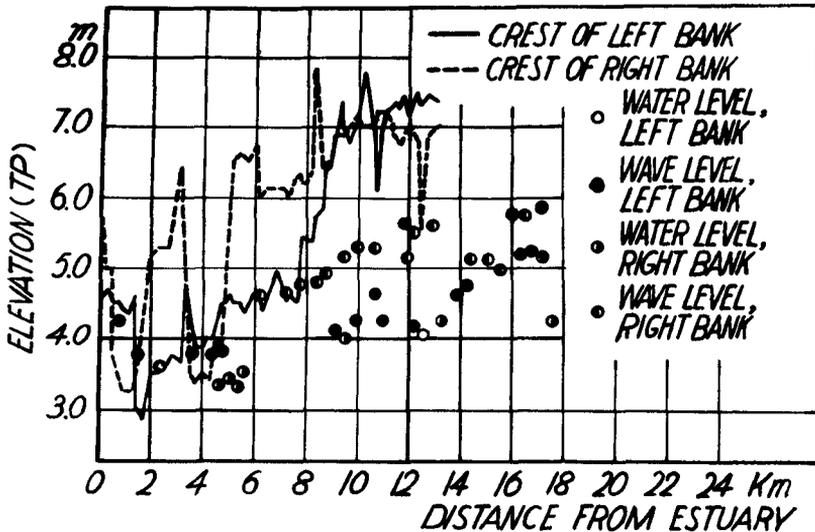
at each river which flow into the Bay. For example, we'll take up the case of Kiso River which flows into the inner part of Ise Bay as shown in Fig.4.13.

Fig.4.13 The water level rising of Kiso River on the occasion of Ise Bay Typhoon.

As storm surges invade into the river, it is seen that water level tends to rise up. Judging from observational results, this fact is also recognized at Nagara, Ibi, and Shin River. It seems that the rate of water level rising in river mainly concerns with the wind shearing force. To investigate this point in the Kiso River, plotting the relationships as shown in Fig.4-14 between the difference of water levels recorded at Yokomakura and Sendohira, and the square of wind velocity at Kuwana, a very good correlation is recognized. Therefore, it will be effective means for estimating storm surges in rivers, if this relationships are studied furthermore. The flow direction of the upper reach of Kiso River is about SSE and it just coincided with the wind direction, so that such effect due to the wind shearing force is seemed to appear distinctly. So it is supposed that in such a case that the directions of river and wind are very different, the phenomenon mentioned above does not always appear. In addition, it is considered that the effect of run off from upper stream was very slight, as the rain fall before the time of the highest tidal level was a very small quantity in Kiso River.

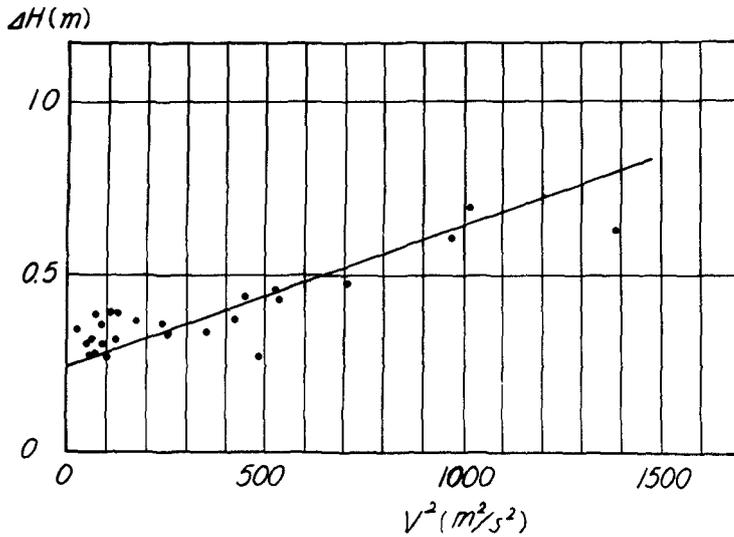
Fig.4.14 The relation between the difference of water levels observed at Yokomakura and Sendohira, and the square of wind velocity.

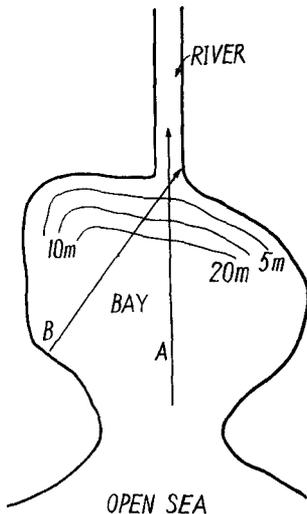
When the waves propagated from the entrance of Bay to the direction of A as shown in Fig.4.15, the heights of waves invading into the river are large, because the fetch is large and there is no effect of refraction due to the topography of the sea bottom. However, because the wave direction and the river levees are in parallel each other and there exists no impact of waves, it will be good enough to consider only the height of wave crest. When the waves travel to the direction of B, the fetch is smaller than that in the case of A, and there is the effect of refraction. So the height of waves entering the river is smaller than that of A. However, because the waves impact on river levees skewly, the run-up of waves will occur.

Fig.4.15 The relation between incident direction of wave and river course.

Therefore in such a case, as a criterion for determining the levee height, we must take the higher one after comparing the height of wave run-up and the height of wave crest in the case of A. That is, more the wave direction are inclined with the river levee, less the wave height itself is, but more vivid the phenomenon of wave run-up is. Therefore it is necessary to make comparison and investigation for various cases in determining the reasonable height of walls.
