CHAPTER 77

RECENT HISTORY OF EROSION AT CAROLINA BEACH, N C

Limberios Vallianos, Chief, Coastal Engineering Studies Section,
Department of the Army, Wilmington District, and Member ASCE

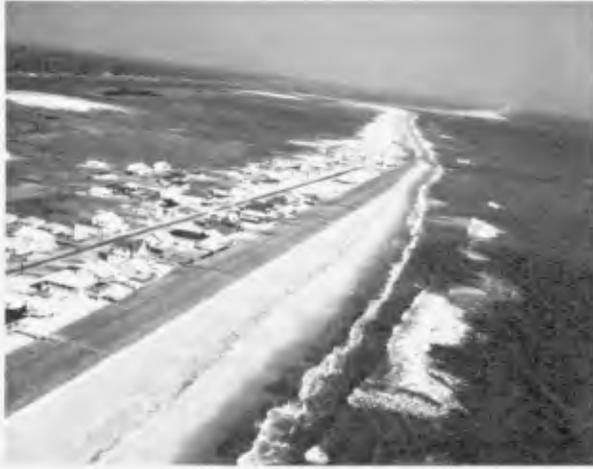
PHOTOGRAPH 1 - VIEW NORTHWARD OVER CAROLINA BEACH PROJECT IN 1965. NOTE CHANGE OF SHORE ALIGNMENT CENTER BACKGROUND OF PHOTOGRAPH.

Of course, wave attack along the area of interest is neither uniform nor unidirectional and, moreover, there is some natural bypassing of material across Carolina Beach Inlet. However, the generalization outlined above is not only rational, in a theoretical sense, but validated by the time - space relationships of the erosion in Segments II and III, presented in TABLE 4. PHOTOGRAPH 1 clearly shows the change of shore alignment.

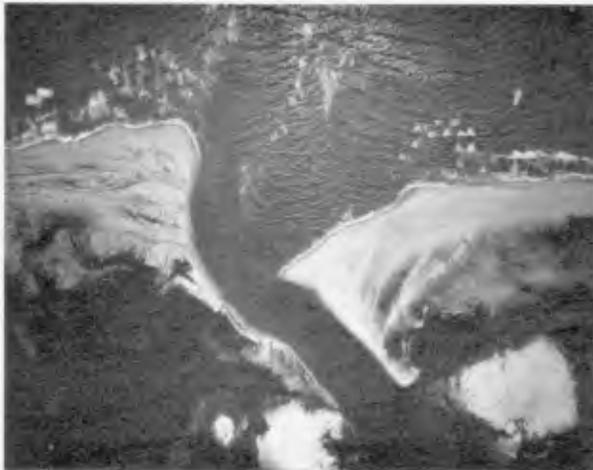
PHOTOGRAPH 2 - VIEW OF CAROLINA BEACH INLET IN 1969. NOTE OFFSET BETWEEN INLET SHOULDERS, AND WAVE REFRACTION PATTERN.

At this point, only the value of the northbound drift, N, remains to be computed. For the determination of this value, conditions at Carolina Beach Inlet are used to develop a continuity relationship for the total alongshore movement of material. Here, the assumption is made that, contrary to the natural southward bypassing of 90,000 cubic yards of material at Carolina Beach Inlet, there has been no significant northward bypassing at the inlet. The rationale on which this assumption is based is as follows. First, bypassing of material at an inlet is highly dependent on storm activity, as wave crests, encroaching on the sea shoal during normal sea conditions, are refracted to such an extent that they split and approach the inlet throat from both the updrift and downdrift directions, making bypassing difficult. This phenomenon is easily observed in the field or from aerial photographs and, in fact, is the reason for the multiple, confused chop existing on shoals. Moreover, the refraction phenomenon can, as at Carolina Beach Inlet, create permanent, but shifting, nodal zones on the shores near and adjacent to the inlet. However, during storm activity with attendant storm tides, high-energy levels, and short-period waves which are not too susceptible to refraction, natural bypassing can be accomplished. Therefore, since most storm activity to which Carolina Beach Inlet is subjected comes from the northeast sector of exposure, it can be assumed that the largest proportion of natural bypassing is in a southward direction. The second reason that bypassing in a northward direction is assumed small relative to southward bypassing is that the ocean shoreline on the north shoulder of the inlet is offset seaward from the shoreline on the south side by a distance of approximately 1,500 feet (see PHOTOGRAPH 2). This offset doubtless restrains the northward movement of material across the inlet. The phenomenon discussed above, insofar as normal sea conditions are concerned, is schematized in Diagram 4. Note that there would be no change in the general refraction pattern for normal conditions if the deepwater wave crest approached from the northeast quadrant under normal sea conditions. The actual refraction phenomenon is readily discernible in PHOTOGRAPH 2.
