## CHAPTER 201

### COASTAL PROBLEMS IN SRI LANKA

Frans Gerritsen<sup>1</sup> and Summa R. Amarasinghe<sup>2</sup>

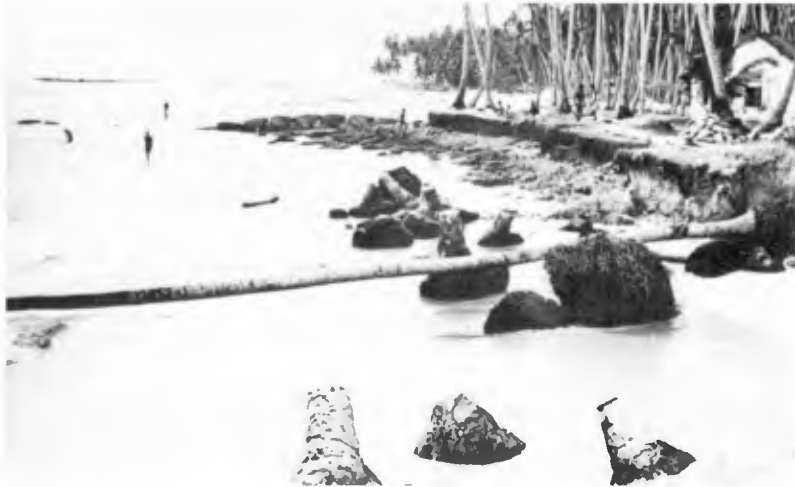
PHOTO 1 SEVERE EROSION ON SOUTHWEST COAST DUE TO COMBINED EFFECTS OF NATURAL CAUSES AND CORAL MINING. NOTE THE REMOVAL OF EXPOSED CORAL.

Coral mining (providing lime for the building industry) has been concentrated within a coastal area about 22 miles north of Galle on the west coast. Coral is obtained by breaking the reef with sharp instruments and by digging in the nearshore and low-lying coastal areas. The excavated material is then burnt in neighborhood kilns and the extracted lime (calcium oxide) is supplied by the producer to the building industry usually through middlemen. It has been estimated that the quantity of coral removed from this area exceeds 75,000 tons per year. This in turn represents a retreat inland of the affected 6-mile stretch of shoreline of about 6 ft per year, only taking into account the sand required to fill in the gaps, while the effect of weakening the protective function of the coral reef and the removal of coral from the littoral drift will be additional in the occurrence of erosion. It has been further estimated that about 20,000 people in this area are dependent on this illegal activity for their livelihood. While existing legislation is weak and new legislation has been prepared, solution of the socio-economic problem is primary in eliminating this destructive activity. As a large percentage of lime for the building industry is supplied from this area, alternative sources of this material have been proposed to meet the demand when coral mining activity in the coastal zone is terminated.
