CHAPTER 56

SOFT DESIGNS FOR COASTAL PROTECTION AT SEABROOK ISLAND, S.C.

Miles O. Hayes¹, Timothy W. Kana² and John H. Barwis³

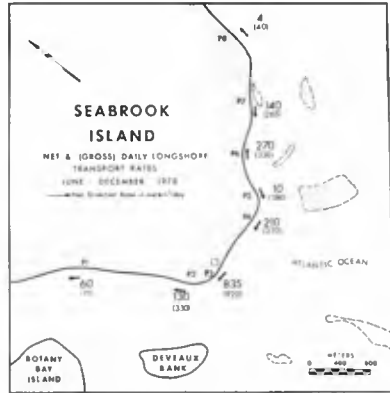
Figure 3. Net and (gross) long-shore transport rates along Seabrook Island based on wave energy flux. Highest net rates at stations 3 and 6 correspond to erosion zones at the time of the survey.

Figure 3 gives the average daily transport rates at each of the 8 process stations, based on monthly wave observations between June and December. Highest transport rates occur at stations 3 and 6, which are least sheltered by offshore shoals and which have higher than normal erosion rates. The range of equivalent yearly rates are $75-300 \times 10^3$ m³/year.

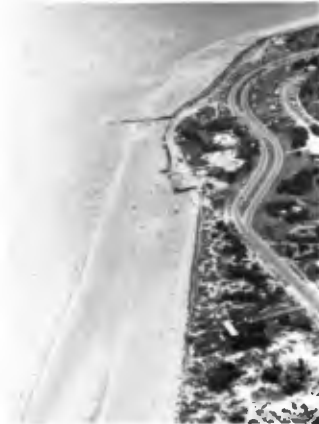
Figure 4. Oblique aerial photograph taken in 1978 of the southwest point of Seabrook Island. View looking southwest. Note coastal structures, including a groin, seawall, and revetment built to protect a community clubhouse. Erosion of the adjacent shoreline has produced the shoreline offset.

Coastal structures existing in 1978 at Seabrook Island included: (1) sand bag groins designed to trap sediment moving alongshore, (2) vertical poured-concrete seawalls to protect a clubhouse at station 3 and houses between stations 4 and 5, and (3) rubble mound rip-rap to anchor the shoreline between stations 2 and 3 (Fig. 4).

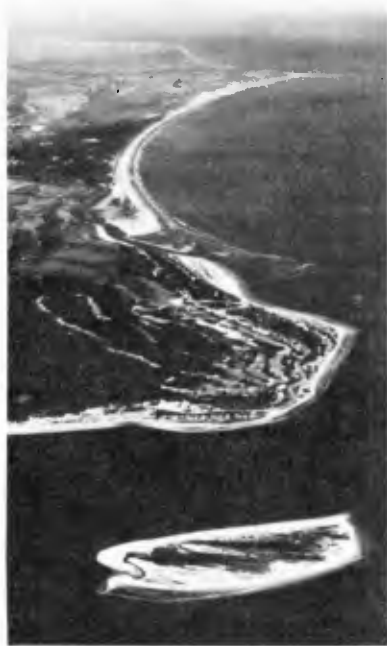
Figure 11. Oblique aerial photograph of Seabrook (foreground) and Kiawah Islands, taken on 7 December 1978. Note position of Deveaux Bank (foreground), located 1500 m landward of the 1939 position. View looking northeast.

A well-defined marginal flood channel has existed for some time off the south-southeast end of Seabrook Island. By 1978, it had shifted toward the island at the southeast point (see aerial photograph in Fig. 11). Sediment eroded from the beach in that vicinity would be carried offshore into the channel where it is undoubtedly redistributed by the strong flood-tidal currents that exist in the channel. In 1978, it appears that the marginal flood channel was too close to the beach to allow for the natural onshore-offshore transfer of sand that normally occurs on beaches.

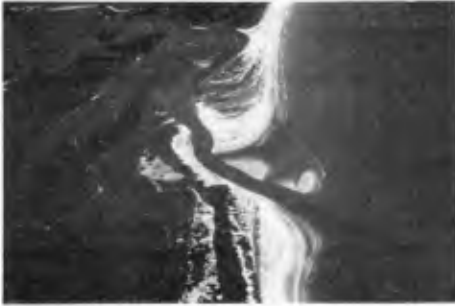
Figure 13. Bar-bypassing at Kiawah River Inlet.

Aerial photograph of Kiawah River Inlet in March, 1975. This is stage two - bar over-extension.

This process has occurred naturally at Kiawah River Inlet, as shown in Figure 13. These aerial photographs were taken over the eleven month period between March, 1975 and February, 1976. They document the evolution from the bar elongation (Fig. 13, upper) through channel abandonment (Fig. 13, middle) to eventual welding of the bar onto the beach (Fig. 13, lower). In 1978, during the present study, Kiawah River was in stage two (bar elongation).

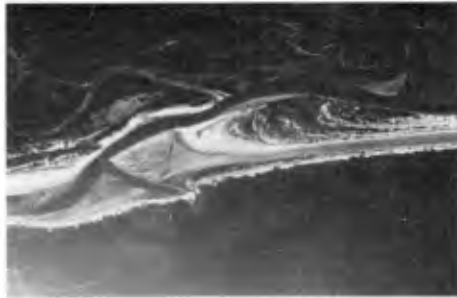
Aerial photograph of Kiawah River Inlet in November, 1975. Note that the channel has breached the updrift end of the bar.

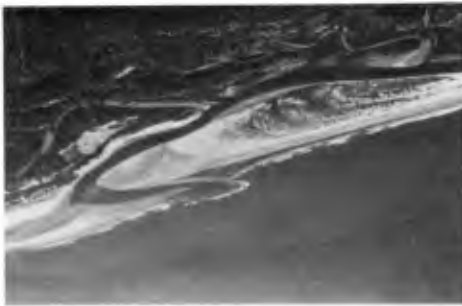
Aerial photograph of Kiawah River Inlet in February, 1976, showing partial welding of the bar onto Seabrook Island. (Photograph by Dennis K. Hubbard.)
