NOOSA BEACH RESTORATION SCHEME

**R.J. Lloyd, B.E. (Civil), Executive Engineer, Beach Protection Branch,
Department of Harbours and Marine, Queensland, Australia.**

1. SUMMARY

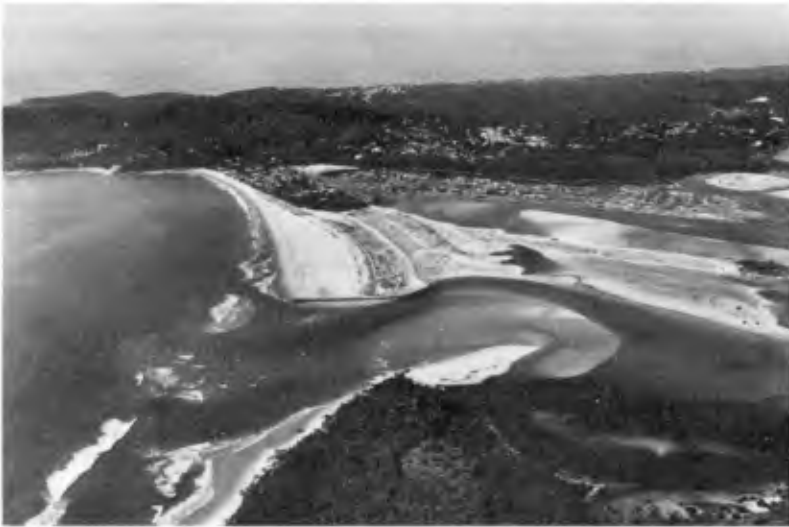
PHOTOGRAPH 1 - The completed scheme (August 1979)

Photograph 1 shows the completed restoration scheme.

From a beach protection viewpoint the Noosa restoration scheme has been successful. The aerial photograph of the restoration scheme site which was taken after the artificially formed beach profiles had time to adjust to prevailing wave and current conditions shows that large areas of new beach are now available for a wide variety of recreational purposes whereas previously no such beach areas existed. Although there have been several periods of rough seas and high tides there is no evidence of a significant nett loss of sand from the beach system. In addition the new beach north of the Noosa Woods camping area has successfully withstood the attack of two cyclones without any damage to the artificially created frontal dune.

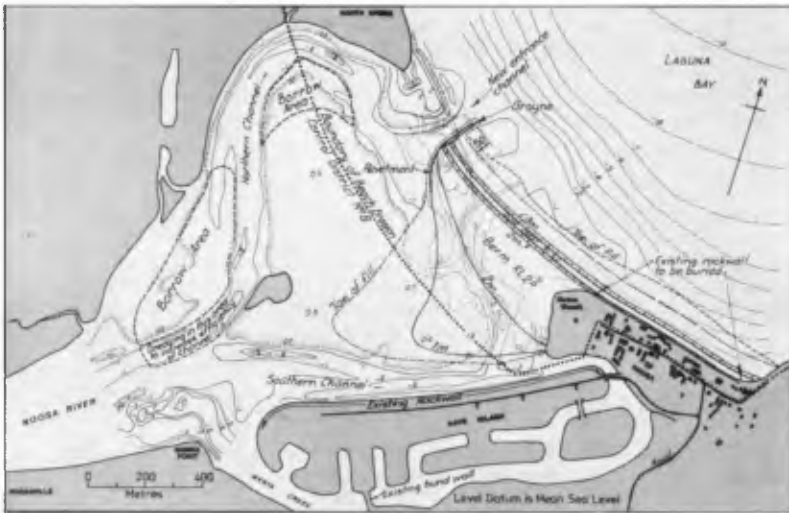
FIGURE 1 - Noosa River estuary showing the scheme of works

The main commercial centre of Noosa is located precariously on the barrier dune landward of the surfing beach. Further landward is the Noosa River estuary and Hays Island - an area which was recently developed as a canal estate. Figure 1 shows the site of the restoration scheme.

Sand required for implementation of the works would be taken from borrow areas within the estuary. Figure 1 shows the location of the works including the designated borrow areas.

Spring tide ranges at Munna Point (refer Figure 1) are as follows:-

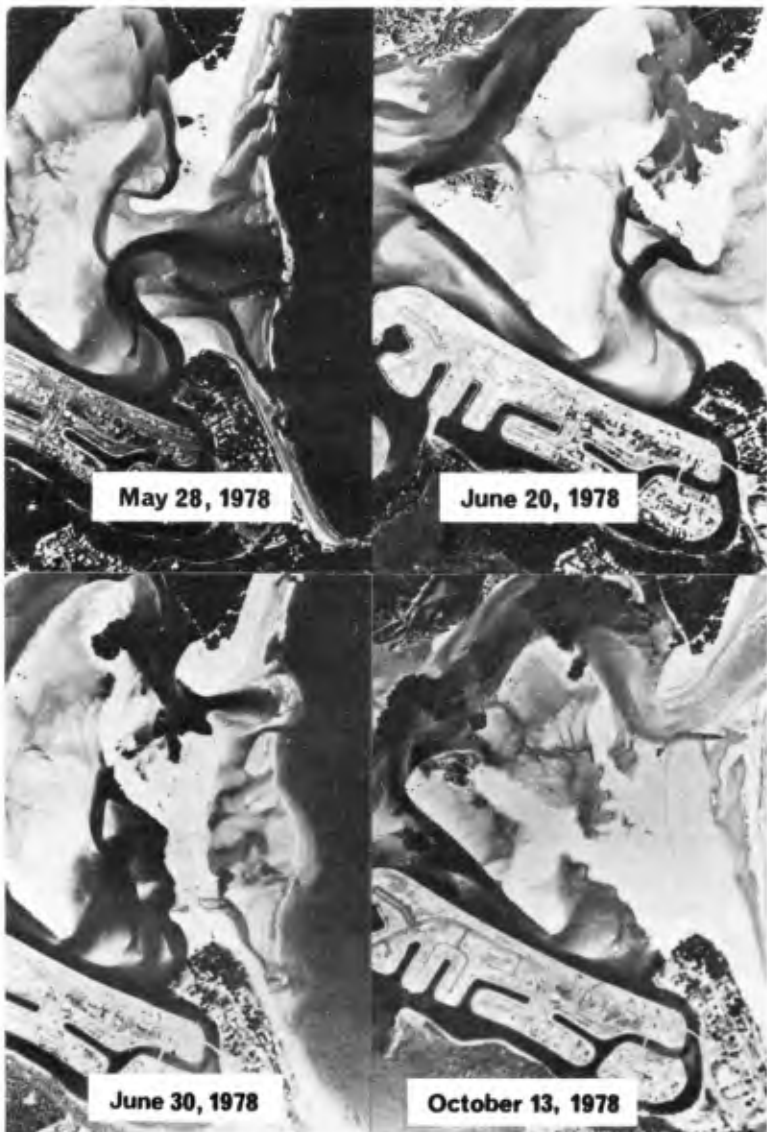
FIGURE 5 - Photographs showing progress of the works

Progress of the civil engineering works is shown on Figure 5, a sequence of aerial photographs of the works.

Dredging commenced at the site of the new entrance with spoil being directed to the closure bund which was being developed from the northern side of the existing entrance. By June 20 the new entrance to the northern channel had been opened and by June 27 closure of the original entrance had been effected.

Following completion of the entrance closure operation, vehicular access to the site of the rock groyne became available and groyne construction was able to proceed. At the same time the final phases of sand pumping works were able to commence and all such works including the development of the beach and dunal areas north of the Noosa Woods camping area as well as sand nourishment of the original beach were completed by September 13, 1978.

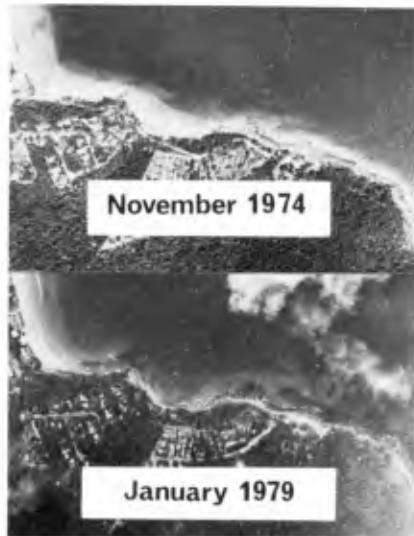
FIGURE 8 - Photographs showing the fluctuating condition of beaches around Noosa Heads. Immediately south of Noosa Beach. The January 1978 photograph is typical of the condition which has existed since implementation of the restoration scheme.

It is postulated that the beach recession which has occurred along the southern portion of Noosa Beach has been caused by an intermittent sand supply from around Noosa Headlands. This argument is supported by photographic evidence which shows that the condition of Noosa Beach and the small pocket beaches between the headlands fluctuates with time. It is considered that the fluctuating condition exhibited by these beaches is the result of a fluctuating sand supply to these beaches and that the condition of the southern portion of Noosa Beach where restoration work has been carried out will continue to fluctuate under the influence of natural processes. The small pocket beaches between the headlands have not been in good condition since the restoration scheme was implemented. Thus it could be expected that the southern portion of Noosa Beach would currently be experiencing a period of recession.
