DOLOSSE

PAST, PRESENT, FUTURE?

J.A. ZWAMBORN, D.E. BOSMAN AND J. MOES\*

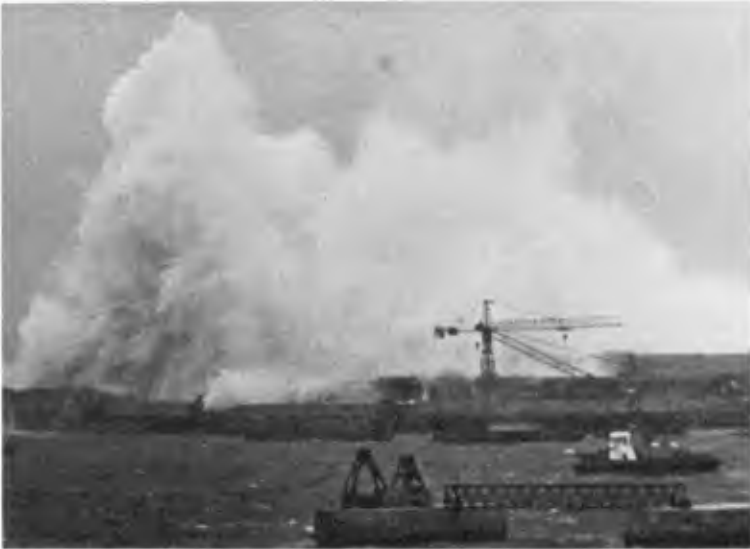
Fig. 4 Peak storm waves, Berth No. 1, 26 February 1978

The partial failure of and major damage to the 42 t dolos armour of the Sines breakwater during a near-design storm in February, 1978, is by far, the most important (Figure 4). From a detailed analysis of the causes of the damage Zwamborn (1979) concluded that failure of the armour was caused mainly by:

The assistance from various authorities and persons who completed the dolos questionnaire is hereby gratefully acknowledged. The photograph used for Figure 4 has been made available by Messrs. Condotte d'Acqua.

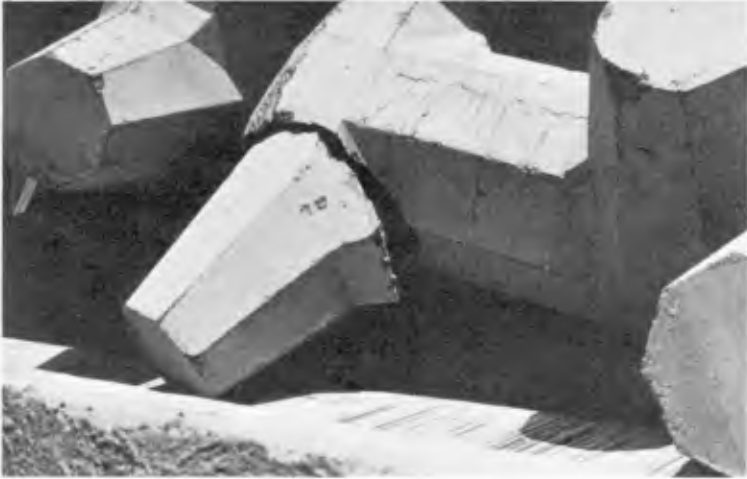
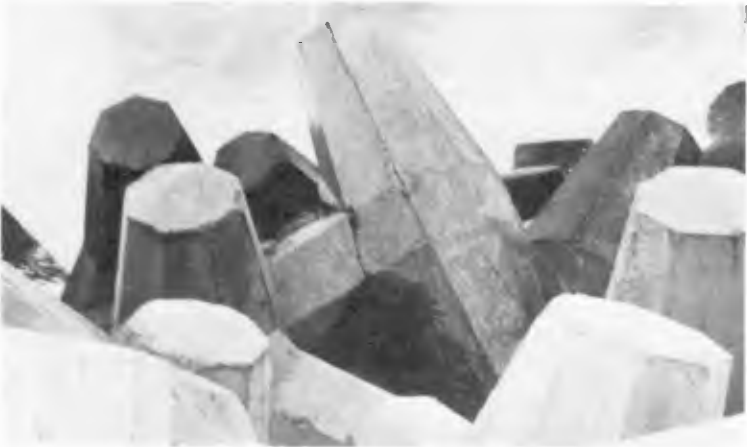
a. Typical fluke breakage

b. Broken reinforced dolos

Fig. 9 Sines breakwater, damage to unreinforced and reinforced 42 t dolosse

Conventional steel-reinforced dolosse were used at Humboldt Bay, Kahului (Hawaii) and for the provisional repair work at Sines. This type of reinforcing is, however, neither very effective (Figure 9), nor economical. For example, a 0,6 per cent reinforcing (by volume) used at Sines resulted in a 20 to 25 per cent increase in strength while the cost of a 42 t dolos increased by 50 per cent. There is also the problem of corrosion, and central reinforcing, using for instance, scrap rails may be more attractive (Standish-White and Zwamborn, 1978).
