FLOATING TYRE BREAKWATERS - A CASE HISTORY

ROBERT C. MCGREGOR* and COLIN H.G. GILBERT**

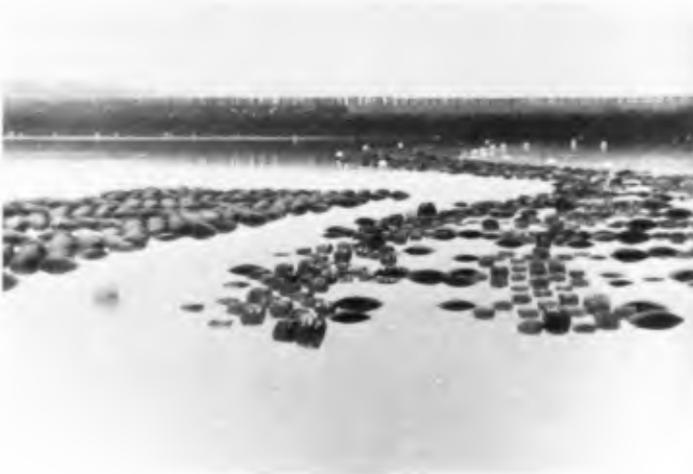
Fig. 7a - New section (with buoyancy) ready for installation

- d) Buoyancy - most truck tyres are tubed and lack the butyl or chlorobutyl lining which is built into car tyres. This means air can leak through the tyre causing the tyre to sink lower in the water. Fig. 7 shows how this effects the breakwater.
- e) Handling - truck tyres and truck tyre modules are appreciably heavier than their car tyre counterparts and this increases handling problems. This is offset to a degree by having fewer module connections to make in the water.
- f) Abrasion - the extra steel in the beading of truck tyres makes them more abrasive to conveyor belting.

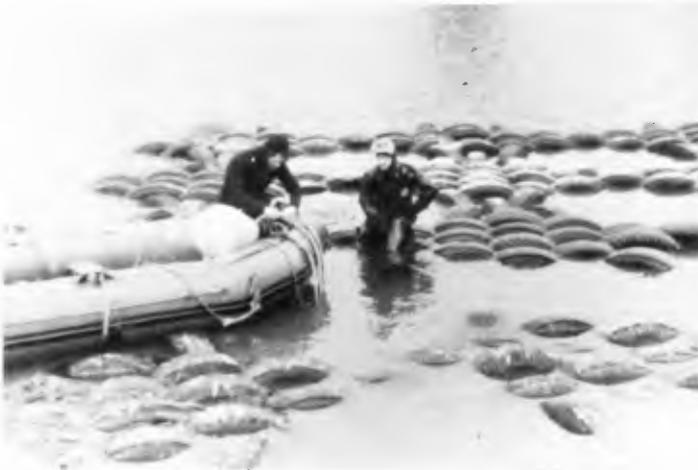
Fig. 7b - Modules with and without buoyance during refurbishing of breakwater

Initially this difficulty was to have been tackled with an air line (operated from a boat) which although quite feasible is labour intensive. In addition during a period when there was a temporary lack of maintenance through staff leave an appreciable part of the breakwater sank. A wind of force 5 or 6 blew while the breakwater was down and some considerable damage was experienced. The breakwater was refloated within 24 hours by divers with an air hose. This led to the assessment of permanent floatation. The choice lay between sealed plastic containers for which various sources give evidence of cracking, crushing, escaping or leaking (Bushell (1978)) and foams. The foam may be moulded, rods or mixed in the tyre. The foam should be high density, resistant to crushing, abrasion and pollutants. Although polystyrene cannot be recommended both polyurethane and polyethylene appear to have been used successfully. In this case polyethylene rod was chosen.
