CHAPTER ONE HUNDRED THIRTY SIX

PERMEABLE GROYNES: EXPERIMENTS AND PRACTICE IN THE NETHERLANDS

ABSTRACT

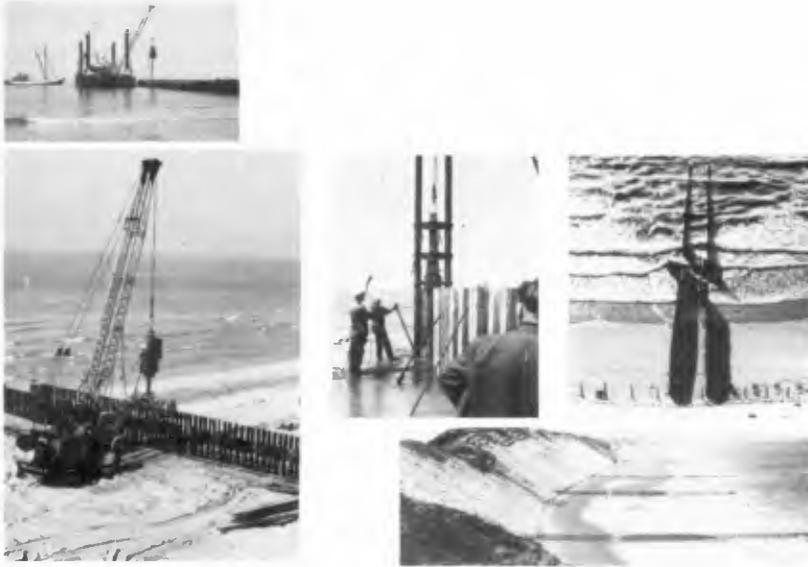
FIG.8 Construction of screens

Obviously, aspects of local materials, construction operations and costs may interfere with the ideal functional design. In the Netherlands only wooden piles (oak or tropical) with round or square cross-section (0.25 - 0.30 m) have been used. Piles of square cross-section may be placed in a diamond pattern rather than orthogonally in order to save material for the same hydraulic resistance. These piles may be subject to borers and/or marine growth; concrete may be an alternative.

The toplevel of the piles is partly determined by the workability conditions (waves and tides). The total length of the piles must allow for natural variations in local bed elevation; as a rule 60% of the total length is in the bed. A typical screen is shown in Fig. 8. When a double screen is applied (which is cheaper than 2 single rows), their mutual distance is 3 m. In order to allow traffic on the beach an oblique opening is provided. The piles may be jetted or rammed with a conventional rig on the dry beach. Beyond the low water line there are several options, viz. working from a floating barge, from a mobile platform (Fig. 8), from a temporary jetty, or working over the top of the finished part (double screens only). The costs of screens increase rather fast if they extend seaward of the low water line. A rough idea is given in Fig. 9, where three screen configurations are shown with their cost per 1000 m¹ of beach length as compared to typical traditional massive groynes.

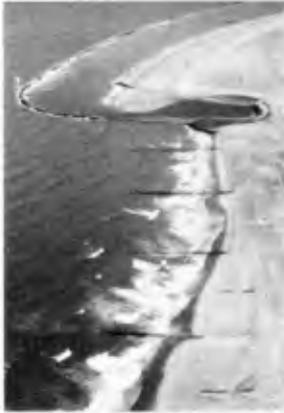
FIG.21 Screens near Europort (7)

- Just south of the new entrance to Europort (Fig. 10, (7)) a new coastal defence system was necessary in order to protect the reclaimed harbour area [Svasek and de Nekker, 1977]. Instead of the original design, which consisted of a section of 4000 m of rubble mound breakwater, an artificial beach and dune combination was proposed, saving about 80 million dollars on construction costs. In order to maintain the artificial beach, an artificial sand supply of 400,000 m³/yr would be required [Svasek and Versteegh, 1977]. Further optimization calculations resulted in a project with seven pile screens (Fig. 21) plus a limited sand supply of 200,000 m³/yr [Bijker et al., 1981]. Four double pile screens extended to the depth contour of MSL - 3 m, and three short single screens down to MSL - 0.5 m were placed in between. The 0.3 m diameter piles were spaced 0.3 m apart. To determine the pile length, a seasonal depth variation of 1 m was assumed. As the planned sand supply of 200,000 m³/yr was not effectuated, a local erosion of about this same rate should be expected. Based on frequent detailed soundings and beach levelings in the area concerned, a comparison was possible (Fig. 22) between the calculated erosion (with pile screens but without sand supply), and the observed erosion which amounted to 220,000 m³/yr. This is in good agreement, taking into account the feasible accuracy of the levelings and soundings. As the area concerned is approximately 600,000 m² large, the average erosion in 2 years was about 0.6 m with local scour of more than 1 m. About 2½ years after construction, the most southern two long screens lost about 30% of their piles (mainly in the deepest section) during a severe storm.

The main causes for this failure are:

- Artificial feeding was omitted, causing the bed to be eroded locally below the storm season profile, for which an overdepth of 1 m was designed.
- The tidal channel "Gat van Hawk", which was shoaling and stable
