## CHAPTER ONE HUNDRED SEVENTY

### NEW TYPE BLOCKS FOR SEAWALL SLOPE PROTECTION

Osamu Toyoshima\*

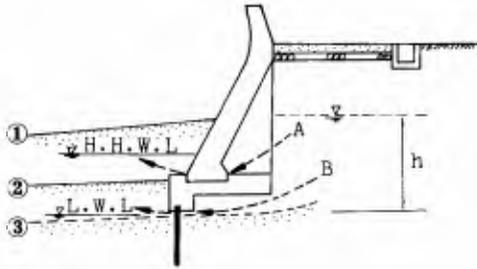
Fig.1 Typical vertical type seawall

In Fig.1,

- ① is the shore just after the construction of the seawall.
- ② incident waves were violently reflected on the steep front slope of seawalls, and foreshore and the toe of seawalls were washed out with the reflected waves like this.
- ③ then, sand is completely washed out.

And furthermore, by the water pressure difference ( $h$ ) between outside and inside of the seawall facing, not a little amount of sand are drawn out with jet streams like A and B in Fig.1 through the small hall in the seawall facing.

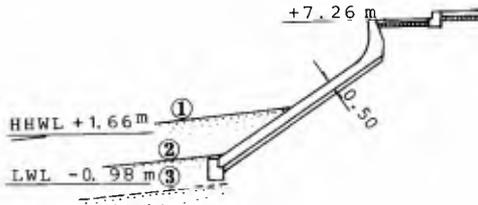
Fig.2 Structure and cross section before the destruction

Fig.2 shows the previous structure and cross section of Shizuoka Coast before the destruction which occurred in March 1977. Since the 1970's, the Shizuoka Coast has turned into a erosive coast. The seawalls of this coast were constructed before 1970.

In Fig.2,

- ① is the shore when the seawalls were constructed in 1961.
- ② just before the destruction in March 1977.
- ③ just after the destruction.

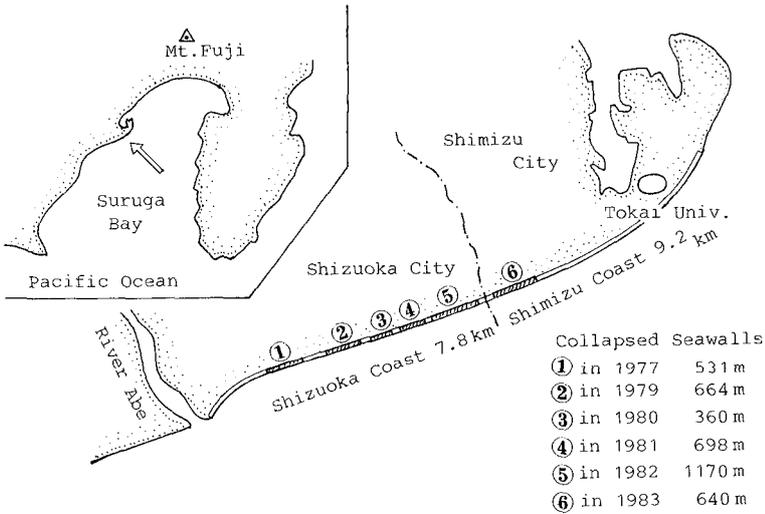
Fig.3 Position of collapsed seawalls

After the first destruction in March 1977, the seawalls in Shizuoka Coast have been broken down by the violent waves one after another. The position of collapsed seawalls are shown in Fig.3.

We have been talking about the first destruction in Shizuoka Coast, the position (1) in Fig.3.

After this restoration works, another destructions from the position (2) to (5) occurred consecutively, and all of them are restored in the same way as the above.

The collapsed seawalls in Shimizu Coast, the position(6) in Fig.3, were restored with Lotus-Uni block lately.

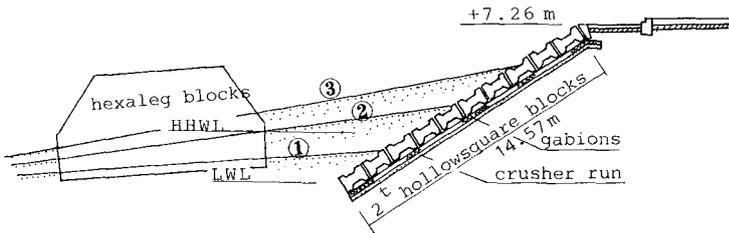
Fig.4 Structure of restored seawalls with block facing

Instead of usual concrete facing, concrete block facing works was used as the restoration works, according to my proposal. Fig.4 shows the structure of the restoration works using the block facing.

In Fig.4,

- ① is the shore at the starting works, in August 1977.
- ② is the shore at the completion of the works, in May 1978.
- ③ is the shore in May 1984.

Before the destruction, the beach had been eroded year by year. But, after the restoration works, the beach finely recovered and sand accumulated as about ten years ago.

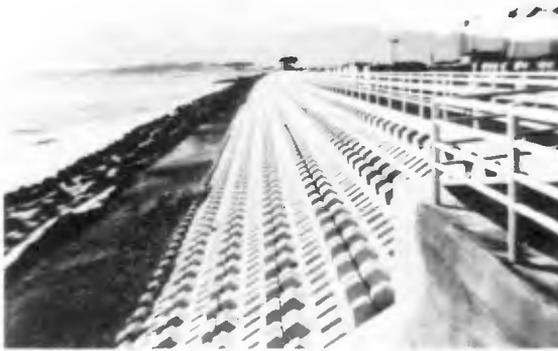
Photo.3 Restoration works completed (1978)

Photo.3 shows the seawalls in 1978 one year after the restoration works. Four blocks are under the beach, and six are seen.

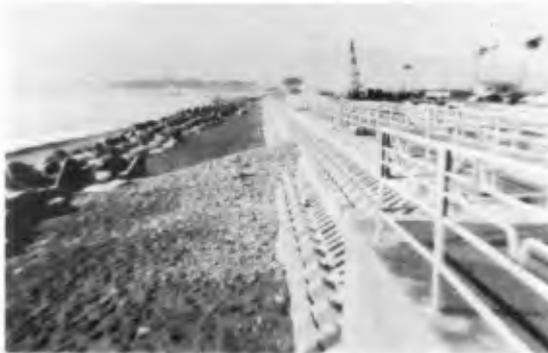
Photo.4 The beach recovered finely (May 1984)

Photo.4 is the later view of the coast. The blocks are covered with sand up to the second step, then eight blocks are under the sand beach. Now the beach looks very stable.

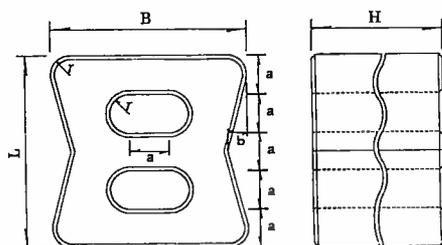
Fig.5 Lotus-Uni block

Fig.5 shows the plane and profile of the Lotus-Uni block. The block has three models according to its weight. Each model has same face, only the thickness is different.

Model	B	L	H	Weight
50H			50 cm	2 ton
75H	1.5 m	1.5 m	75 cm	3 ton
100H			100 cm	4 ton

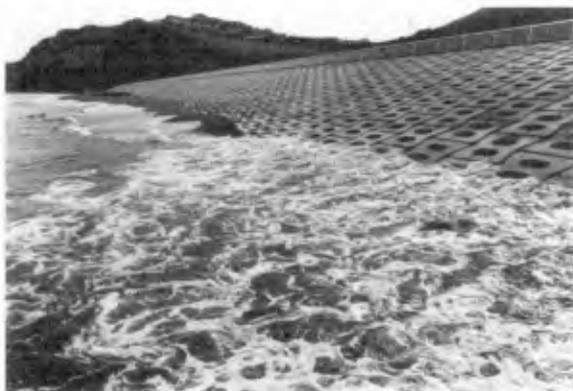
Photo.6 Soon after the completion (1982)

Photo.6 shows the seawall soon after the completion in 1982. The foundation blocks were set on the shoreline of the low water level, and there was no foreshore in front of the seawall. The uprush runs up with sand and gravel on the slope.

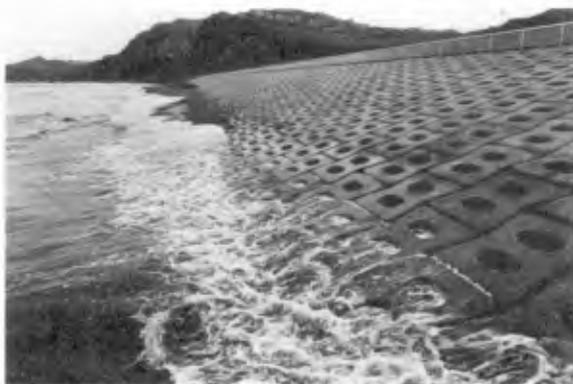
Photo.7 Uprush are sucked into the holes

Some of the uprushes are sucked into the holes of the block, and the back rush decreases.

The velocity and the volume of the backrush become slow and small. Then, the reflected waves become weaker, and the erosive beach turn into an accumulative one.

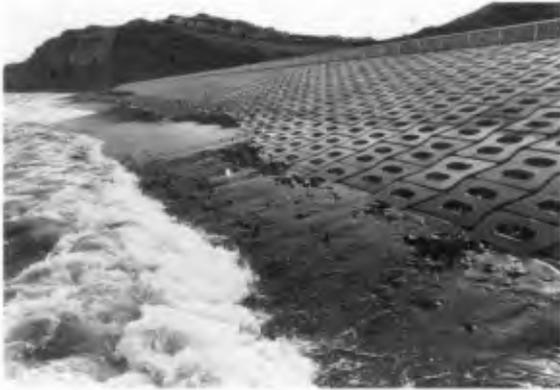
Photo.8 Gravel are left on the toe of the seawall

Sand and gravel, came from the offshore and included in the uprush, are left on the slope, in the holes and the toe of the slope of the seawall.

Eight or nine blocks are seen on the slope.

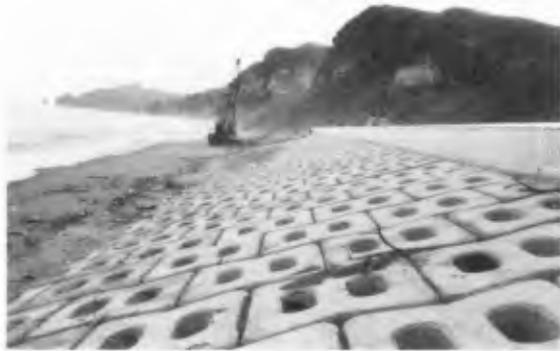
Photo.9 One year after the photo.8

More than ten meters long foreshore has grown in front of the seawall. Four or five block are to be seen, and five or four blocks are under the sand beach.

Sand has accumulated gradually and surely.

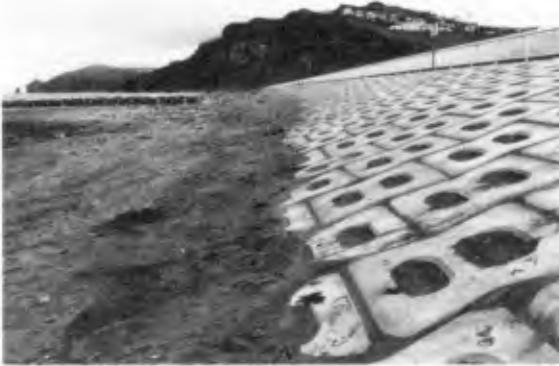
Photo.10 The latest view of the beach (1984)

The shoreline has advanced substantially, and the sand beach has grown extensively.
