ANALYSIS OF BEACH EROSION AROUND LARGE-SCALE
COASTAL STRUCTURES

T. UDA*, M. SUMIYA** and Y. KOBAYASHI**

ABSTRACT

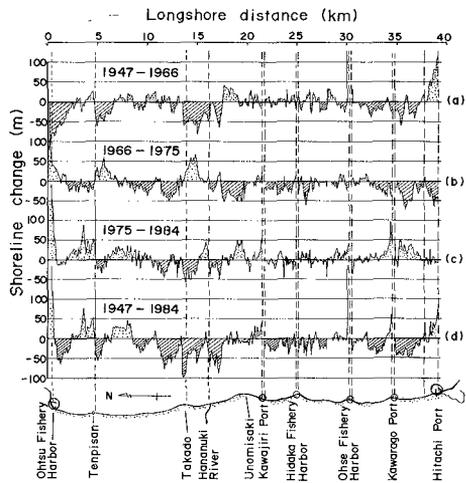
Figure 2 Shoreline changes between Ohtsu Fishery Harbor and Hitachi Port during 37 years from 1947 to 1984.

The shoreline changes between Ohtsu Fishery Harbor and Hitachi Port along the Joban Coast are investigated. The shoreline positions were digitalized at 50 m intervals continuously from the aerial photographs, and the changes of the shoreline positions during each subsequent period are calculated (Fig. 2). Regarding the general condition of the coastal landform, there protrude some capes between Ohtsu Fishery Harbor and Unomisaki Cape, and the sandy beaches extend between these capes. The coasts south of Unomisaki Cape generally consist of the coastal cliffs, but locally there exist narrow sandy beaches. For instance, the sand spit is formed around Kawarago Port because of the shelter effect of the offshore rocks¹⁾. The shoreline changes at locations north of Unomisaki Cape are comparatively larger than those between Unomisaki Cape and Ohse Fishery Harbor, which is mainly due to the types of the coast. The former coast consists of the sandy beach, and the latter one the cliff coast, so that the shoreline change is small. Here, the region between Ohtsu Fishery Harbor and Unomisaki Cape, showing the large shoreline changes, should be discussed in detail. In the region there are three capes, Tenpisan Cape at the mouth of the Ohkita River, Takado and Unomisaki Capes. The existence of the rocky head of the capes, projecting offshore, prevents the longshore sand movement across the head, and thereby some characteristic shoreline changes are noted.

First, it is seen from Fig. 2(a) that the shoreline retreats south of Ohtsu Fishery Harbor and it advances north of Tenpisan Cape. To the contrary the shoreline south of the cape retreats, and again the shoreline north of Takado Cape advances except the

adjacent part of the cape. In addition to these changes, the same features can be observed between Takado and Unomisaki Capes. The shoreline changes as described above have a distinct feature that the shoreline north of the cape advances and that south of it retreats. The shoreline change is due to such reason that the southward longshore drift caused by incident waves from northeast was obstructed at the capes. On the other hand, it is found in Fig. 2(b) that the shoreline changes are totally reversed. Due to the field observation of wave direction having been conducted over 10 years at Ajigaura Beach located south of Joban Coast, southeastern wave direction prevails in summer and northeastern wave direction in the other seasons, and the wave direction has a periodic feature of one year²⁾. Taking these features into account, it is concluded that Figs.2(a) and 2(b) designate the shoreline changes after the northeastern and southeastern wave incidences prevailed, respectively. Figure 2(c) shows the different feature from those in Figs.2(a) and 2(b). Between Tenpisan and Takado Capes the shoreline in a region next to the capes retreats and the shoreline advances at the central part of each stretch of the coast. Between Takado and Unomisaki Capes the influence of the river mouth jetty of the Hananuki River to the adjacent beach is newly observed, and the beach is eroded south of the capes and the coastal structure, and vice versa

Regarding the shoreline change in Fig.2(d) between 1947 and 1984, the shoreline advances to a great extent on the south side of Ohtsu Fishery Harbor, whereas it retreats far from the harbor. The main cause is considered to be the influence of the construction of the breakwater as described in the following section. In addition, the shoreline retreats in south and north regions around Takado Cape, but the cause of the extensive beach erosion is not known at present.

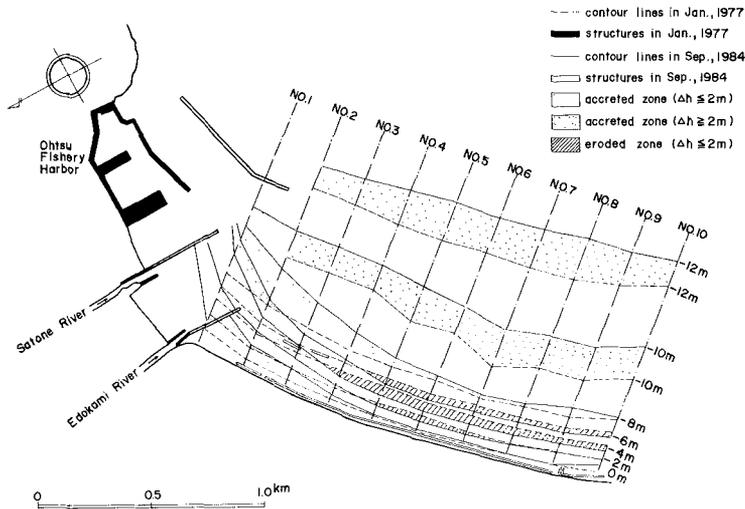
Figure 3 Changes of some contour lines around Ohtsu Fishery Harbor.

Since it is found that the shoreline change is large around Ohtsu Fishery Harbor, the change of the bottom contours is compared as shown in Fig.3, using the sounding data obtained in 1977 and 1984. The construction work of the offshore breakwater finished in 1974, and thereafter large amount of sand accumulated on the southwest side of the harbor. On the other hand, the beach up to 6 m deep below the mean sea level was eroded at No.5 through No.10. The beach erosion at No.7 is so severe in recent years that the coastal revetment fell down in 1983. In the same figure the contours of 10 and 12 m deep have a large change, but they are thought to be the error accompanied with the bottom sounding and not to be the significant change of the beach, considering that large onshore-offshore change of the contours could be observed at a small depth change at the mild slope beach, and that the contours advanced in all region without the difference of the locations. The beach changes stated above are considered to be

caused by the influence of the construction of the breakwater, taking the facts into consideration that sand accumulate inside the harbor and the beach far from the breakwater is eroded. Namely, the nearshore circulation directing toward inside the harbor from outside the shadow zone of the breakwater may develop due to the existence of the offshore breakwater, and the current induces the sand movement toward the lee of the breakwater³⁾.

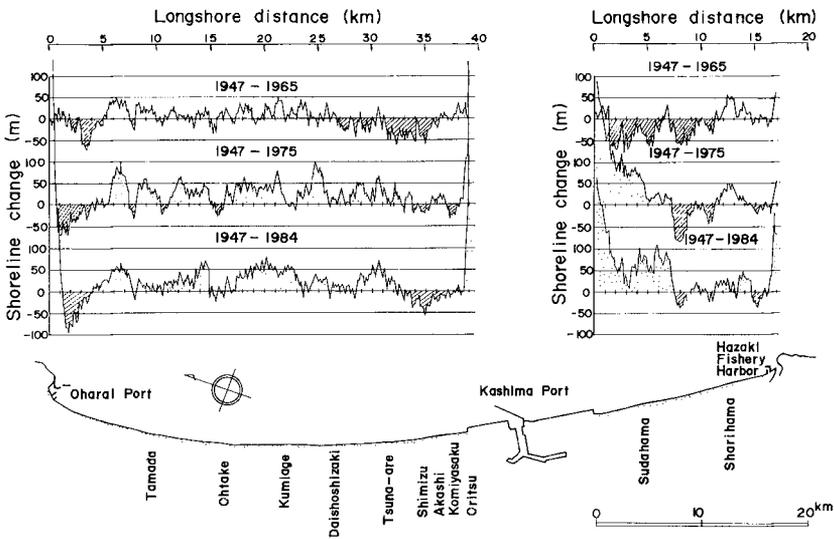
Figure 4 Shoreline changes along the Kashimanada Coast during 37 years from 1947 to 1984.

The shoreline change along the coast is expressed in Fig.4 with reference to that in 1947. Since there exists Kashima Port at the central part of the coast, the shoreline changes around the port are not shown in the figure. The construction of the breakwater of Kashima Port began in 1963⁴⁾, and almost completed in 1976. Regarding the shoreline changes between 1947 and 1965, the beach at 3-4 km south of Oharai Port was eroded locally, and the shoreline tends to advance to the location, of which longshore distance is around 26 km. In further south the shoreline has a tendency to be eroded

except the vicinity of Kashima Port and the region between Hazaki Fishery Harbor and the location 5 km north of the harbor. The construction work of Kashima Port began in 1963, and therefore littoral drift could move up and down alongshore freely before 1963. As a result, it may be concluded that for an overall feature of the beach erosion the coasts between Oharai Port and 5 km south of it, and the coasts far south of the longshore distance of 26 km were eroded, and the coasts between the longshore distance of 5 through 26 km were accreted. On the shoreline change around Kashima Port some local changes due to the influence of the existence of the breakwater may be considered to superimpose over the large-scale beach changes as described above.

Comparing the shoreline changes in 1947 and 1975, it is found that the shoreline advanced around 300 m on the south side of Kashima Port. This is due to the artificial nourishment of sand produced by the excavation of the Harbor⁴). Regarding the shoreline changes between Oharai and Kashima Ports, the shoreline tends to advance generally, whereas the shorelines south of Oharai Port and in the vicinity of Kashima Port retreat.

On the shoreline changes between 1947 and 1984, the amount of the retreat increases at the south coast of Oharai Port and the north coast of Kashima Port. Between Kashima Port and Hazaki Fishery Harbor part of sand nourished on the south side of the harbor may have moved southward, and the shoreline inside Hazaki Fishery Harbor advanced to a great extent. Consequently, it is concluded that the littoral cell along the coast was separated into two portions by the existence of the breakwater of Kashima Port, although before the construction of the harbor there existed a northward longshore drift south of the location, of which longshore distance is about 26 km.

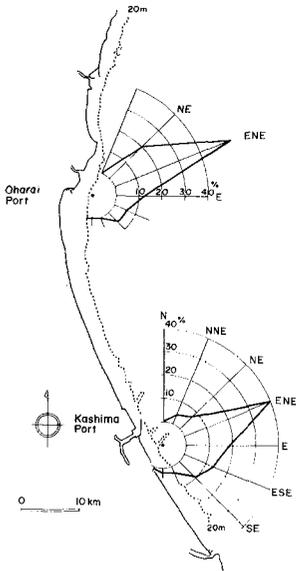
Figure 5 Wave directions at Oharai and Kashima Ports.

In order to study the cause of the shoreline change, wave directions measured at Oharai and Kashima Ports are investigated (Fig.5). The wave gauges of both positions are placed at a depth of around 20 m off the coast as shown by the solid circles in the figure. At Oharai Port the wave data from January, 1980 to February, 1982 are referred^{5),6)}, and at Kashima Port those in 1980 are used⁷⁾. The ratio of the period when the wave data were obtained to the total period at Oharai Port is 24%, considering the significant wave height over 1 m, and that at Kashima Port is 97% with regard to the total period. It is clearly understood from Fig.5 that the dominant wave direction is from ENE at both locations. This means that waves are incident from counterclockwise direction with respect to the normal to the coastline in the vicinity of Oharai Port and from clockwise direction near Kashima Port. These wave incidences induce southward and northward longshore transport, respectively, at both locations.

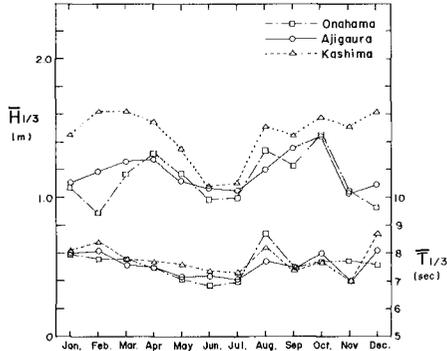
Figure 6 Monthly change of the averaged significant wave height and wave period at Onahama Harbor, Ajigaura and Kashima Port.

Next, seasonal changes of significant wave height and wave period are examined based on wave observation data of Onahama Port, Ajigaura Beach and Kashima Port during January, 1980 and February, 1982^{8),9),10)}. Mean wave height ($\bar{H}1/3$) and wave period ($\bar{T}1/3$) averaged monthly are expressed in Fig.6. Significant wave height measured at Kashima Port is slightly larger than those at two other locations, but almost similar seasonal changes of wave height are observed at Onahama Port and Ajigaura Beach. In summer and winter $\bar{H}1/3$ takes on around 1 m, and in spring and autumn it increases to about 1.4 m. The difference of wave period between three locations is relatively small, and dominant wave period is about 7-8 sec.

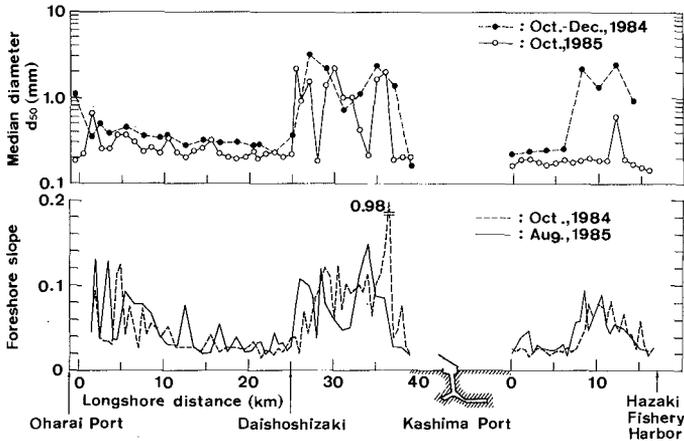
Figure 7 Longshore distribution of median diameter (d_{50}) and foreshore slope along the Kashimanada Coast.

In the present study the topographic surveys and the sampling of beach-face materials along the Kashimanada Coast have been carried out. Corresponding to the advance or retreat of the shoreline position, the foreshore slope and the median diameter of the bed materials on the foreshore have also changed to a great extent. Using the topographic survey data, the foreshore slope, defined by the mean slope between 1 m above the mean sea level and 1 m below it, is calculated (Fig.7). The foreshore slope is steep between Oharai Port and the Tamada Coast. On the south of the coast mild slope of around 1/70 continues to the Daishoshizaki Coast, and again the beach slope steepens near Kashima Port. On the south of Kashima Port the beach slope is mild, but again the slope steepens in the vicinity of Hazaki Fishery Harbor. Comparing the foreshore slope with the shoreline changes between 1947 and 1984 shown in Fig.4, it is found that the foreshore slope steepens in the eroded region and it becomes mild in the accreted region. In the comparison between the shoreline change and the foreshore slope, it should be noted that the region of steep foreshore slope is wider than the one where the shoreline actually retreated. This may be partly due to the relatively low accuracy of measurement of the shoreline position, and partly due to the fact that actually the foreshore slope begins to steepen before the change of the shoreline position accompanying with the beach erosion.

The longshore distribution of the median diameter of beach face materials sampled along the shoreline is also expressed in Fig.7. The median diameter takes a

large value between Oharai Port and 5 km south of the port, and the same between the Daishoshizaki Coast and Kashima Port. The median diameters between these areas are fine, that is, $d_{50} = 0.2-0.3$ mm. Coarser materials are found between Hazaki Fishery Harbor and the location 10 km north of the harbor, and on further north coast fine materials are seen again. It is found from Figs.4 and 7 that the longshore distribution of the median diameter corresponds well with that of the shoreline change, because large and small grain sizes are found on the eroded and accreted beaches, respectively. It is also understood from Fig.7 that coarser materials can be found on steep beaches. This reason is given by the sorting effect of bed materials due to waves, in which finer materials are carried away first and coarser materials are left on the eroded beach. Furthermore, the region of steep foreshore slope extends in the longshore direction through 1984 and 1985. This means that the eroded region extended in the longshore direction, taking the fact into consideration that the foreshore slope steepened on the eroded beach. It is clear that the foreshore slope and the median diameter on the foreshore become good parameters on judging whether the beach has been eroded or not.

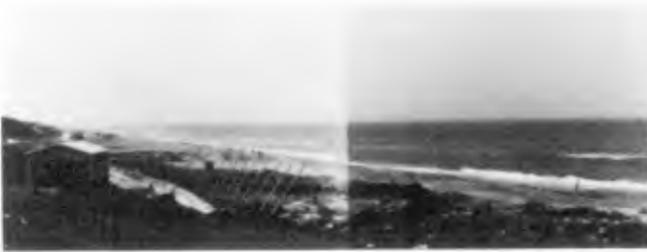
Picture 5 Situation of the beach of the Akashi Coast north of Kashima Port in July, 1980.

The north coast of Kashima Port has been eroded and particularly the beach erosion was severe in the summer and autumn of 1986, because high waves generated by the tropical storms attacked the coast frequently. In this study many pictures, showing the historical changes of the beach since 1938, were gathered. In order to examine the beach condition qualitatively, the pictures are compared. Picture 5, taken in July, 1980, shows the situation of the beach at the Akashi Coast (For location, see Fig.4) adjacent to Kashima Port. At this stage wide foreshore extends in front of the coastal revetment, and the vegetations can be seen on the foreshore, expressing that the beach has been stable for a fairly long time. On September 15, 1986, the foreshore totally disappeared as shown in Picture 6 due to the beach erosion. These change may be attributed to the beach erosion caused by the imbalance of the littoral transport. Because at the south of the coast a large breakwater of Kashima Port is located, and the northward longshore sediment transport is obstructed at this location.

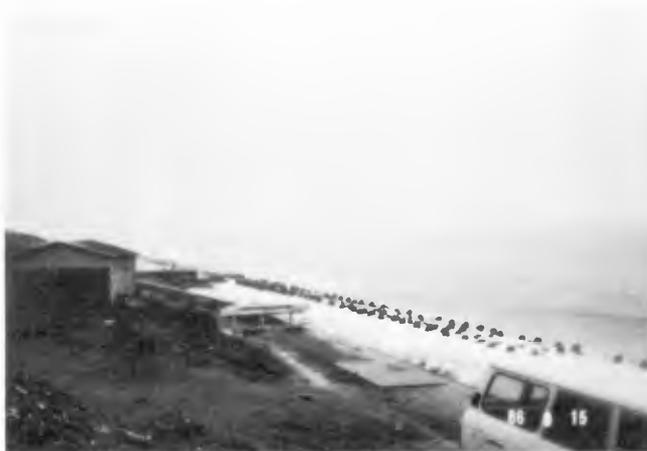
Picture 6 Same location as Picture 5. The picture was taken on September 15, 1986.

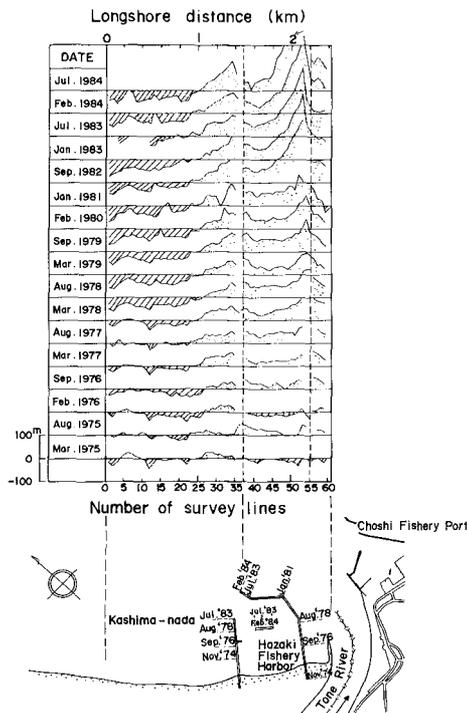
Figure 9 Temporal and spatial changes of shore-line position around Hazaki Fishery Harbor.

The construction work of the breakwater of the fishery harbor began in 1974 at Hazaki next to the mouth of the Tone River. The breakwater was elongated year by year, and until 1984 south and north breakwaters had been completed (Fig.9). With the elongation of the breakwater sand accumulated inside the harbor, and at the same time the north coast of the harbor was eroded. The temporal and spatial changes of the shoreline positions can be examined as shown in Fig.9 because the topographic surveys around the harbor have been conducting twice a year since 1974. In September, 1976 the lengths of the north and south breakwaters were elongated until about 470 m and 360 m respectively. During the period the shoreline advanced in the vicinity of both breakwaters. On the other hand, the beach between No.12 and No.26 north of the breakwater was eroded. Thereafter both breakwaters were further elongated in the offshore direction until January, 1981 and simultaneously the shoreline inside the harbor gradually advanced. Furthermore, the eroded region extended north over No.0. The

breakwater was elongated normal to the direction of the shoreline until January, 1981. During 1981 and 1984 the parallel part of the breakwater was constructed and the north breakwater was also elongated. With these construction works, the shoreline inside the harbor advanced to a great extent to reach to 263 m at maximum. The shoreline on the north side of the harbor advanced with the elongation of the breakwater, but the amount of the advance is smaller than that inside the harbor. The cause may be given by the following reason. First, the predominant direction of the littoral transport is considered to be northward at the coast, judging that the eroded zone extended in the northwest direction. In other words, the dominant wave is incident from clockwise with respect to the normal to the initial shoreline. Under such a condition of wave incidence, longshore current directing southeast develops in the lee of the breakwater, and sand accumulate on the north side of the breakwater. Regarding the cause of the beach changes inside the harbor, not only the littoral drift turning around on tip of the breakwater due to the mechanism, but also the deposition of a part of the sediment outflow from the Tone River is thought to be important. Because it is not until 1981, when wave condition inside the harbor was getting calm by the construction of the offshore breakwater, that the shoreline advanced quickly.
