CHAPTER 147

GENTLE SLOPE SEAWALLS COVERED WITH ARMOUR UNITS

by
Osamu Toyoshima

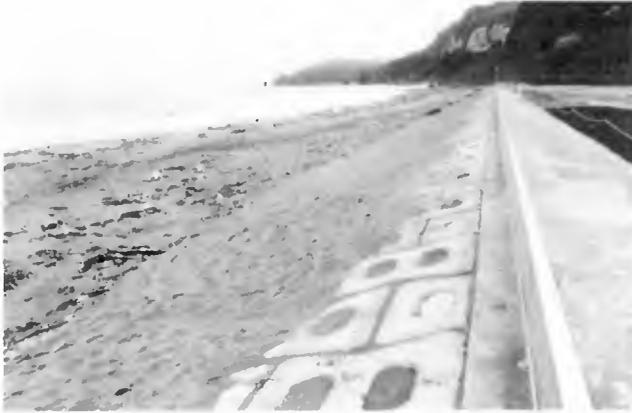
Photo 2. A later view of the experimental seawall.

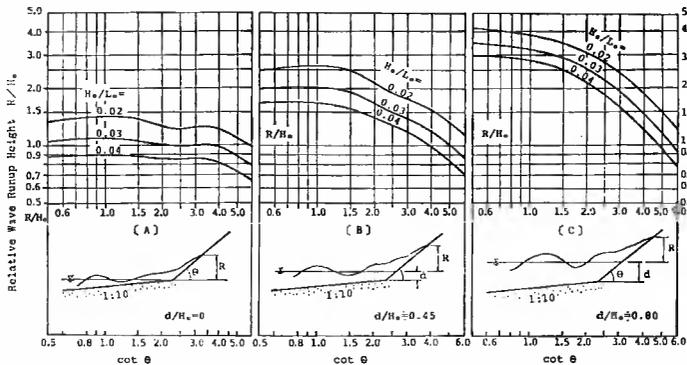
In general, wave runup on a gentle slope is lower than that on a steep slope. Fig.2 shows diagrams of the wave runup height based on laboratory measurements by Saville (1958), where H_o is the offshore wave height and H_o/L_o the offshore wave steepness. The laboratory test was conducted using periodic waves on smooth impermeable slopes. The slope of the model seabed was 1/10.

Fig.2 Wave runup height on smooth, impermeable slope faces on the seabed of 1/10 slope(Drawn after Saville,1958).

The diagram [A] is for cases of the relative toe depth $d/H_o=0$, [B] for $d/H_o =0.45$, and [C] for $d/H_o =0.80$.

The relative wave runup height R/H_0 in [A] is comparatively small and varied little with the structure slope (1/cot), where as R/H_0 in [B] and [C] shows a considerable increase with the relative toe depth d/H_0 and with the slope. In the case of the structure slope of 1:5 or 1:6 (cot θ = 5 or 6), however, the runup height is considerably small and its variation with the toe depth is rather insignificant. then, the slope of 1:5 and 1:6 are very favorable to wave runup in comparison with the slope of 1:3 or 1:4. This is why the author regards gentler-slope seawalls as the optimum measure for shore protection.

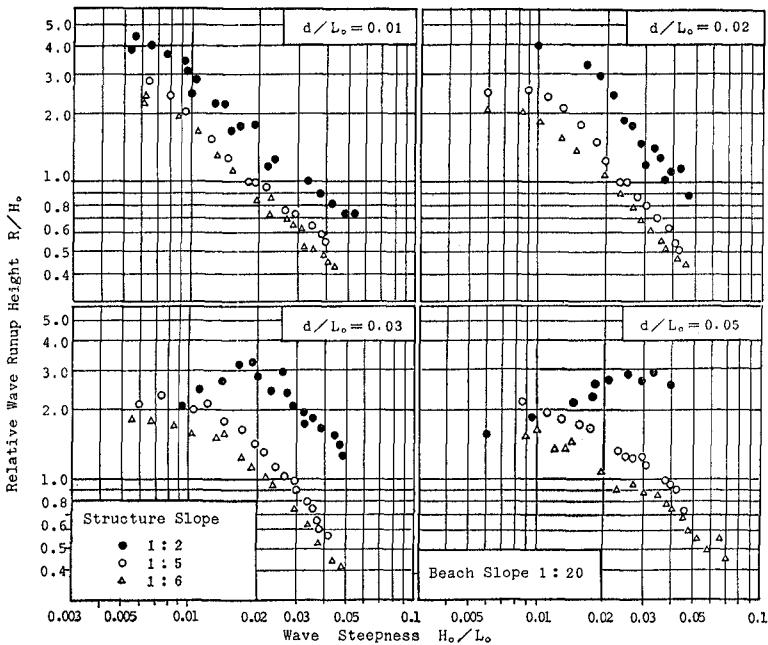
The length of the two dimensions water tank was 52 m, water depth was 0.70m, slope of the model seabed was 1:20, all model slopes were made as smooth and impermeable, and regular waves were used.

Fig.3 Wave runup height on smooth, impermeable slope faces on the seabed of 1:20 slope (by Toyoshima, 1985).

From the results of the laboratory test, as shown in Fig.3, it has become clear that,

- (1) the wave runup height on 1:5 and 1:6 slope are considerably small in comparison with 1:2 slope.
- (2) the depth at the toe of seawalls become deeper, gentler slope seawalls are advantageous on the runup heights, generally.

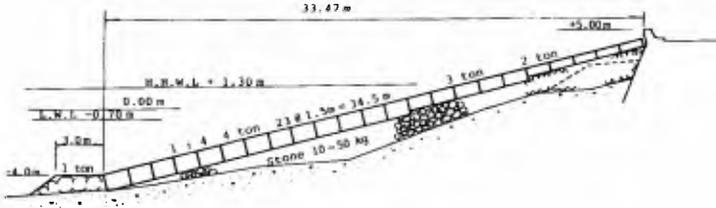
Fig.4 Reformed type experimental seawall on Hongo Coast.

Fig.4 shows the standard cross section of the experimental works of reformed type seawall with gentler slope (1:4) on Hongo Coast. Three models of Lotus-Uni block were used as facing blocks without any special foundations or rubble stone works.

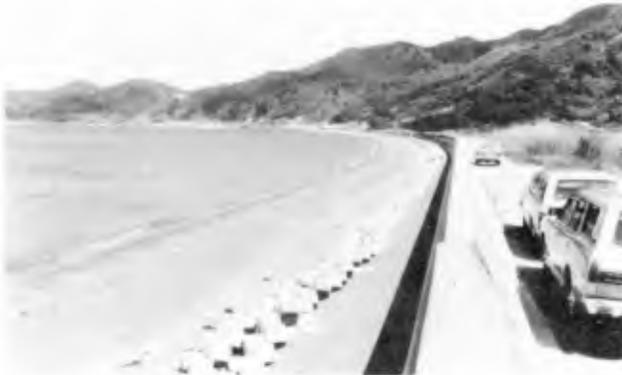
Photo 3. A former view of Hongo Coast (1977).

Photo 3 shows a former view of Hongo Coast in 1977 after the construction of the old seawall. A little sand beach were remaining.

Sand beach remaining in Photo 3 disappears in Photo 4 which was taken before the experimental works. In winter stormy weather, considerable amount of splash overtopped the seawall in spite of armour units placed in its front. Photo 5 shows the experimental seawall under construction. The depth at the toe of the slope was about 4 m.

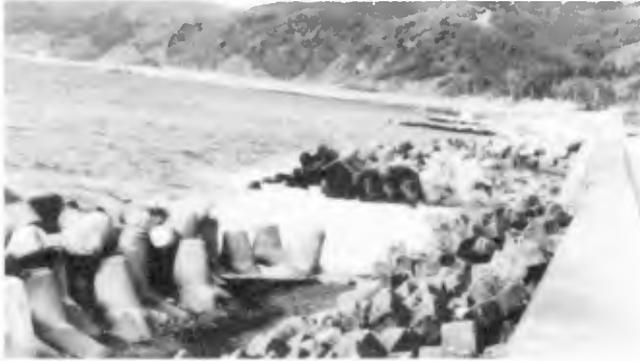
Photo 4. Before the experimental works on Hongo Coast.

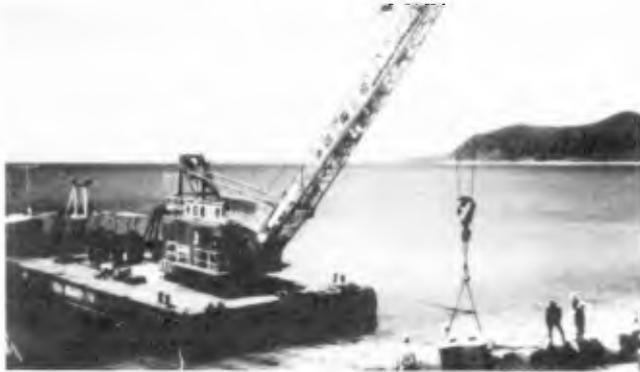
Photo 5. The experimental seawall under construction.

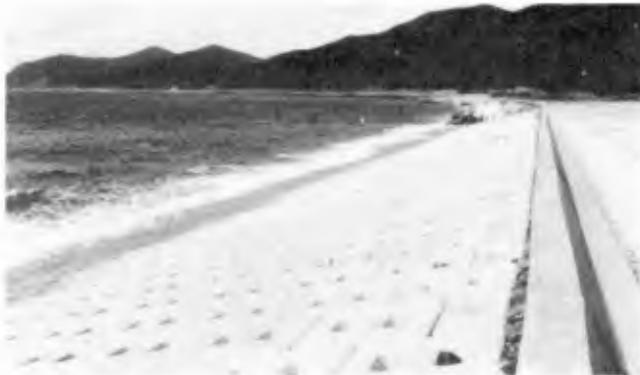
Photo 6. The experimental seawall completed.

The works were completed in August, 1985, (Photo 6). Although this seawall has been attacked annually by severe winter waves, no collapse of the slopes or dispersion of the facing blocks has occurred up to now.

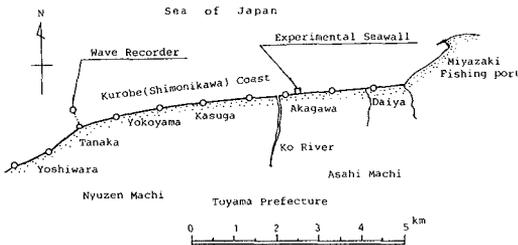
Fig.7 Location of the experimental seawall works.

The location of Kurobe Coast is shown in Fig.6, together with Muroran and Hongo Coasts. The Kurobe Coast is one of the most eroded coast in Japan. Fig.7 and Fig.8 show the location and area of the experimental seawall works in Kurobe Coast. The wave recorder located about 500 m offshore from the coast, and 5 km to the experimental works site. The water depth of the wave recorder site is 15 m, and the wave recorder is set at -14m depth.

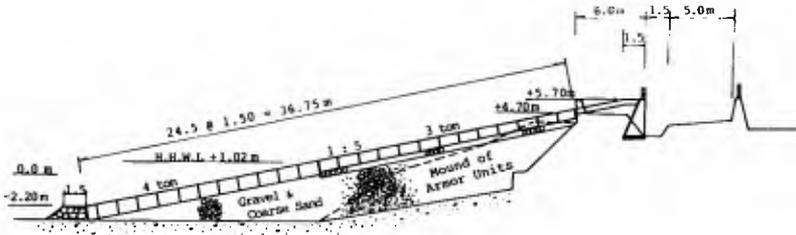
Fig. 9 Standard cross section of the experimental seawall.

In fiscal 1986, a part of the experimental seawall and the secondary detached breakwater were constructed. The predominant direction of severe winter waves is NNW. The cross section of the experimental seawall is shown in Fig. 9. The front slope is 1:5, and two models of Lotus-Uni, 4 ton and 3 ton, are used as the facing blocks without any special foundations. Removing the existing parapet wall, and reformation of the crown protection and retaining wall were carried out in fiscal 1987.

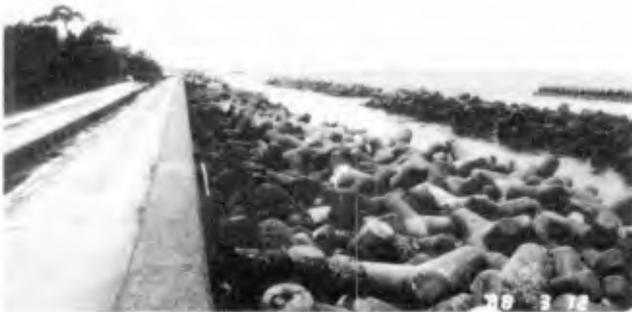
Photo 7 shows a latest view on the left-hand side of the experimental seawall construction site, and that is the same conditions before the experimental seawall works. There are vertical type seawalls, large mound of armour units for wave dissipation works and detached breakwaters. The weight of armour units for wave dissipation works and detached breakwaters are 8 ton and 20 ton respectively.

Photo 7. Left-hand side view of the experimental works.

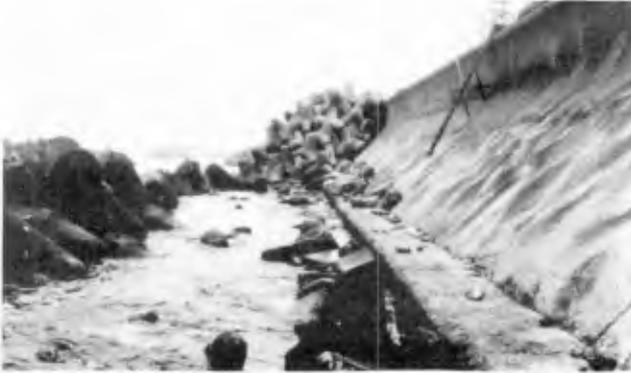
First, as shown in Photo 8, the existing mound of armor units were removed. The existing seawalls are visible. Until the early 1960's, some narrow sandy beaches had been remaining in this area. However, immediately after the construction of this seawall, the beaches have vanished away. Then, large mound of armor units have been built, in order to protect the toe of seawalls from scouring and reduce the wave overtopping and splashing of sea water. However, these have been not enough to reduce the wave overtopping and splashing. And sometimes, the seawalls were damaged due to the leakage of the backfill sand.

Photo 8. First, mound of armour units were removed.

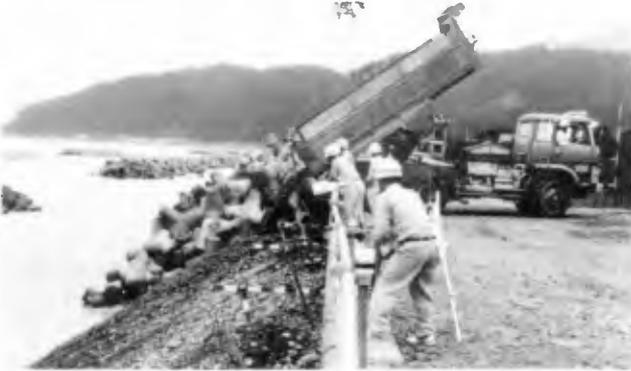
Photo 9. Filling of sand and gravel, which were diverted from the dredging of Miyazaki fishing port, located 4 km away from the site (cf. Fig.7).

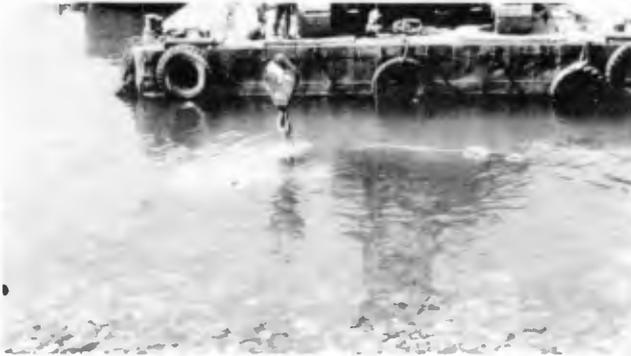
Photo 10. Setting the Lotus-Uniblock on the rubble stone. The lowest block were set at -3.3 m water depth.

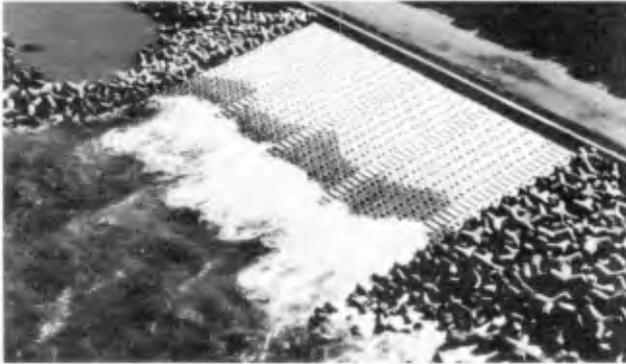
Photo 11. The works of the fiscal 1986 have completed in September 1986. The length of works is 40 m.

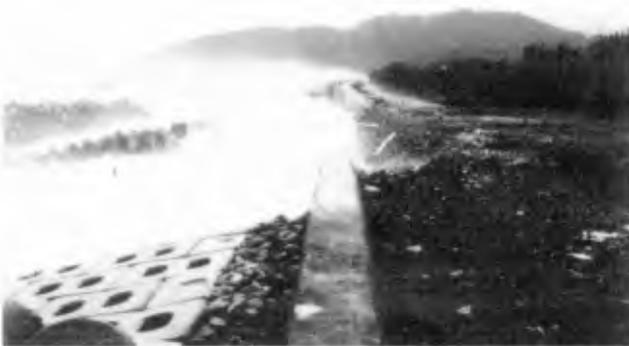
After the completion of the experimental works, the first heavy wave struck the seawall in November 1986. On the 20th December 1986, pretty heavy waves attacked the Kurobe Coast, and overtopped the crown of the experimental seawall, as shown in Photo 12.

Photo 12. Heavy waves overtopped the crown of the experimental seawall, on the 20th December 1986.

Naturally, a number of runup waves overtopped the crown of the experimental seawalls, as shown in Photo 12.

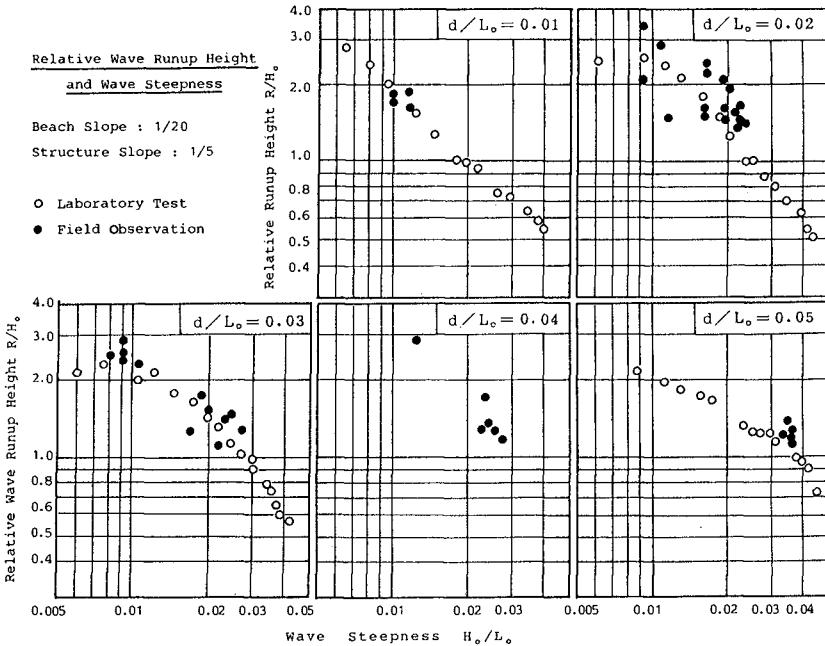
Fig.10. Comparison between the laboratory test and the field observation on the wave runup height on gentle slope seawalls.

The data of the field observation are plotted in Fig.10, together with the data of the laboratory test. Open circles are laboratory test and solid dots are field observation. At a glance, both of these data show a good agreement. The slope of the seawalls in the field are covered with armour units, but in the laboratory test all slope of model are smooth and impermeable. The waves in the laboratory test were regular waves. The wave recorder is 5 km away from the site of works, the runup waves are not the same waves as recorded by the wave recorder.

Although, there are many problems in these data and their calculation processes, the author considers that these results on the gentle slope 1:5 seawalls are very useful for designing of the shore protection in future.

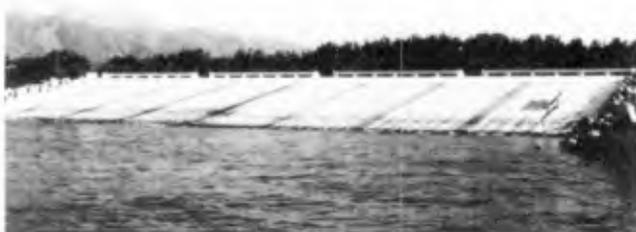
Photo 13. The works of fiscal 1987 was completed. The left half are of fiscal 1986.

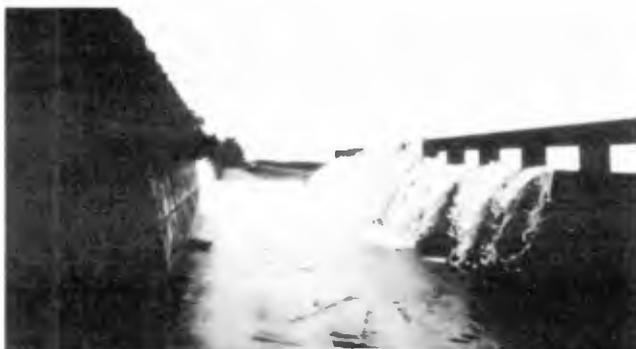
Photo 14. Heavy waves attacked the Kurobe Coast, and some of them overtopped the experimental seawalls.

On 6th November 1987, heavy winter waves attacked the Kurobe Coast, and some of them overtopped the experimental seawalls. However, the spray of sea water on the gentle slope seawalls were excessively small in comparison

with that of existing vertical type seawalls with large mound of armour units.

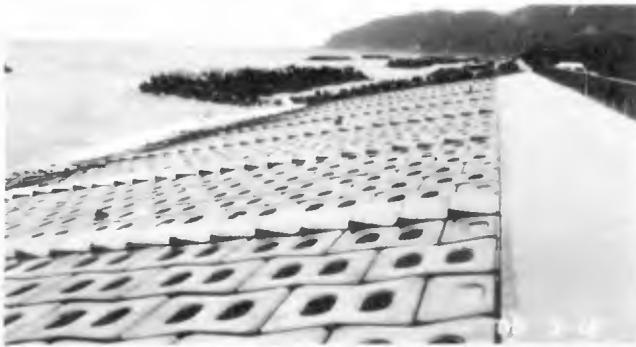
Photo 15. The latest view of the experimental seawalls.

After the construction of the experimental works, one or two winter seasons are over, but there has not been any trouble, damage or collapse, on the body, slope, covering blocks, foot and toe of the experimental works. At this time, these new type gentler slope seawalls are successful.
