CHAPTER 131

STATIC AND DYNAMIC LOADING TESTS ON THE HARO ARMOUR UNIT

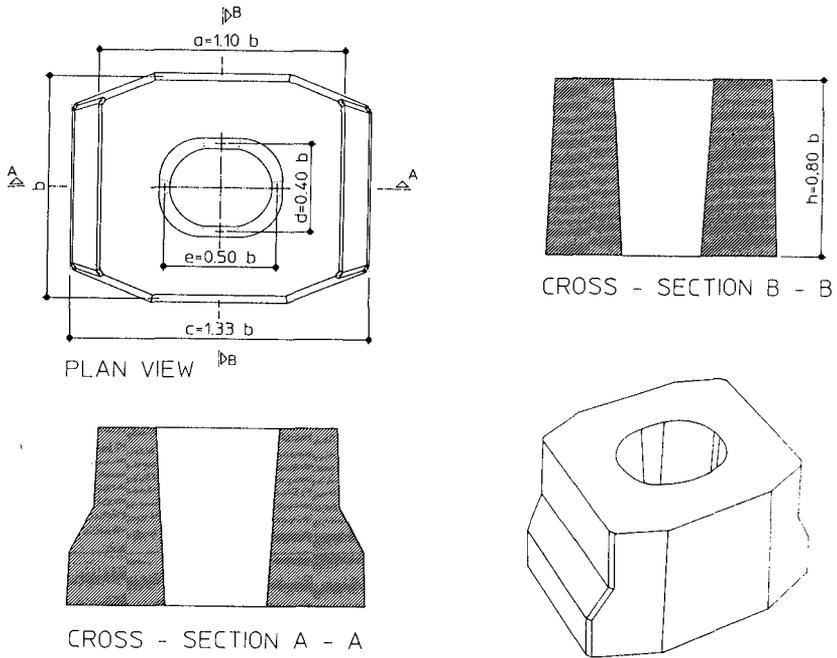
The HARO is a compact concrete block with a large central opening (fig. 1). Both short sides are made wider at the base. The corners are asymmetrically tapered in plan. Thanks to the large central opening, the protuberances at the short sides and

Figure 1. Geometry of the HARO armour unit

conform an appropriate placement pattern, a porosity as high as 51-53 % can be achieved.

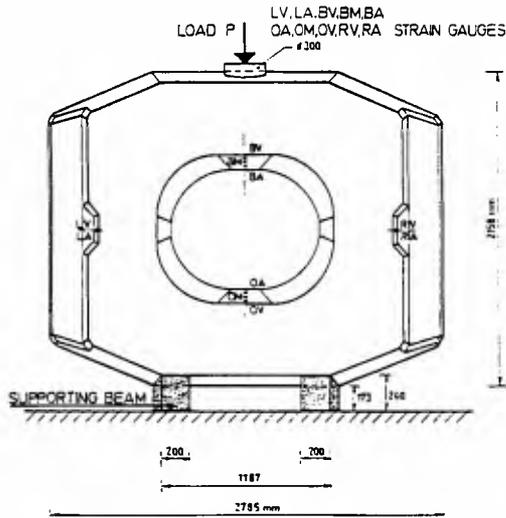
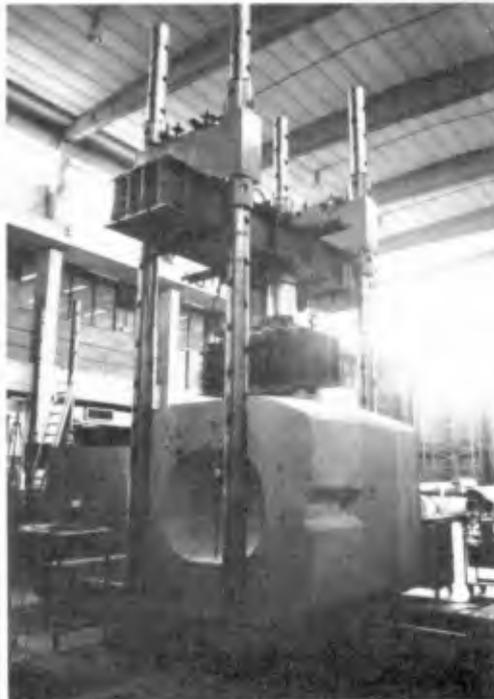
The test set-up for the static loading test on a 150 kN HARO is shown in fig. 2. The block was turned on its side and placed on two supporting concrete beams with variable depth. On the upper surface, a circular steel disc (300 mm \varnothing), on which the load P was applied, was placed. This load application point is located on the axis passing through the centroid of cross-section BB (fig. 1). During the test, the total load P was

Figure 2. Test set-up for the static loading test

increased by increments of 200 kN. At each load level the deformation of the concrete surface was measured at 10 different points by means of strain gauges with a gauge length of 60 mm. The strain gauges were positioned parallel to the original upper and lower faces of the block. The shortening of the minor axis of the central hole was measured along three verticals.

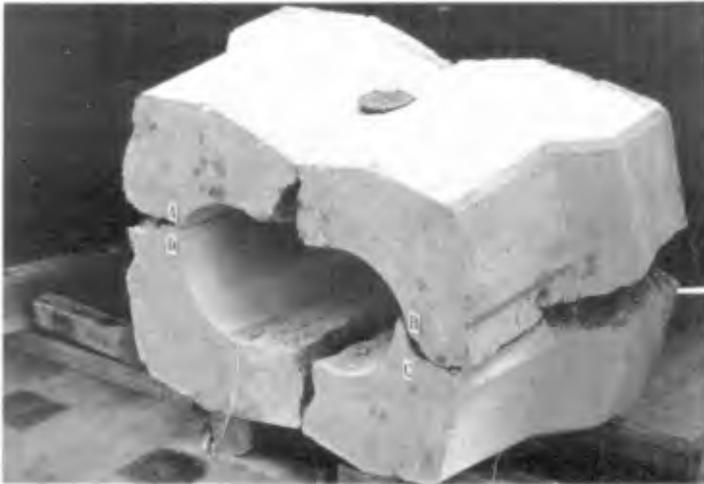
Rupture of the block occurred at a load level of 2400 kN which corresponds to 16 times the weight of the block itself. Fig. 3 shows the HARO after failure.

Figure 3. Block after the static loading test

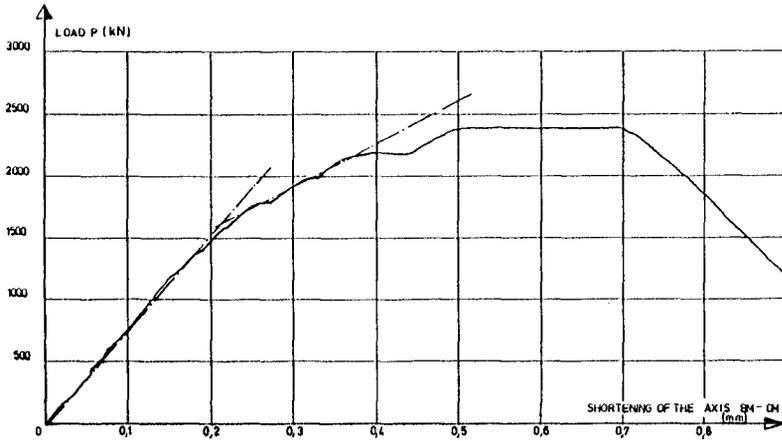
The shortening of the short central axis BM-OM in relation to the applied load P is shown in fig. 4. From this figure it appears that the elastic state extends to about 1600 kN. Beyond this value the shortening of the axis BM-OM increases at a higher rate. This non-linear behaviour is confirmed by the strain gauge readings. Measured strains and strains found in a supporting 3-dimensional linear elastic finite element analysis correspond reasonably well for loads up to $P = 1600$ kN, as is shown in fig. 5 for strain gauge LA. From this load level on, the course of the measured strain signals varies rather widely depending on the location of the strain gauges. This is due to the fact that during the loading process the internal stress distribution gradually changes and that only local strains are measured. The maximum measured (tensile) strain equals $190 \cdot 10^{-6}$ (strain gauge BV).

Figure 4. Shortening of the axis BM-OM as function of the load P

As the static loading test concerns, the total input energy is obtained as the surface under the load-displacement curve. Associating the decrease Δd of the axis BM-OM with the displacement at the point load, one can obtain from fig. 4 the energy values mentioned in table 1.

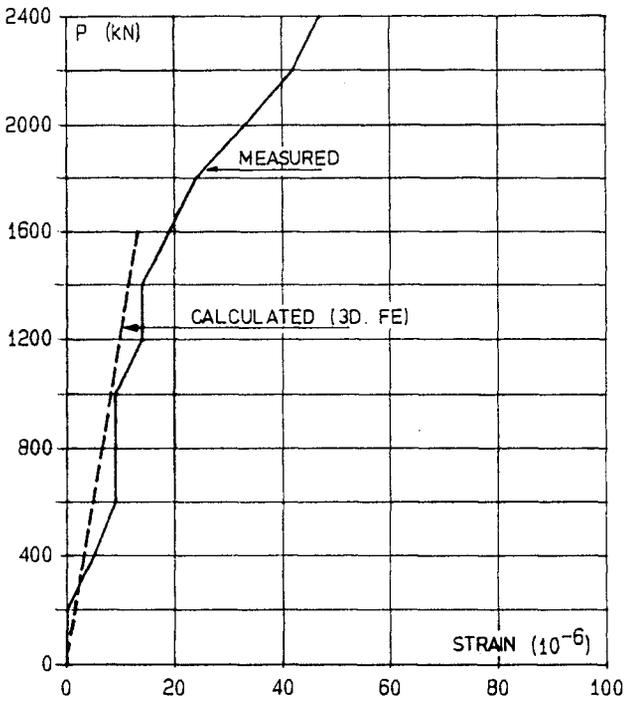
Figure 5. Comparison of measured and calculated strain at LA

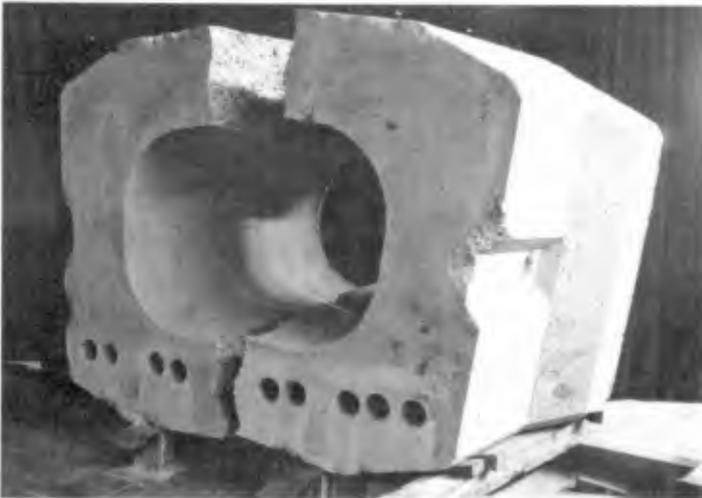
Figure 6. Block after the dynamic loading test

- drop height of 650 mm : vertical crack at the upper inner face, extending to the front and back face.
- drop height of 700 mm : vertical crack at the lower inner face.
- drop height of 750 mm : horizontal crack at the left inner face.
- drop height of 800 mm : extension of the vertical cracks and rupture of the block into two parts (fig. 6).

- During a static loading test in the laboratory, the HARO block failed at a load of 2400 kN, which represents 16 times its own weight.
- During a dynamic loading test in the laboratory, rupture of a block took place after the impact of a steel block with a mass of 516 kg from a drop height of 800 mm.

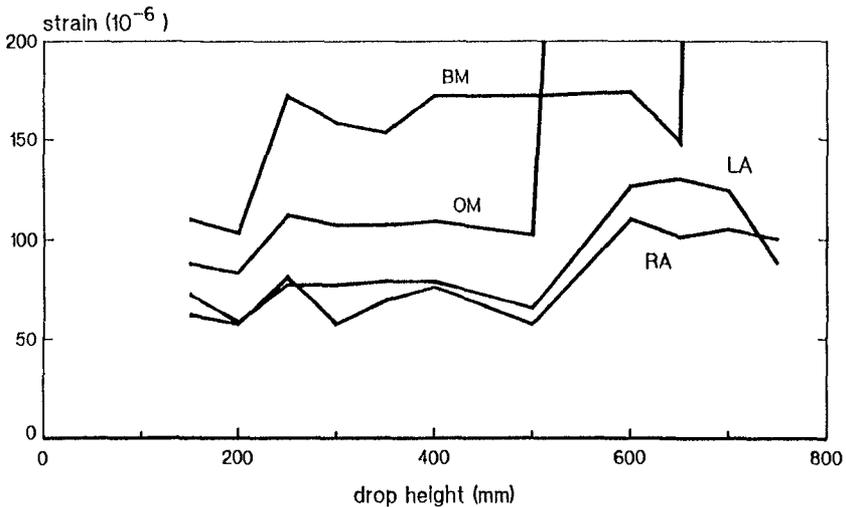
In fig. 7, the maximum tensile strain, recorded during the impact at the locations RA, BM, LA and OM is plotted. It follows that after the impact from 550 mm height, cracking already occurred at the lower inner face (OM). The maximum strain at the upper inner face appears to remain almost constant at a value of 180 microstrain from the impact from 250 mm height on. Noteworthy is that the maximum concrete strain, again corresponds to the usual range i.e. 150-200 10^{-6} , as encountered in the static loading test.

Figure 7. Measured peak strains during impact

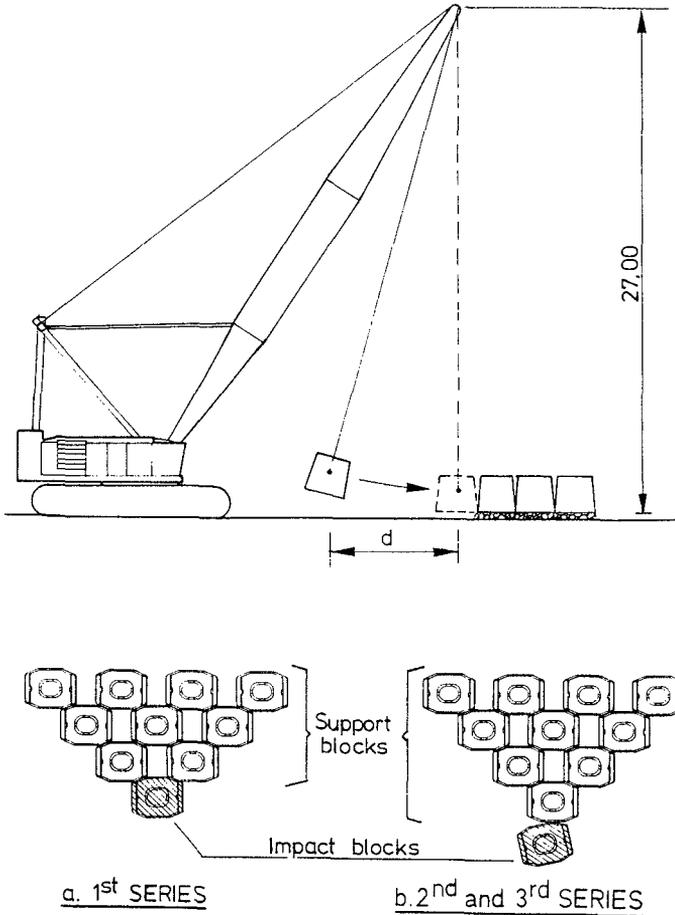
A 150 kN HARO suspended by a cable at the top of a crane jib was first given a horizontal deviation d from its equilibrium position and then swung against other blocks at rest on a rock bed (fig. 8). Two different impact situations were envisaged (fig. 8). In the first test, the impact block hits two blocks of an adjacent row. In the second test, an edge of the impact block hits another block on its weakest side. The first situation results from the design placement pattern (a block of an upper row rests against two blocks of the lower row). The second is deemed to correspond to an exceptional event.

Figure 8. Test set-up for pendulum test on site

- Pendulum tests on the site were performed according to two different configurations (lower part of figure 8). When the impact block was swung in between two other blocks, up from a horizontal deviation of 7 m, only local damage of the blocks occurred. When the impact block hit an adjacent block at its weakest side, failure of the blocks occurred for a horizontal deviation of 4 m.

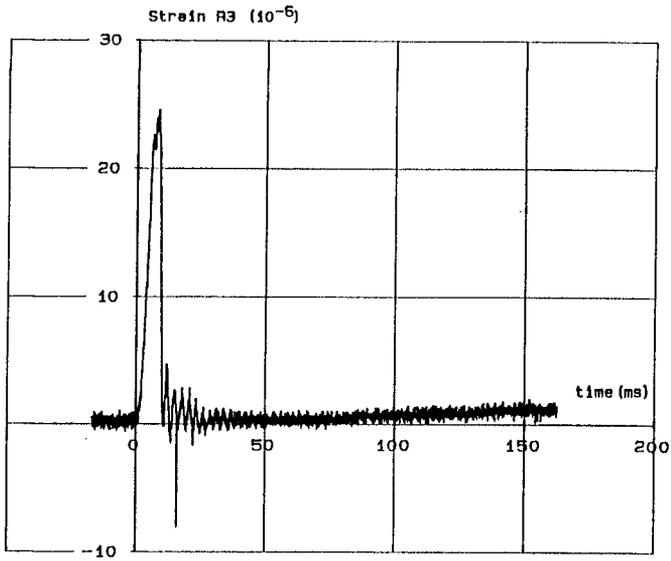
The maximum peak strain, before rupture of strain gauge R1, is equal to $160 \cdot 10^{-6}$ which indicates that for the three tests considered so far, the maximum concrete strain could be considered as a useful failure criterion. In fig. 9, the recorded strain signal from strain gauge R3 is shown for the impact from $d = 3$ m. It follows that the impact time is about 12 ms. Fig. 10 shows the acceleration signal A3 for the same impact situation. The second impact at about 295 msec is caused by the rotation of the impact block after the first contact at one of the edges. It has to be noted that the time scales of figs. 9 and 10 are different.

Figure 9. Strain signal R3 during impact from $d = 3$ m (second test series)

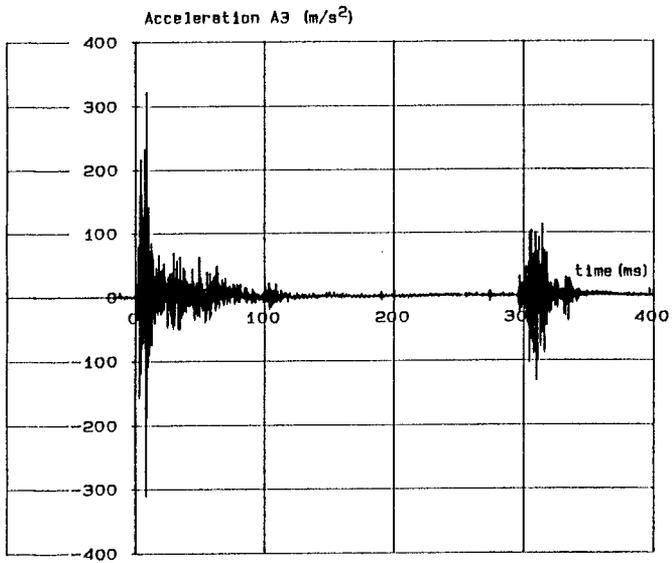
Figure 10. Acceleration signal A3 during impact from $d = 3$ m (second test series)
