CHAPTER 183

Causes of Damage to Saldanha Sand Breakwater

J S Schoonees*, J W J Kluger*** and J A Zwamborn*

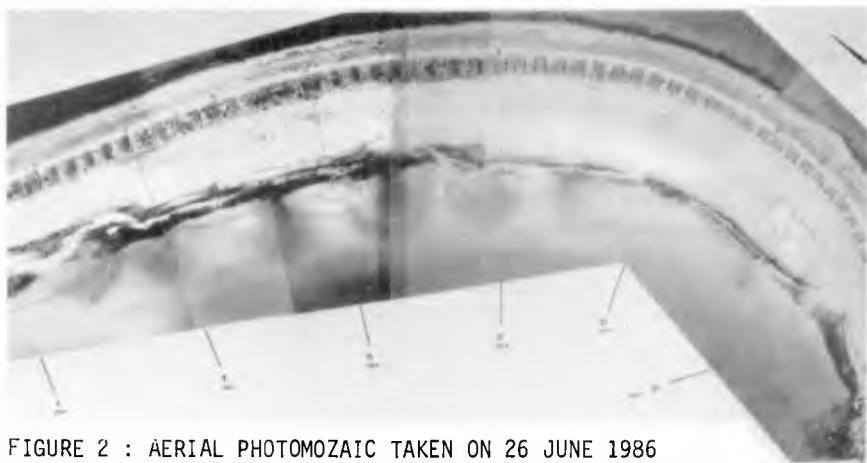
FIGURE 2 : AERIAL PHOTOMOZAIC TAKEN ON 26 JUNE 1986

The aim of the aerial photography, conducted at roughly three-monthly intervals and taken at low water, was to establish whether overall changes of the breakwater, and especially the erosion areas detected previously in the rock protection placed during construction, had taken place.

Figure 2 is an example of a photomosaic compiled from such photographs.

The aerial photography showed that no drastic change of the erosion areas occurred and that the overall appearance of the breakwater has virtually stayed the same during the period August 1985 to November 1986.

Before rock can be placed as protection, the erosion areas (Figure 2) should be filled up with sand. This should be followed by a geo-textile on the sandy areas and a layer of 0,5 m of well-graded filter stone (2 kg to 5 kg) over the whole area to be treated. Rock protection using stone between 1 t and 6 t should be placed as conceptually shown in Figure 12. The foundation of geo-textile and filter stone should extend beyond the toe of the rock armouring to provide scour protection. About 50 000 m³ of rock will be needed for the erosion areas and approximately 150 000 m³ for the entire sand breakwater.

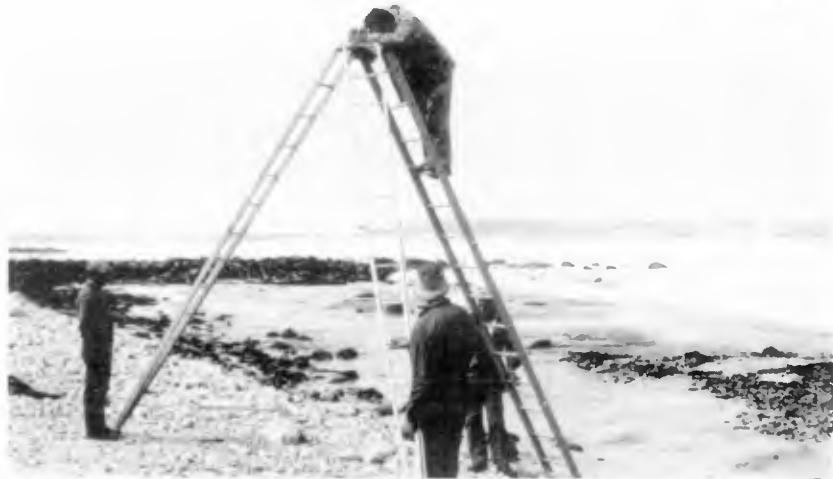
FIGURE 3 : TRIPOD USED FOR THE BEACH PHOTOGRAPHY

An aluminium tripod, giving a camera elevation of 3 m above ground level, was used to photograph the beach. One leg of the tripod consisted of a ladder which provided access for the photographer to the top of the tripod (Figure 3). At each position of the tripod, a horizontal area of 4,2 m × 4,2 m was photographed. Thus, by moving the tripod 4 m along a selected line after taking each photograph, a continuous strip of the beach 4,2 m wide and as long as required, could be photographed.
