## CHAPTER 259

### STUDY OF 50 YEARS COASTAL CHANGES AT HADERA, ISRAEL

by Dov S. Rosen<sup>1</sup>, MASCE, MIAHR

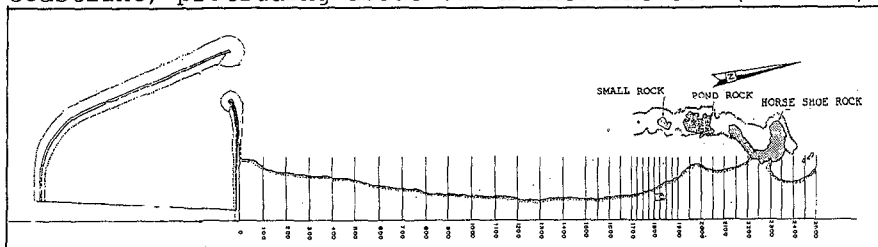
Figure 2. Hadera-Sdot-Yam Coast with Baseline & Sections

(b) Preparation of a mylar (polyester, i.e. non-shrinking) transparent base map of the area at a scale of 1:2500, on which all present beach features (structures, rocks, etc.) and the baseline and control sections were included ( see Fig. 2)

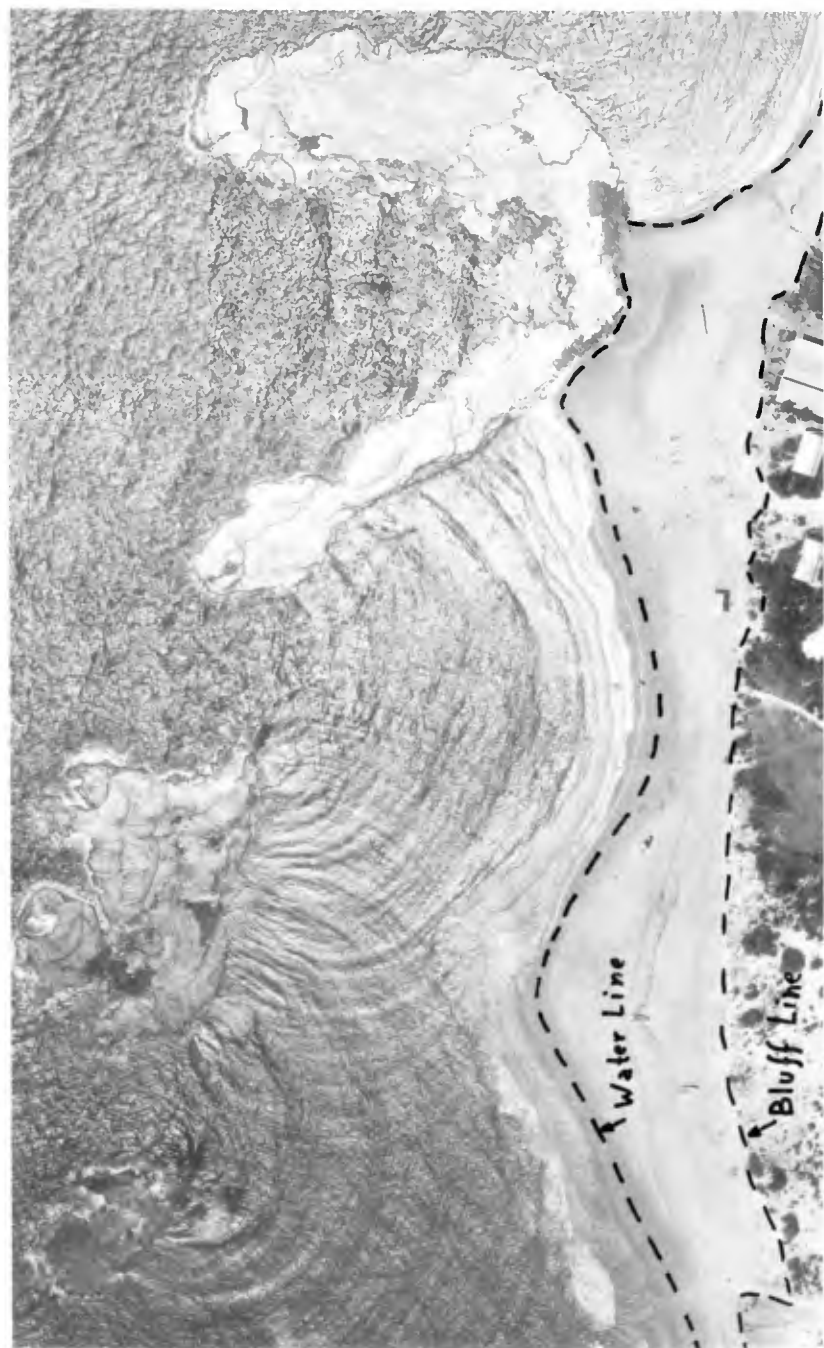
Figure 3 Example of marking of waterline and bluffline  
on an aerial photograph (Sdot-Yam 31.07.1970)

The study was based mainly on the analysis of some 90 aerial photographs of 45 flights and 24 maps and correlation with the wave climate history. The correct determination of the bluff and waterline positions in the various charts and aerial photographs, relative to a fix baseline, parallel to the coastline, represented an important item of the study. In view of the suggestions of other investigators (Lueder-1977, Striem-1965), the prevailing (mean) waterline in the air-photographs at the time they were taken, was marked in the middle of the wet area of beach (dark area - see Fig. 3) and bounded by the visible water line.

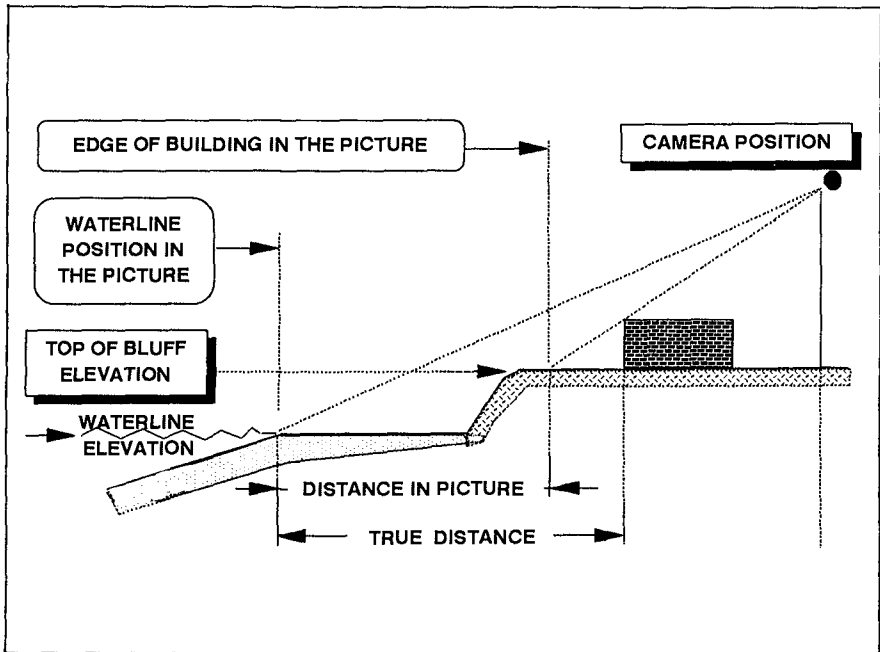
Figure 4 Schematic representation of error source in air photographs due to camera angle and elevation differences

those on the pictures, the distances between the base line and the waterline position at nearby sections could be accurately measured (with very little distortion), since the waterline and rock tops were at about the same elevation (Fig. 4). For correct interpretation of the fluctuating positions of the waterline and bluff with time and along the beach, an evaluation of the errors associated with the values computed for their positions due to various factors like paper shrinkage, drafting accuracy, scaling, positioning, etc., was also performed. The overall errors assessed were 5 m for the maps and 10 m for the air-photographs. Then, the waterline and beach bluff fluctuations prior, during and after the construction of the cooling basin breakwaters were analyzed at constant control sections along the base line (Fig. 2). The distance along the base line between control sections was 100 m, except at certain recently eroded sectors, where the distances were shortened to 25 m. Furthermore, the morphologic features of the coastal sector studied (bars, cusps, rip currents, spits, breakwaters, groins, sea walls and antique coastal structures) were also observed. Time histories of the corrected positions of the bluff and waterlines were

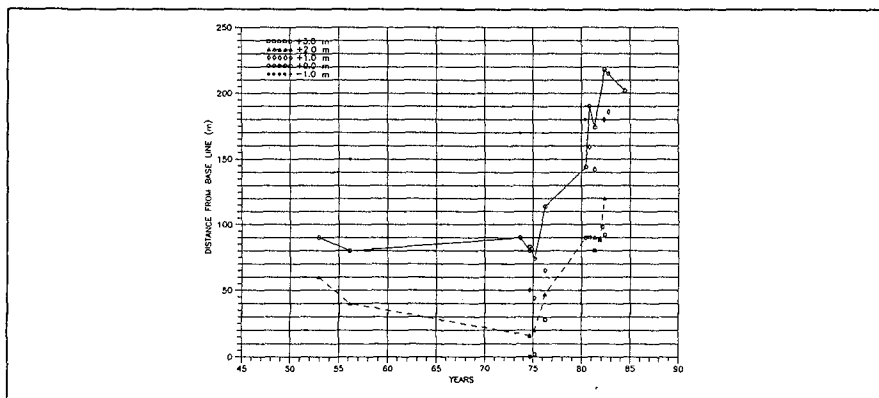
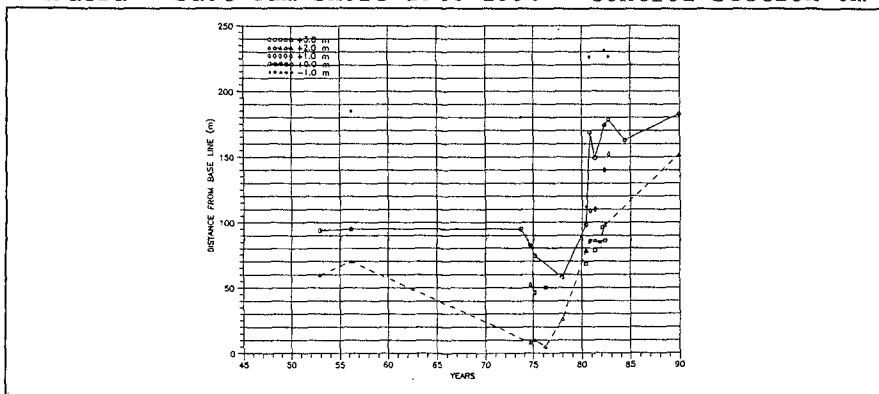
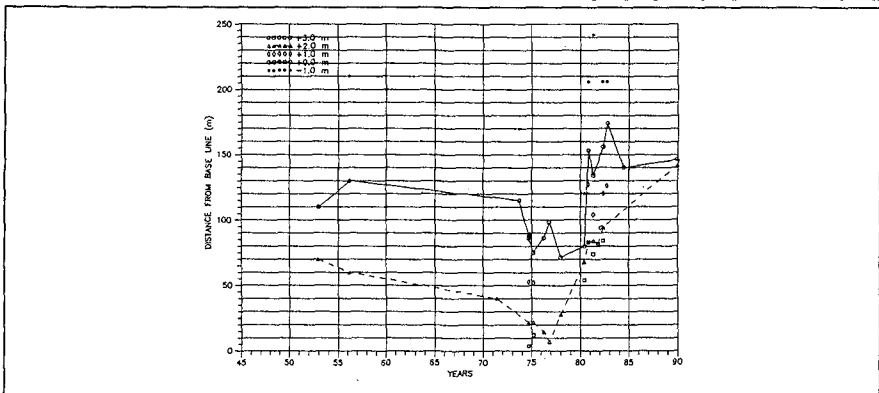
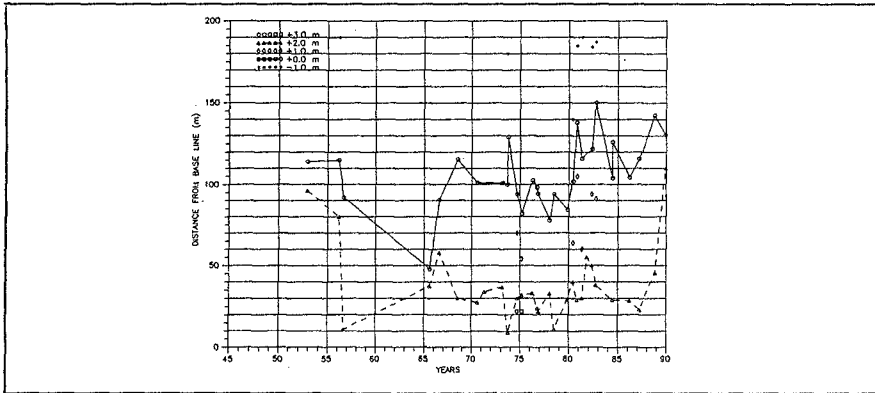
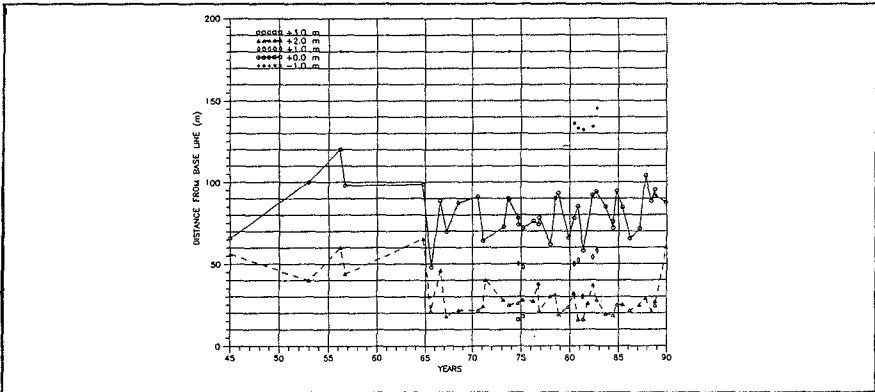
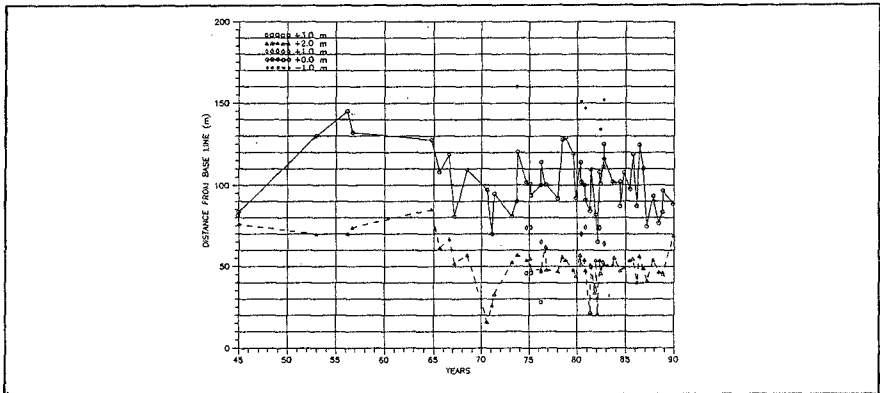
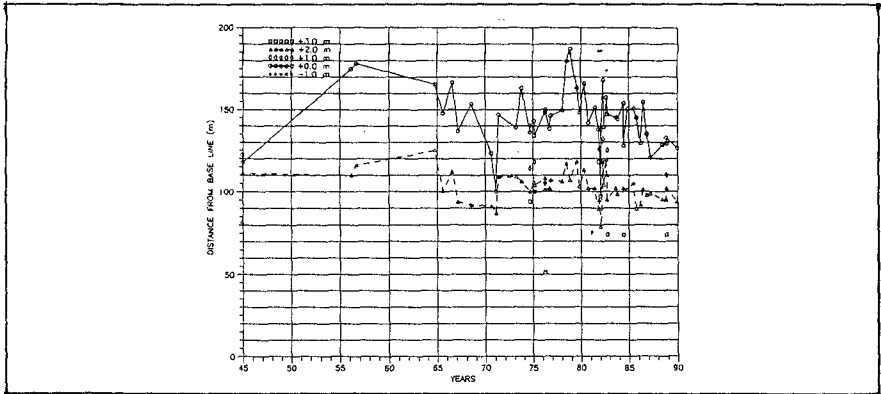
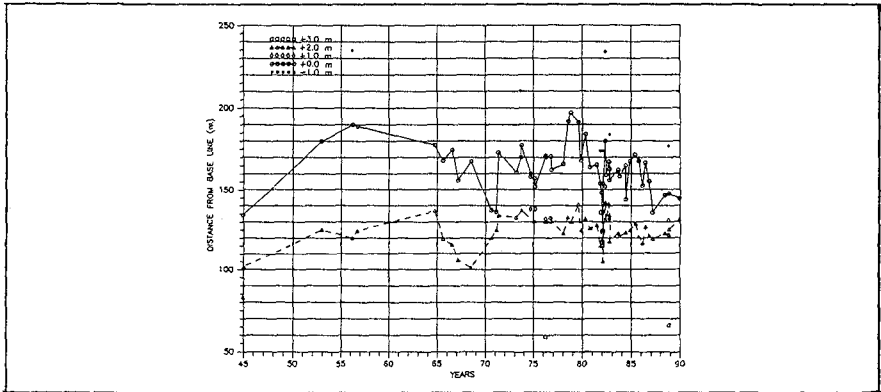
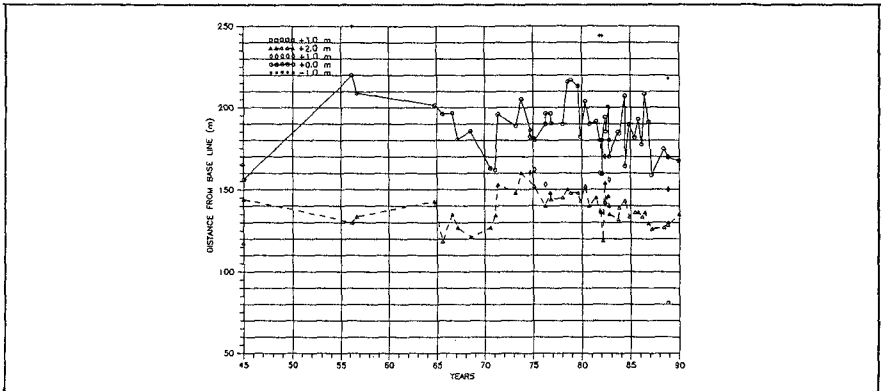
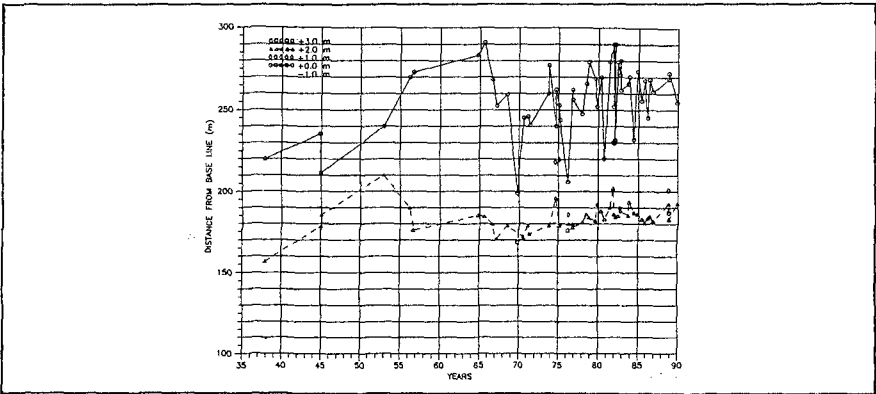
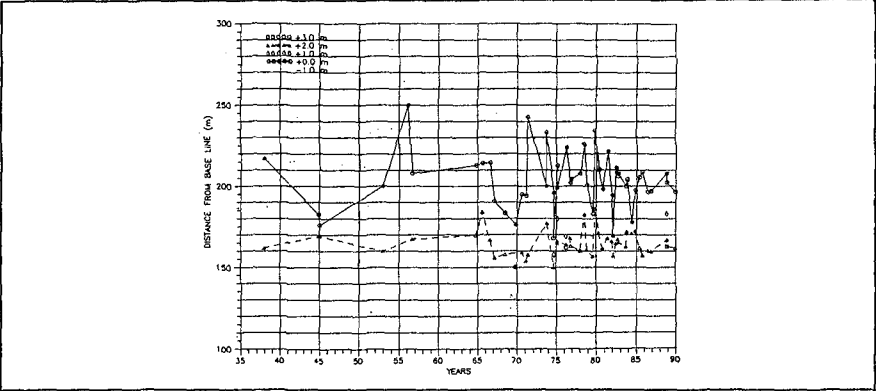
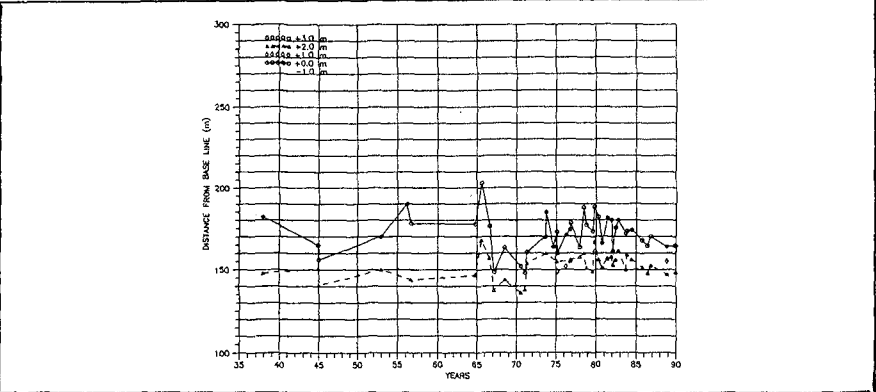
Figure 5. Waterline and Beach Bluff Fluctuations  
Hadera - Sdot Yam Shore 1945-1990 - Control Section 0m

Figure 6. Waterline and Beach Bluff Fluctuations  
Hadera - Sdot Yam Shore 1945-1990 - Control Section 100m

Figure 7. Waterline and Beach Bluff Fluctuations  
Hadera - Sdot Yam Shore 1945-1990 - Control Section 200m

Figure 8. Waterline and Beach Bluff Fluctuations  
Hadera - Sdot Yam Shore 1945-1990 - Control Section 500m

Figure 9. Waterline and Beach Bluff Fluctuations  
Hadera - Sdot Yam Shore 1945-1990 - Control Section 1000m

Figure 10. Waterline and Beach Bluff Fluctuations  
Hadera - Sdot Yam Shore 1945-1990 - Control Section 1500m

Figure 11. Waterline and Beach Bluff Fluctuations  
Hadera - Sdot Yam Shore 1945-1990 - Control Section 1750m

Figure 12. Waterline and Beach Bluff Fluctuations  
Hadera - Sdot Yam Shore 1945-1990 - Control Section 1800m

Figure 13. Waterline and Beach Bluff Fluctuations  
Hadera - Sdot Yam Shore 1945-1990 - Control Section 1850m

Figure 14. Waterline and Beach Bluff Fluctuations  
Hadera - Sdot Yam Shore 1937-1990 - Control Section 2200m

Figure 15. Waterline and Beach Bluff Fluctuations  
Hadera - Sdot Yam Shore 1937-1990 - Control Section 2300m

Figure 16. Waterline and Beach Bluff Fluctuations  
Hadera - Sdot Yam Shore 1937-1990 - Control Section 2400m

plotted for each control section. Results at representative control sections are presented in Figs. 5 through 16. They were compared to the time histories of the yearly maxima of deep water significant wave heights and of the yearly rain volume (Figs. 17 and 18). The whole waterline and bluffline fluctuations for the whole coastal sector are represented in Figs. 19 and 20 respectively. A isolines map of the waterline fluctuation in time and space was prepared from the data of the waterline position during 50 years along the whole sector of coast studied (Fig.21). This map facilitates to depict the location and duration of erosion or accretion in time along the whole coast. A tri-dimensional view of this fluctuations map in time and space is also presented in Fig. 22.

The results obtained show that this coastal sector was relatively stable until the beginning of the sixties, when a coastal erosion pattern was observed. The observed erosion seems to have occurred due to extensive quarrying of beach sand for construction purposes, forbidden by law since 1966. By the end of the sixties that erosion ceased, but reappeared for a short period at the beginning of the seventies, after an extreme storm in January 1968 and heavy rain 1969 year, which removed the beach sand, probably to the offshore bar. It disappeared from the mid-seventies, but reappeared in limited locations since 1982 due to local reasons. Beach bluff erosion, which encountered at a location remote 1800 m from the cooling basin was assessed to be due to local land reclamation from the sea without adequate scouring protection. At another sector (2100 m to 2300 m remote from the cooling basin ), a 3 m recesses in bluff position was measured in 1988. The erosion occurred after the cooling basin construction, but was induced by the construction of two groins that stopped longshore sand transport within a local pocket beach. A rather surprising result was that although the ending (northern) sector of that coast suffered from a recent small bluff erosion, it accreted some 15 m within the 1956-1964 period. The outcome indicated that the longshore influence of the cooling basin (accretion) extends for about 1500 m of the neighboring beach and nulls at about 1600 m from the lee breakwater (2.5 times its protrusion into the sea) and that a dynamic sedimentologic equilibrium state was reached after about 8 years from the cooling basin construction. Though some recent

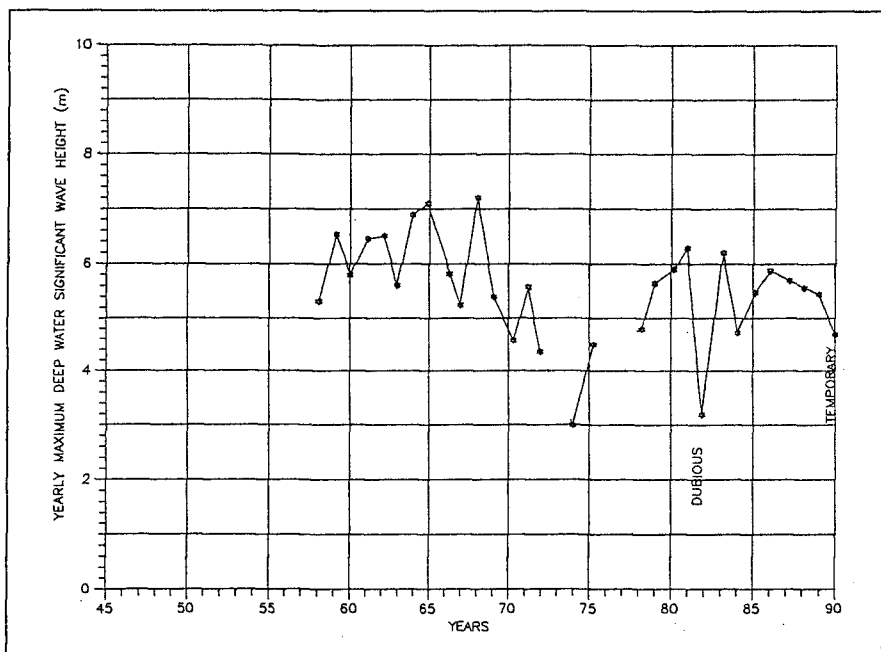
Figure 17 Time History of Yearly Deep Water Hs Maxima

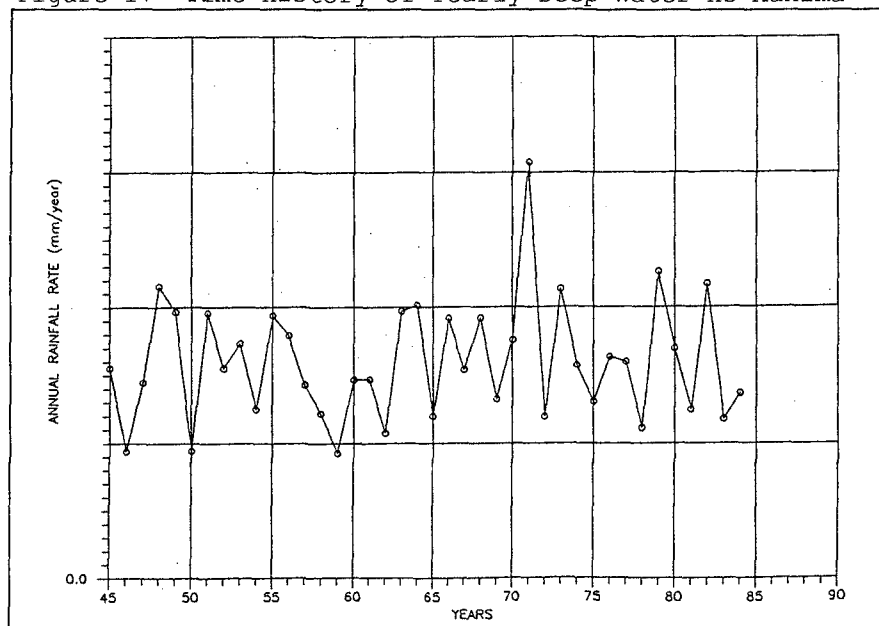
Figure 18 Time History of Yearly Rainfall Volume

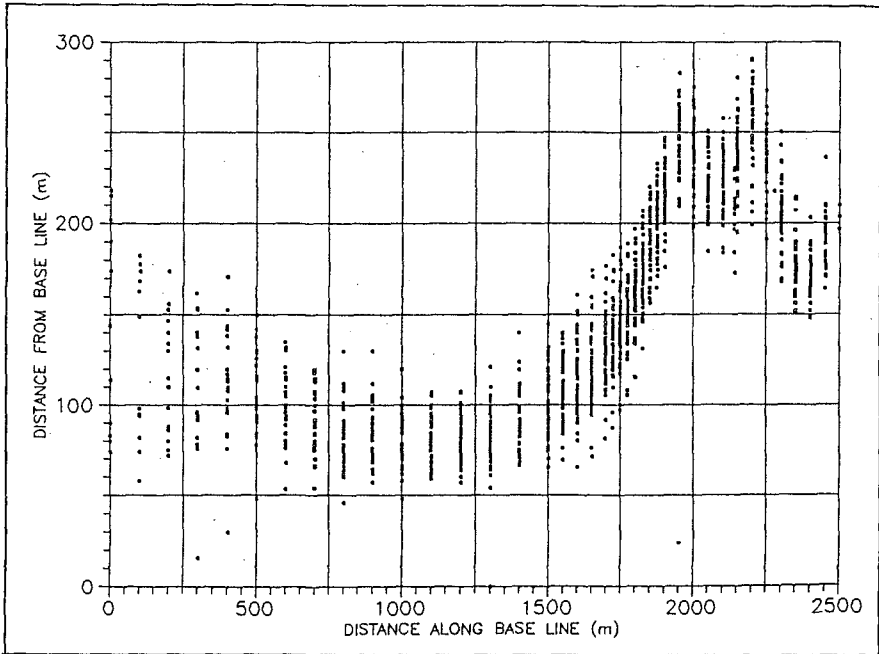
Figure 19 Waterline Fluctuations in the Study Sector

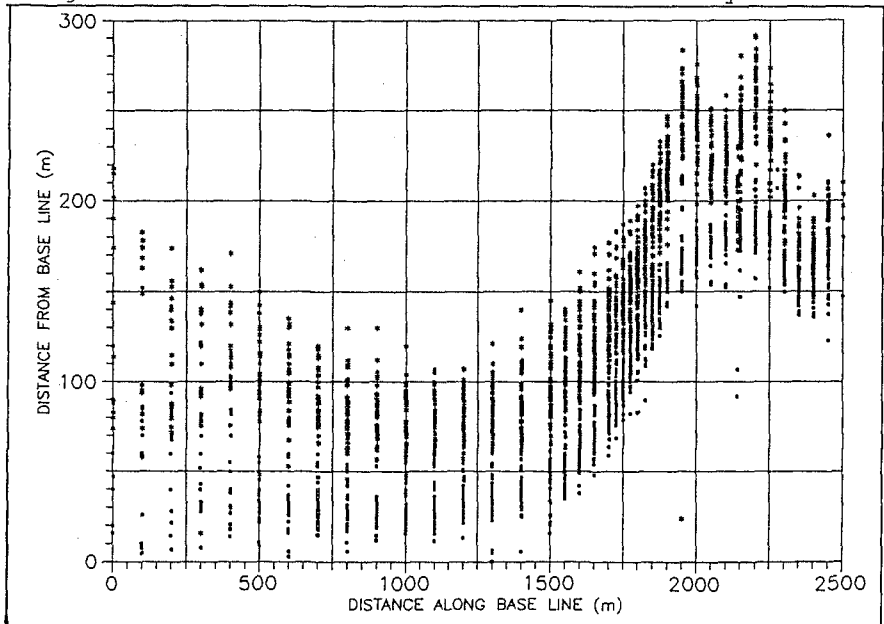
Figure 20 Waterline and Bluffline Fluctuations in the Study Sector (\* -waterline ; O - bluffline)

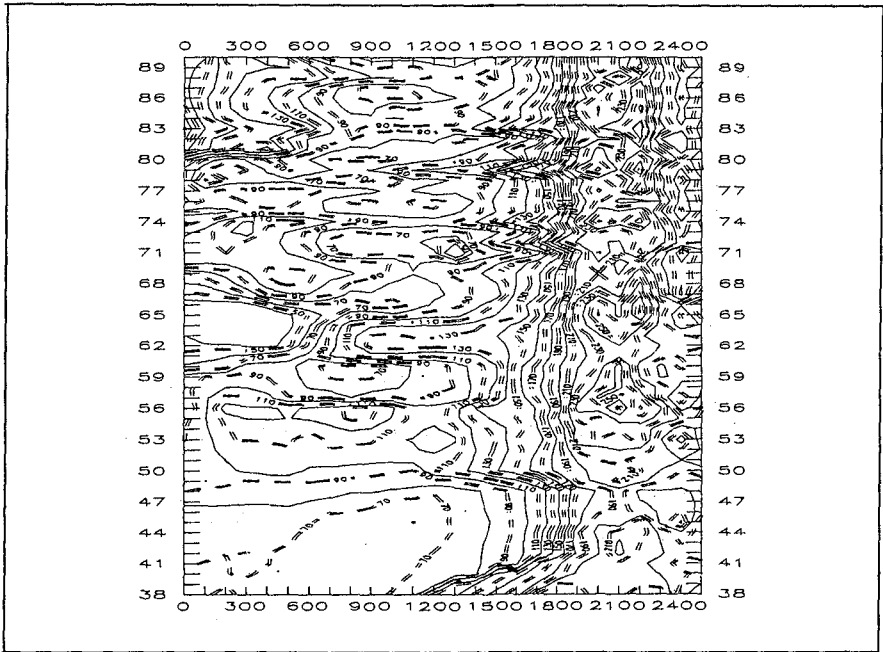
Figure 21. Map of Equidistant Contours from Baseline  
Hadera Sdot-Yam Coast Waterline (1937-1989)

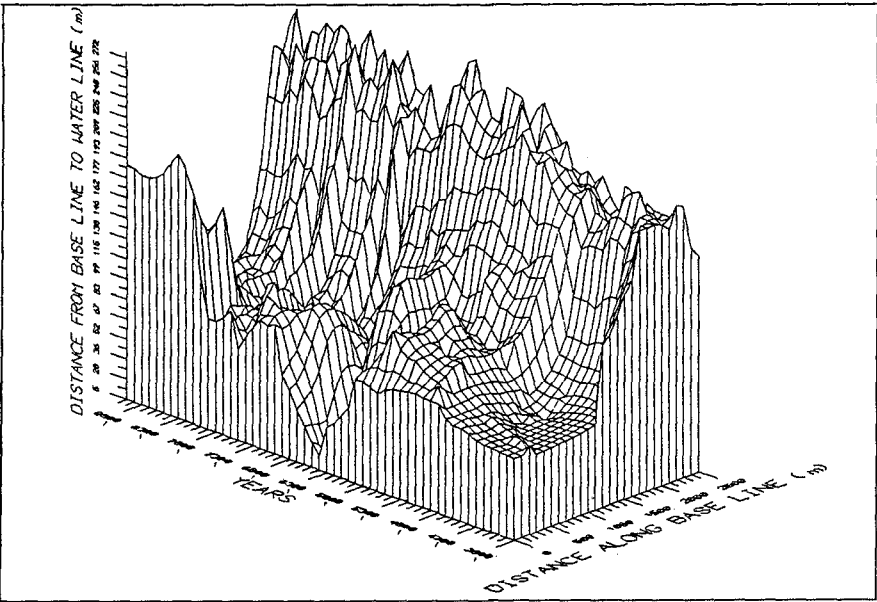
Figure 22 Tri-dimensional View of Hadera Sdot-Yam Coast  
Waterline Fluctuation in the period 1937-1989
