CHAPTER 253

The Complementary Interaction between Beach Nourishment and Harbour Management : Four Cases in Spain

Gregorio Gómez-Pina (*) & Jose L.Ramírez()**

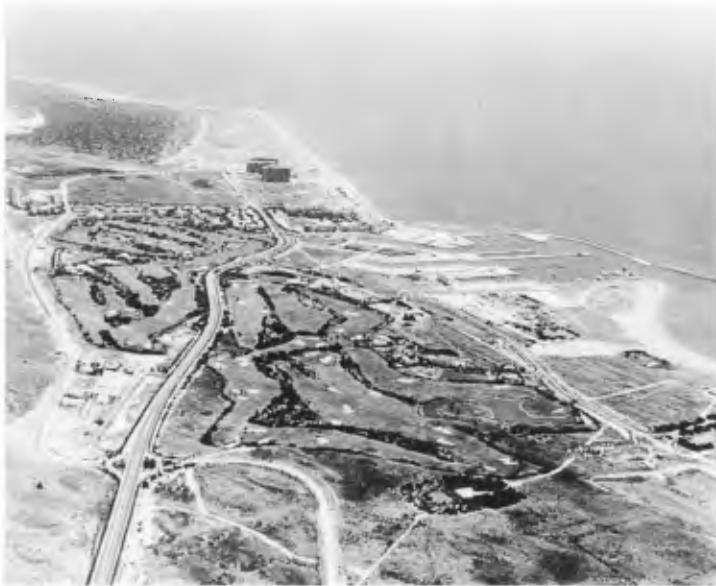
Typical negative effects which the presence of harbours cause on the coasts could be the following: A) Littoral Drift Interruption B) Beach Change Induced by a Harbour and C) Effect of Wave Reflection on the Coast Induced by a Harbour Breakwater. Fig.1 depicts a view of Almerimar Marina, located in the Almerian coast. Note the interruption of the littoral drift and the improper design of the marina entrance.

Fig 1. A View of the Effect Caused by the Littoral Drift Interruption.
(Almerimar Marina, Almerian Coast)

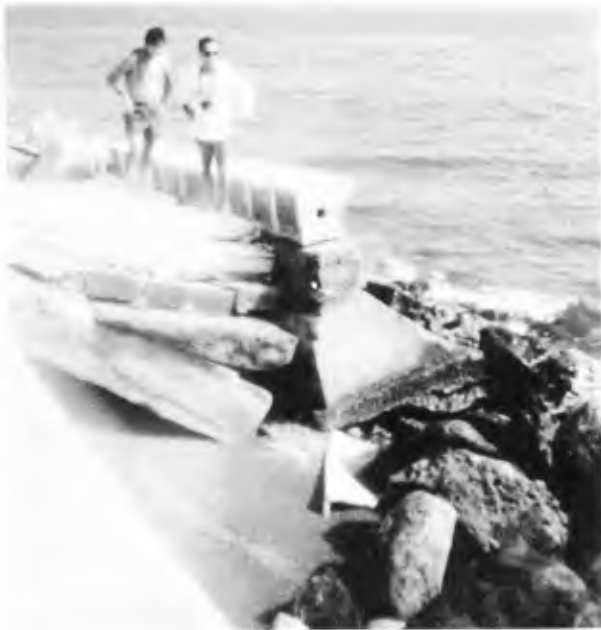
Fig.2 shows the destruction of the seafront due to the coastline erosion caused by the negative effect produced on coast by the construction of the aforementioned marina.

Fig.2.- Erosion Caused by Littoral Drift Interruption.

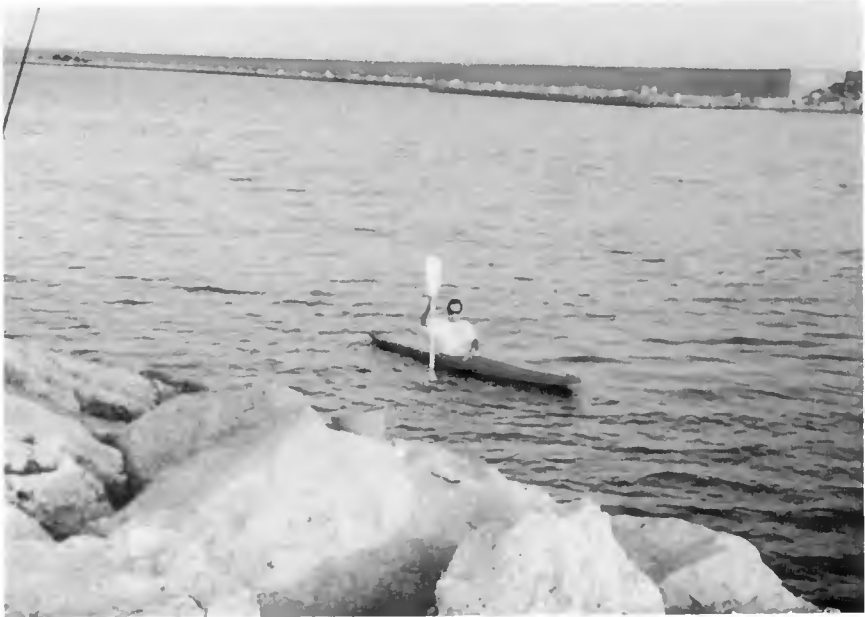
In Fig.3 the siltation at the entrance channel is clearly indicated "on site" by the length of the first author's kayak paddle.

Fig.3.- Siltation at the Marina Entrance Channel.

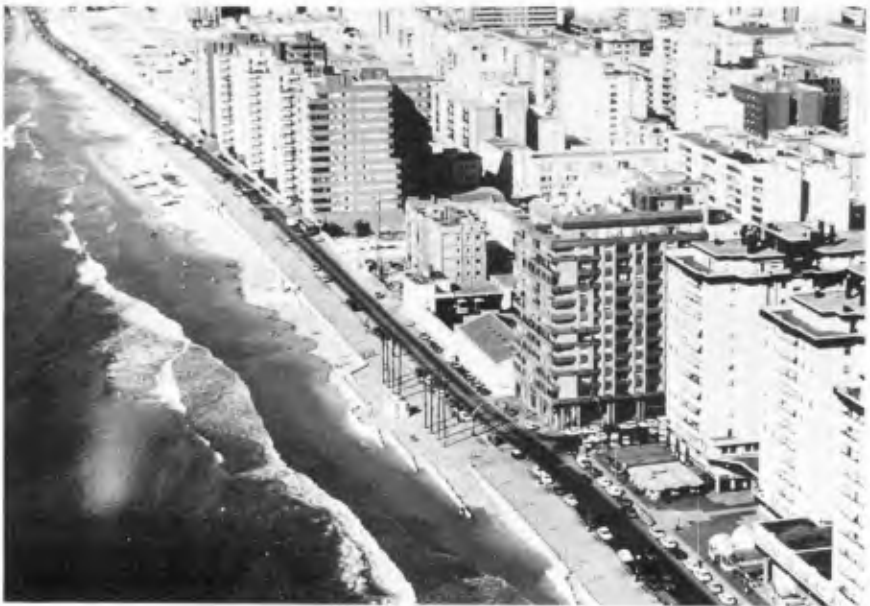
The following picture depicts an aerial view of La Victoria Beach under daily high tide conditions. Notice the occupation of the former dune by high buildings and the seafront as well as waves impinging upon the vertical face of the sea-front.

Fig.4.- A detail of the La Victoria Beach under Daily Tide Conditions Prior to Beach Nourishment.

The need to dredge the entrance channel in Cádiz Harbour, together with the loss of dry beach width, at the popular urban beach of La Victoria under normal daily high tide conditions, prompted the Spanish Directorate of Ports and Coasts to plan a joint project looking at both harbour and beach requirements.

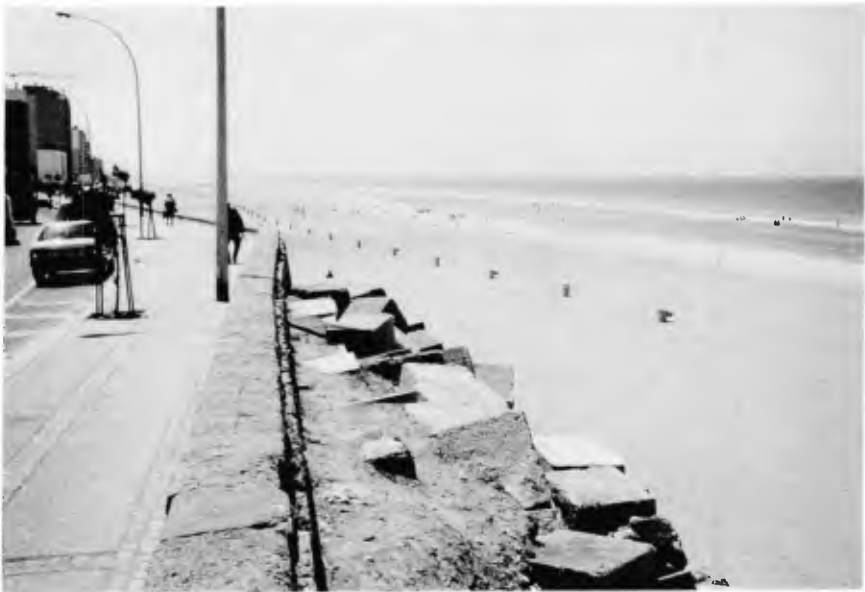
The following pictures show the general dredging plan for beach nourishment, as well as a detail of the beach width (Notice the blocks used to protect the seafront from waves under daily high tide conditions).

Fig 6.- La Victoria Beach after Beach Nourishment.

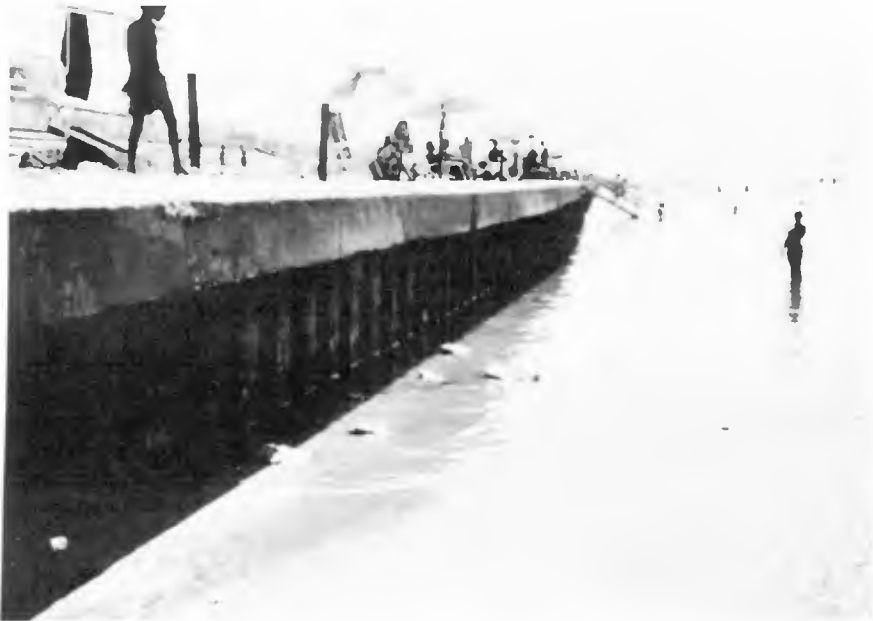
The Huelva Harbour Authorities have recently carried out a project to dredge the main harbour entrance channel. Approximately 5 million cubic meters of sand could be adequate for beach nourishment. Presently Coastal Authorities are studying the feasibility to build a submerged bar at -4 m. water depth to restore the littoral drift interrupted, among other causes, by the Huelva Harbour breakwater. These works will enhance a previous littoral drift restoration project carried out at the adjacent beach, Playa de Castilla (Refer.1, 2 & 3), where 1.5 million cubic meters of sand were supplied to form a protruding area, aimed at restoring the net littoral drift balance. The following picture depicts the erosion existing at the end of Playa de Castilla, in Matalascañas Beach. It should be noticed that this erosion is also caused by the former construction of a seafront and buildings on the dune.

Fig.7.- Erosion at the End of Playa de Castilla (Matalascañas Beach)

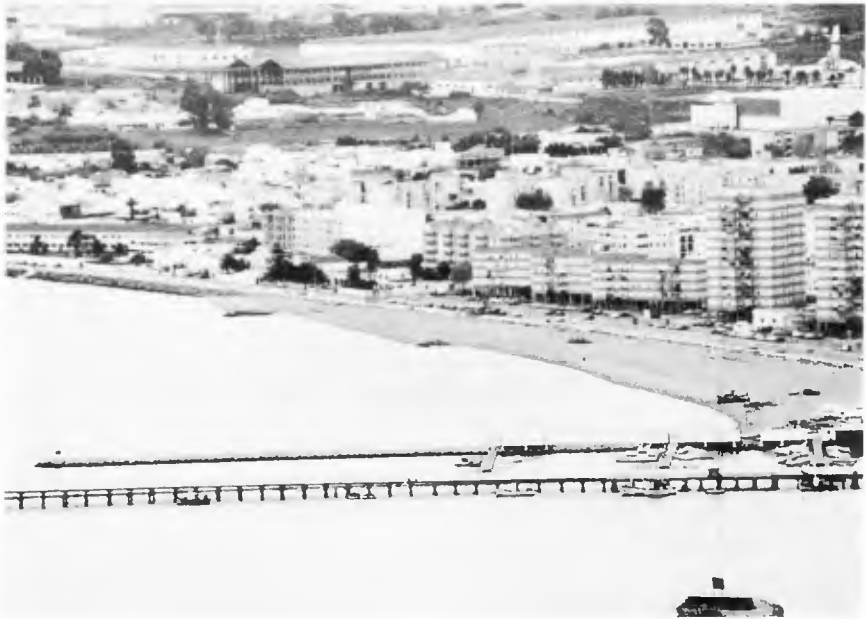
The need to provide a sheltered inner basin in Algeciras Harbour was combined with the creation of an urban beach in great demand by the La Línea city's population. The following picture shows an aerial view of the works.

Fig.8.- A view of La Línea Beach Restoration.

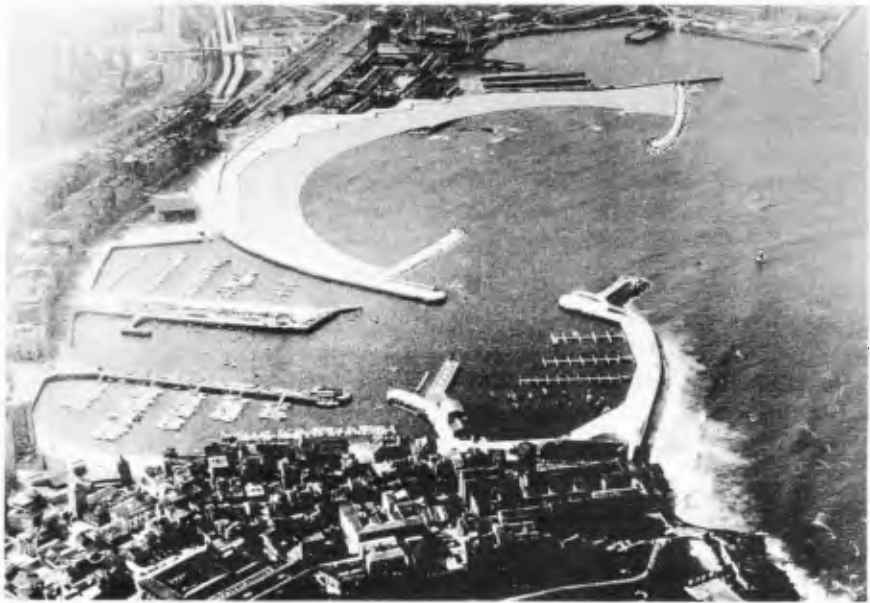
An urban beach and seafront were designed taking advantage of one of the marina's existing breakwater (Fig.9). Navigational and sedimentation problems at the marina entrance channel were two important problems taken into consideration, as well as the overall integration of the beach design into the existing urban development. In this case the Gijón Harbour Authorities were responsible of the whole project and work. The technical staff of the Coastal Authorities cooperated during different stages of the project.

Fig.9.- A Composite Aerial View of Gijón Marina & Levante Beach

The project consisted of the construction of two breakwaters and the dumping of 380,000 m³ of sea bottom sand. It was necessary to dredge 17,000 m³ of rock, as well as to demolish 32,000 m³ of an existing seawall protruding into the sea. The project cost was 1,000.000.000 pts. The projected magnitudes obtained for the new beach are the following : HTWL beach : 60,000 m²; (3 m² /p); 20,000 people; M.T.W.L. beach : 100,00 m² ; (3 m² /p) 33,000 people. Breakwaters'length: 400 m; Seafront length: 800 m.

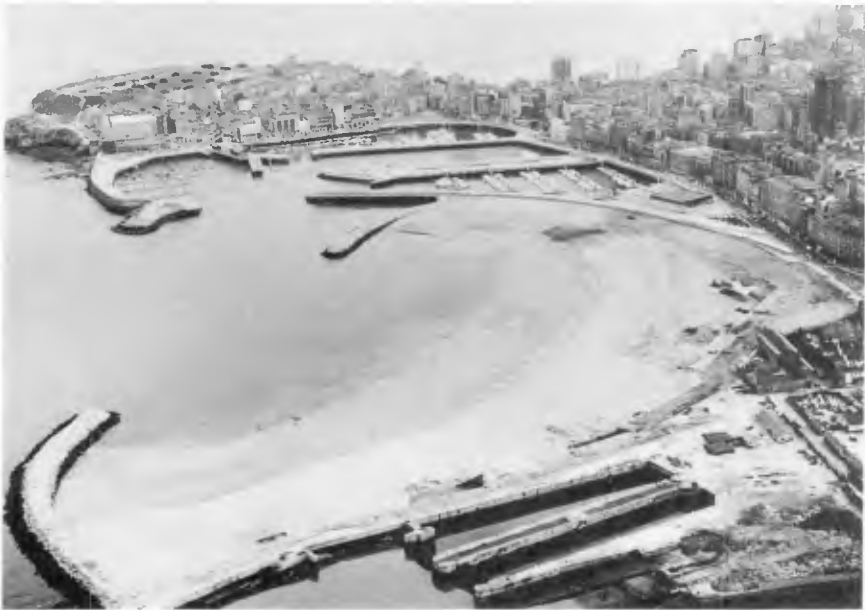
Next figure shows aerial views just after project completion.

Fig.10.- Aerial Views after Project Completion.
