### SANTA CRISTINA BEACH NOURISHMENT WORKS AND MONITORING PROGRAM

#### ABSTRACT

The purpose of this paper is to analyze the suitability of the solution adopted to restore Santa Cristina beach in La Coruña (Spain). The solution, which did not include any structures such as groins, consisted of adding 450.000 M3. of sand dredged from the sea bottom.

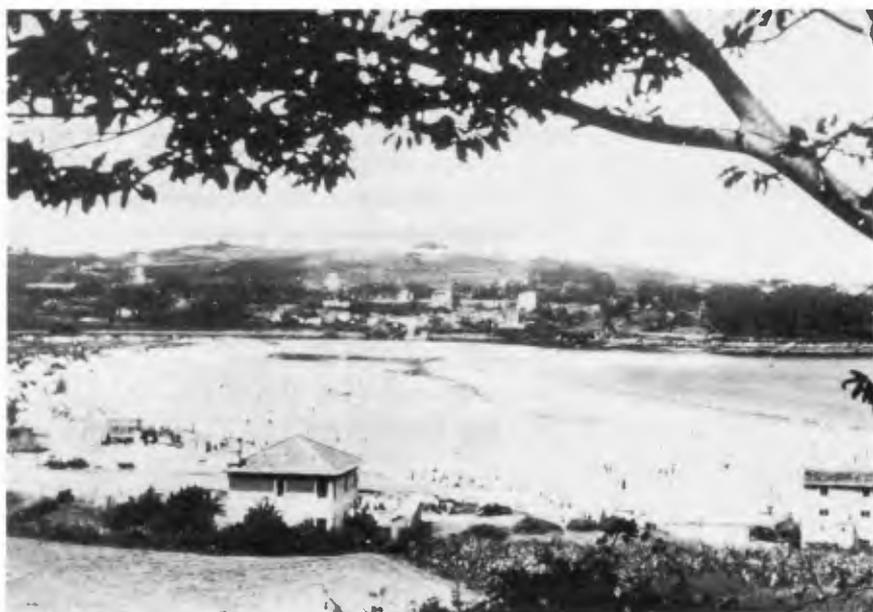
FIG. 1 SANTA CRISTINA BEACH. 1.940 (PHOTO: BLANCO)

Santa Cristina Beach before urban development of the spit (see figure 1 and 2)

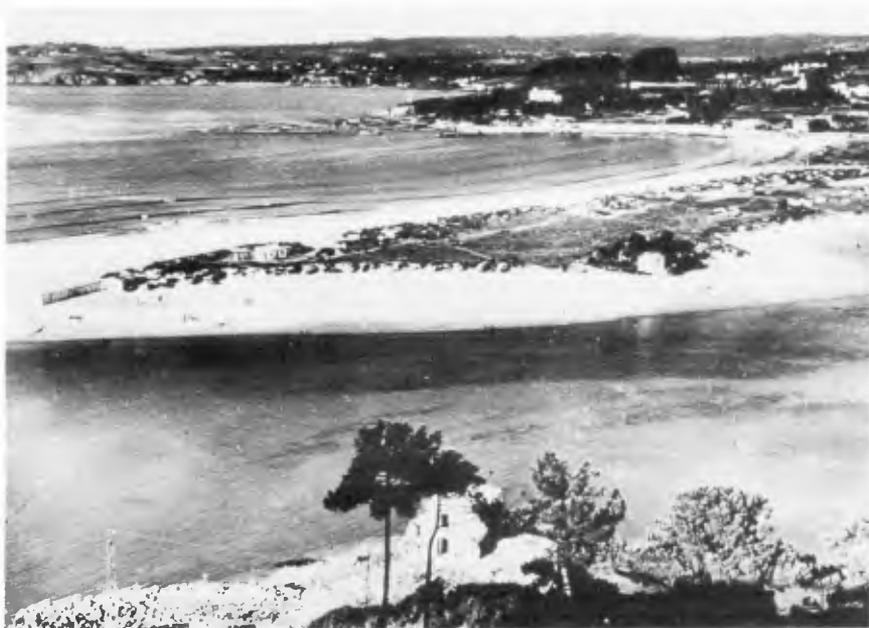
FIG.2 SANTA CRISTINA BEACH. 1.950 (PHOTO: BLANCO)

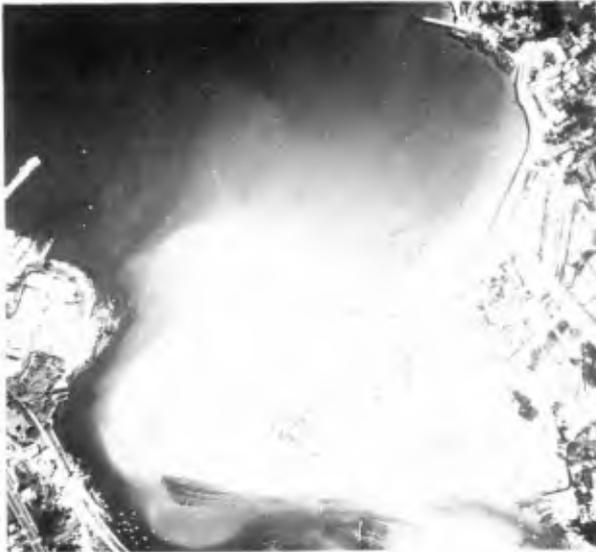
FIG. 5 SANTA CRISTINA BEACH BEFORE NOURISHMENT WORKS.  
AERIAL PHOTO 1.990

Figures 3, 4, 5 and 6, illustrates the shoreline evolution.

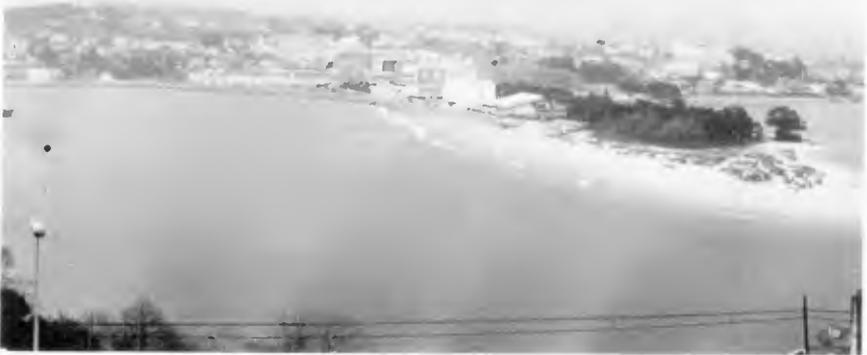
FIG. 6 SANTA CRISTINA BEACH BEFORE NOURISHMENT WORKS

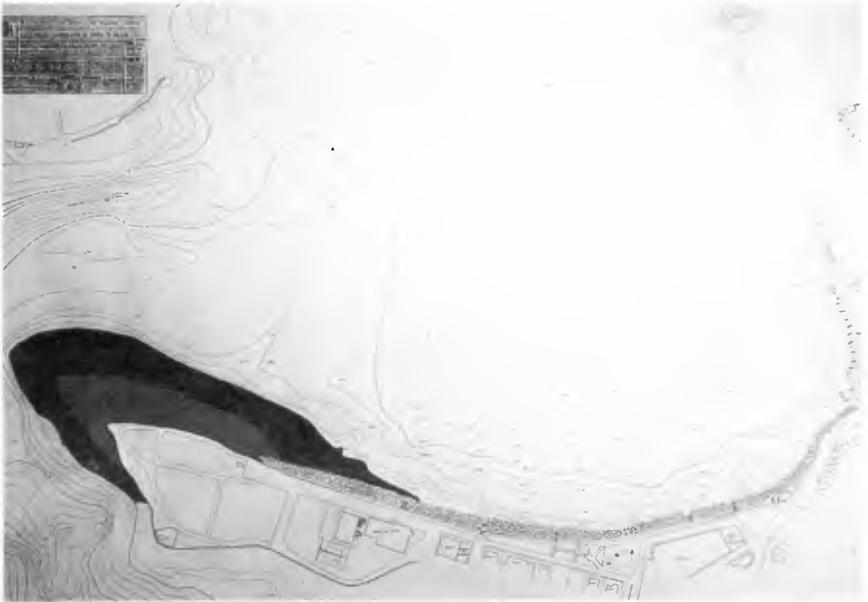
FIG. 7 SANTA CRISTINA BEACH BEFORE NOURISHMENT WORKS

After studying the effect of the newly constructed Oza Dock on Santa Cristina beach, it was concluded that it would be feasible to restore the spit to its original position, by means of adding approximately 450.000 M3 of sand dredged from the sea bottom. This figure is similar to the one reached by the CEPYC. (See fig. 7 and 8)

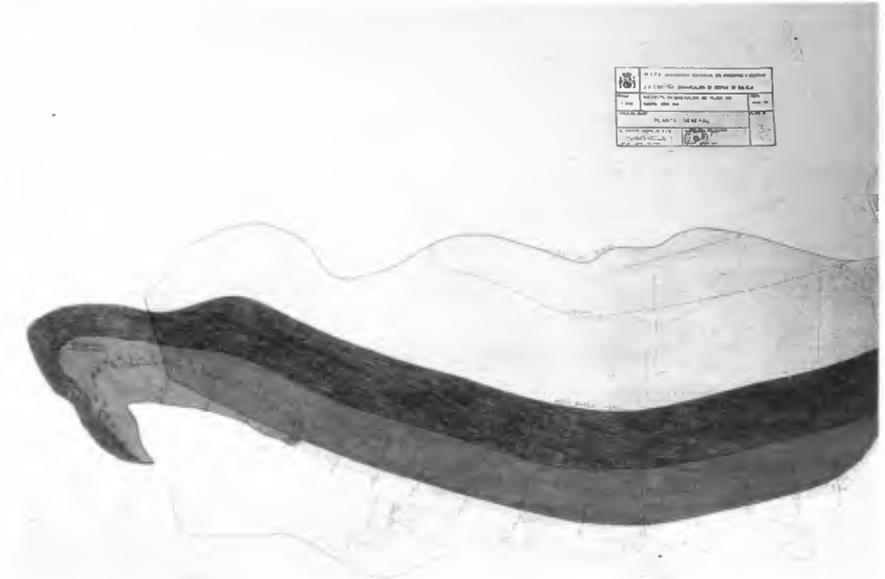
FIG. 8 SANTA CRISTINA BEACH AFTER NOURISHMENT WORKS FORECAST.

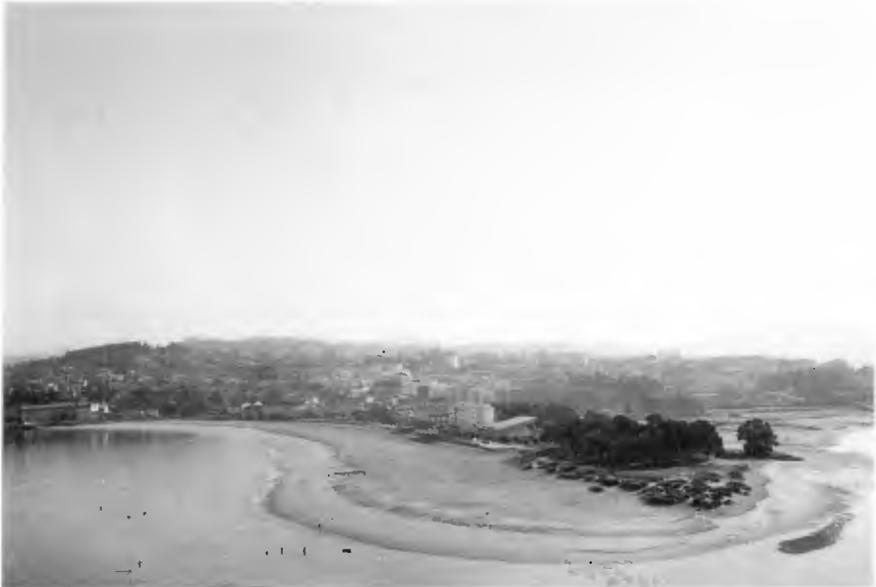
FIG. 9 SANTA CRISTINA BEACH AFTER NORISHMENT WORKS

450.000 m<sup>3</sup> of sand from the sea bottom was added which is D50 = 0,45 mm at -5.0 meter water depth. (FIG.9)

Furthermore, the rubble mound defending the sea front was modified to satisfy aesthetic and social considerations. The city's population can now enjoy sitting on the stepped sea front which has become a popular meeting point at night for the city's teenagers.

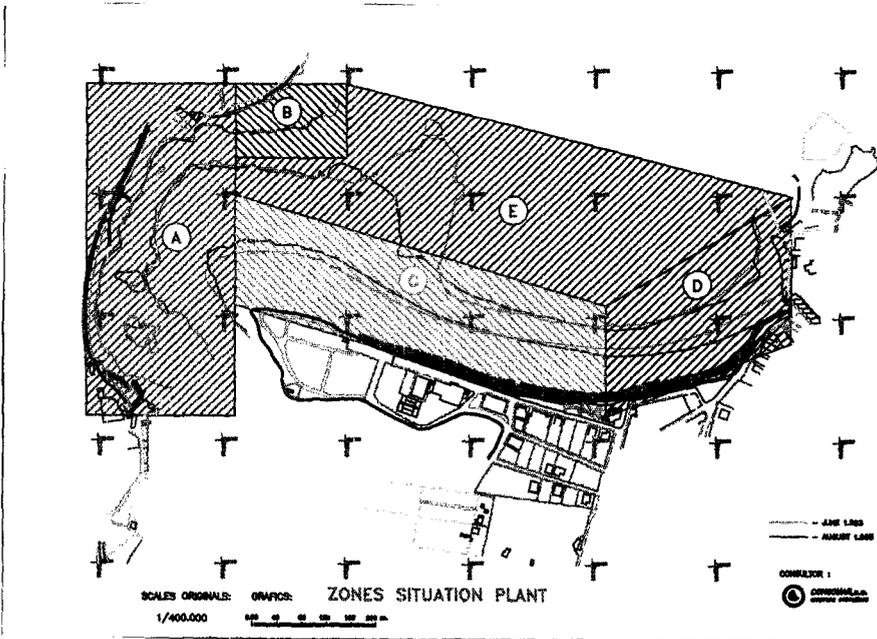
FIG. 10 ZONES SITUATION PLANT

Presently, bathymetric and granulometric works are performed every three months to monitor its evolution for the purpose of identifying areas where accretion and erosion occur. (Fig. 10)

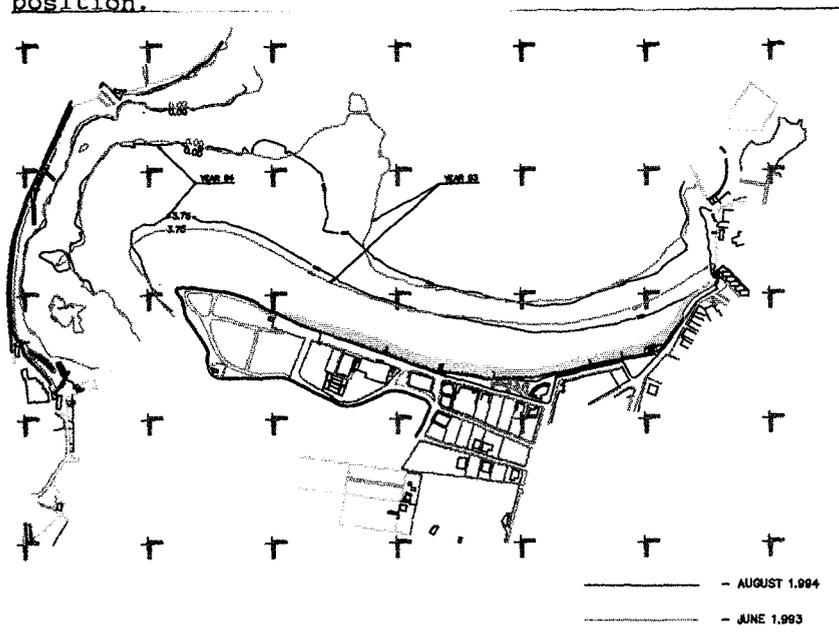
FIG. 11 BEACH EVOLUTION/DEVELOPMENT JUNE 1.1993-AUGUST 1.1994.

The beach has a 900 m.l. coastline which is exposed directly to waves. (See figure 11)  
 The eroded area (600 meters in length) is situated between the transversal outlines 1 and 4 in the East zone and reflects a typical spiral form due to the diffraction process. In this area, the beach is at 30° angle with respect to the alignment of the spit, as indicated in the outlines 5, 6 and 7, whose bathymetrics are noticeably parallel to the Paseo Marítimo and have experienced no changes during the entire process. Therefore, we can emphasize that this alignment corresponds to the beach's geomorphological equilibrium position.

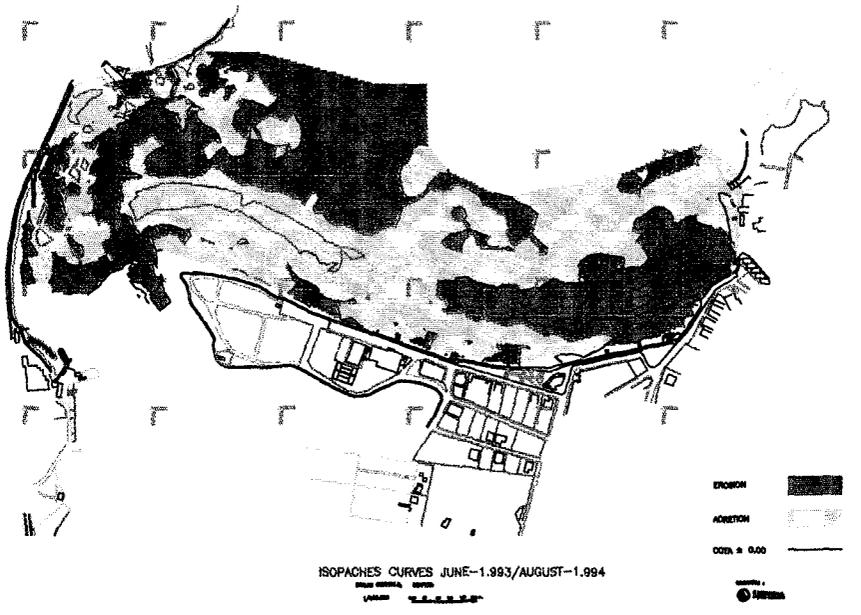
FIG. 12 ISOPACHES CURVES JUNE 1.993 - AUGUST 1.994

Figure 12 shows the isopachetes curves in the period june 1.993 - august 1.994

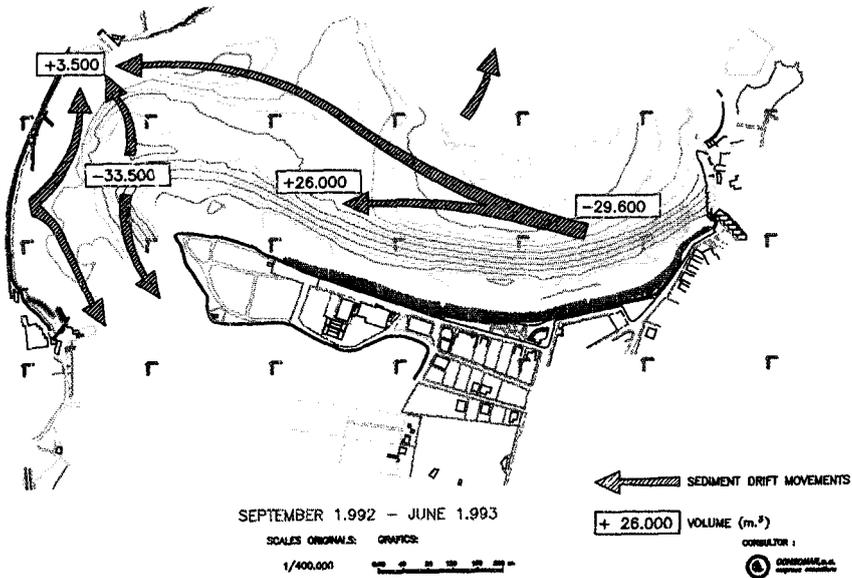
FIG. 13 SEDIMENT DRIFT MOVEMENTS SEPTEMBER 1.992 - JUNE 1.993

The sediment drift movements are showed in figures 13 and 14.

The sand eroded at the beach's Eastern zone is carried and deposited to the Western zone (spit) where significant growth is noted both in surface and elevation as a result of receiving 52.000 M3 continuously in two years (actual monitoring period).

The beach area submerged under the low tide has lost 17.000 M3 due to erosion in the last year. This sand has shifted to the spit's mouth (extreme West) and to the left bank of the river mouth.

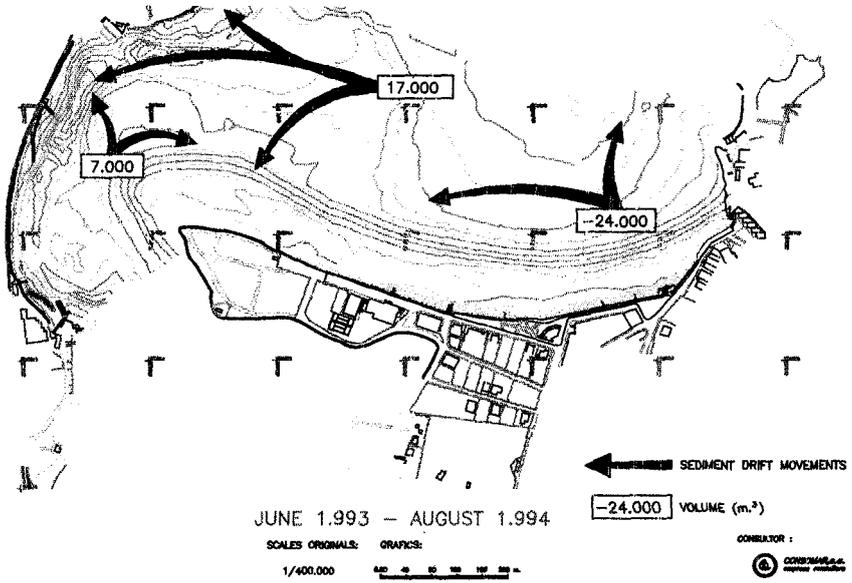
FIG 14 SEDIMENT DRIFT MOVEMENTS JUNE 1.993 - AUGUST 1.994

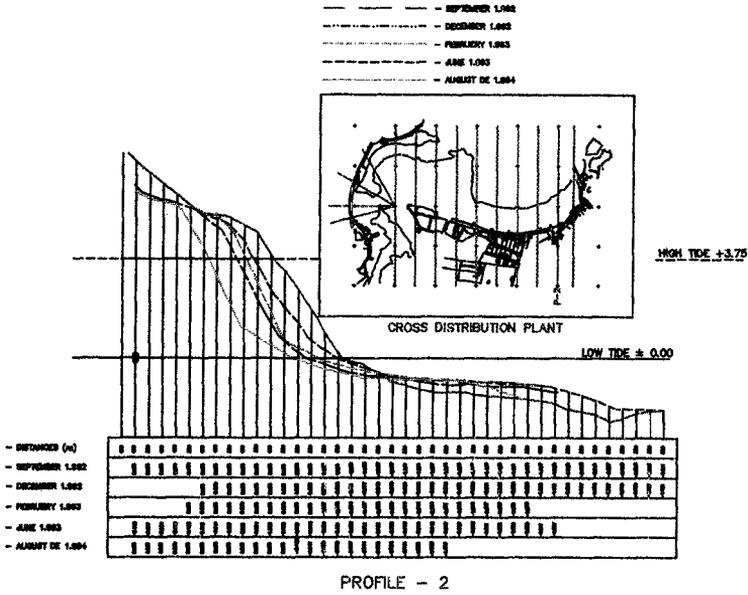
FIG. 15 PROFILE - 2

a) Coastline retreat (outline 2) "East zone" has been:

Elevation +0,00	Elevation +3,75
Period Sept. 92 to June 93:	-28,00	-28,00
Period June 93 to Aug.94:	-10,00	-21,00
	-----	-----
TOTAL	-38,00	-49,00

The results of the profiles evolution are showed in figures 15 and 16.

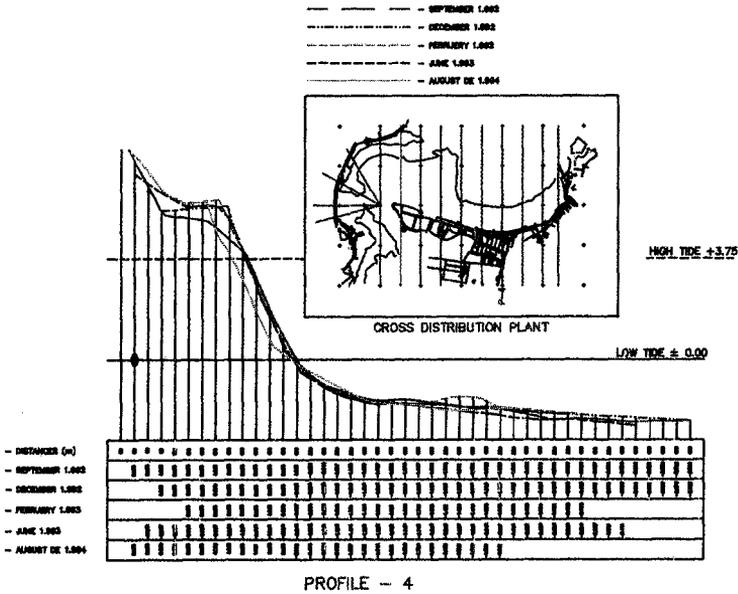
FIG. 16 PROFILE - 4
