## CHAPTER 166

### PERMEABLE PILE GROINS

Thomas Trampenau<sup>1</sup>, Frank Göricke<sup>2</sup>, Arved J. Raudkivi<sup>3</sup>

**ABSTRACT:** Permeable pile groins have been built on the southern shores of the Baltic Sea in large numbers for the past century and a half, yet no detailed literature has been written on how these structures function. The study of the groin system at Warnemünde, has shown that this type of groin causes a reduction of the littoral current and elimination of the local rip currents. This, in turn, causes underwater profiles to raise, a widening of the beach and a seaward movement of the shoreline.

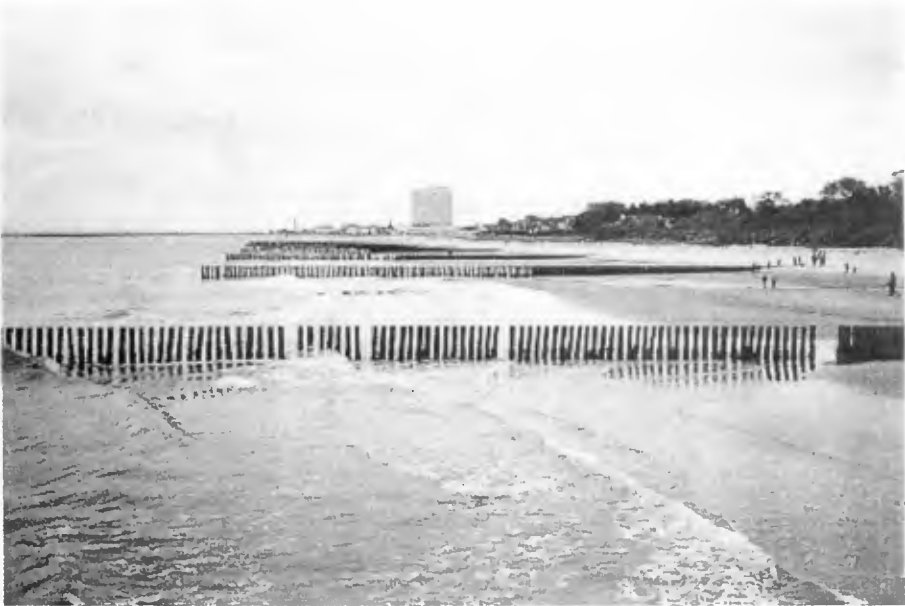
Figure 1. A permeable pile groin field in the test area Warnemünde during low water (caused by wind set-down)

The following discussion is restricted permeable pile groins. These are pervious by nature and built using piles rammed with predetermined spacing that may vary along the groin. Such a groin is illustrated in Fig. 1.

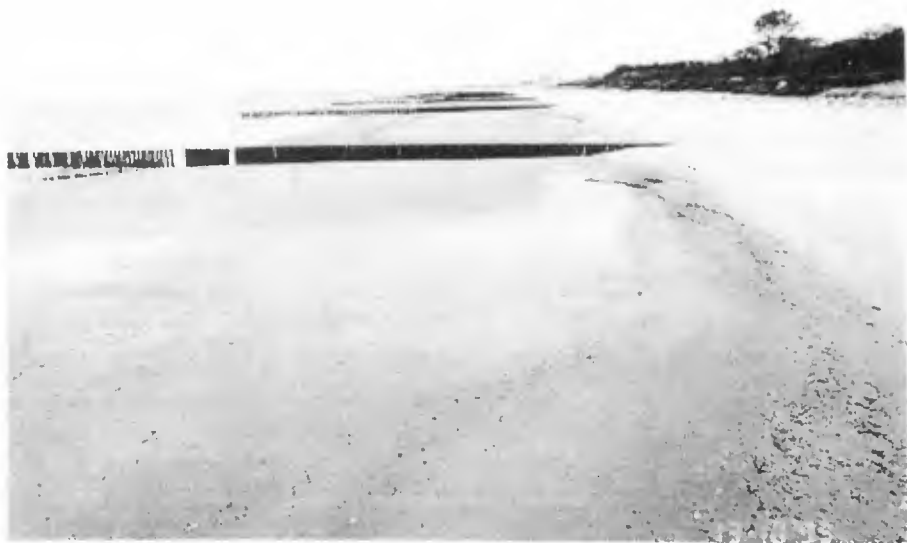
Figure 2. Typical shoreline alignment of a permeable groin field at low water

Frequently, the food of the groin has been rammed tight (permeability = 0%). The groins typically protrude 0.5 m above the sea level. Unlike non-permeable groin fields which cause a saw-tooth shoreline to form, permeable pile groins fields retain a continuous, straight shoreline (Fig. 2).
