## CHAPTER 351

### **A Unique Look at Oregon Inlet, NC USA**

#### Abstract

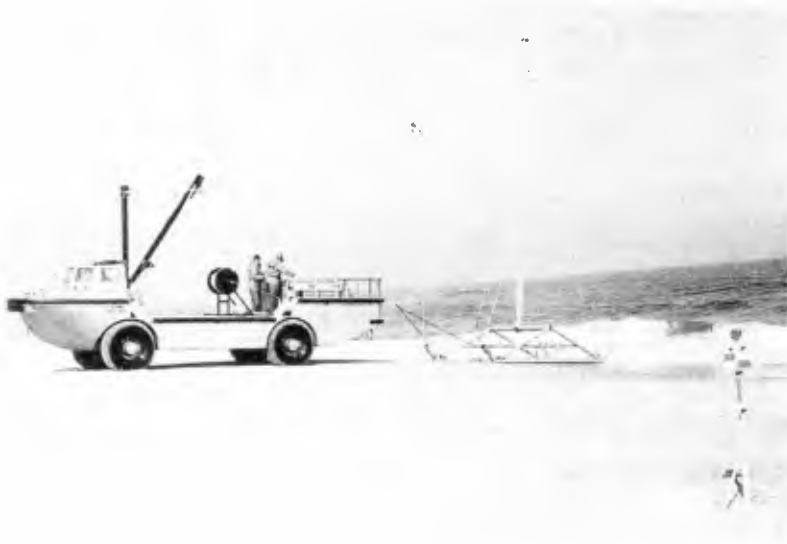
Fig. 3. Survey sled and amphibious vehicle. The sled mast carries the prism array at an 11m elevation.

The sled-survey system (Miller, 1991) consists of an amphibious vehicle and a sled with an 11 m tall mast, Fig 3. The sled, which slides across the ocean bottom virtually unaffected by waves and currents, carries a ring of reflective target-prisms. HYPACK software on a PC is used to collect position and depth measurements every 1 m along a profile using a Geodimeter 140T tracking total-station that is aimed at the prisms. Processing the profile data was facilitated by the Interactive Survey Reduction Program (Birkemeier, 1991). Summaries were generated using Intergraph Inroads/Insite software.
