INTRODUCTION

The coast of Yucatan, located in the Gulf of Mexico, is a fragile island barrier system where beach erosion has turned into a problem since the last 25 years. This, in combination with hurricane strikes (Gilbert (1988), Isidore (2002)), led to environmental damages along about 300 km, in 60 km of which, the coastal infrastructure is at risk; fact that decreased the coastal development. Mitigate the erosion required emergency protection works mainly made by beach property owners. The lack of planning and engineering design resulted in areas with high erosion rates and the destruction of neighboring beaches and properties.

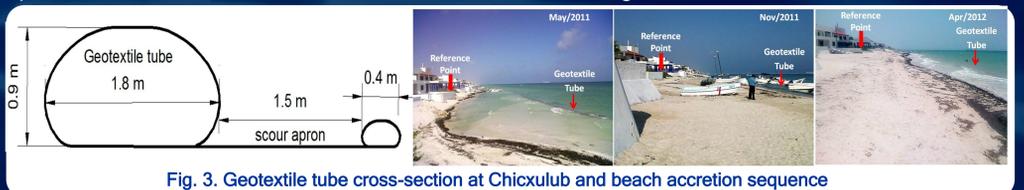
Fig. 3. Geotextile tube cross-section at Chicxulub and beach accretion sequence

These conditions determine the design parameters and the installation conditions of geotextile structures mainly as submerged detached breakwaters between 0.7–1 m depth and at -0.3 m (MLWL) referred to MSL. This cross section (Fig. 3) has proven to be an optimal design for the proper accumulation of sand and as an effective coastal protection measure for various stretches of coast along Yucatan.

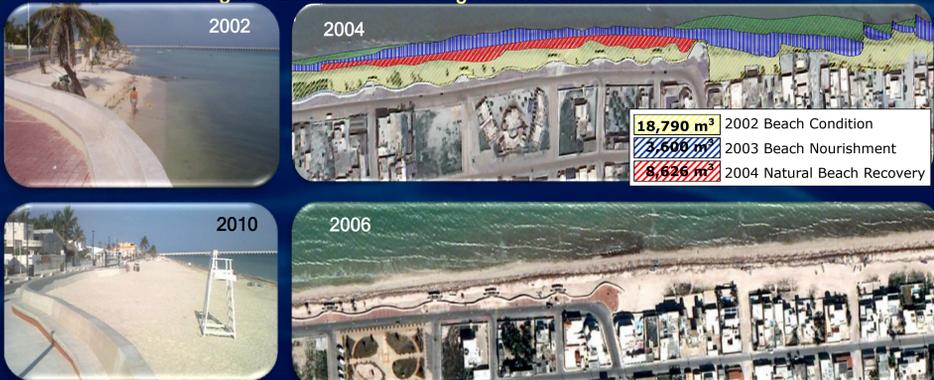
Progreso Beach after timber groin removal and nourishment

Fig 2. Based-engineering efforts for long term beach rehabilitation at Yucatan coast

Different based-engineering's efforts have been made in order to mitigate and to try to solve erosion problem in the long term. Axis Ingeniería, as well as academic research institutions, in conjunction with federal and state authorities (i.e. Ministry of Environment - SEMARNAT) started in 2002 the promotion of programs for beach rehabilitation consisting on groins removal and the use of soft solutions (i.e. structures based on geosynthetics for shore protection)². After the removal of groins, a nourishment in 2002 of Progreso Beach along 7 km, has been one of the most successful efforts (technically and economically) among the beach restoration program, allowing the development of a stable system for about 10 years, even without maintenance works.
