DAMAGE TO REINFORCED CONCRETE BUILDINGS AND COASTAL TREES DUE TO THE 2011 OFF THE PACIFIC COAST OF TOHOKU EARTHQUAKE TSUNAMI

Hideo Matsutomi¹, Eriko Yamaguchi², Kazunori Naoe³ and Kenji Harada⁴

Macroscopic conditions of the damage to RC building and coastal black pine tree in the 2011 Off the Pacific Coast of Tohoku Earthquake Tsunami are discussed through field surveys and field tests. Effects of RC building's location and arrangement, submerged vertical section area in the tsunami inundation flow direction, ratio of the area of submerged windows and/or doorways to the area of submerged vertical wall on the side hit by the inundation flow (so-called, aperture ratio), and foundation piles on the damage condition of the building are examined. The damage condition of the coastal tree is also discussed from the viewpoints of the drag force and moment assessed using inundation flow velocity estimated by a simple method. Moreover, effects and limits of coastal woods on the tsunami energy and force reductions are illustrated through the field surveys.

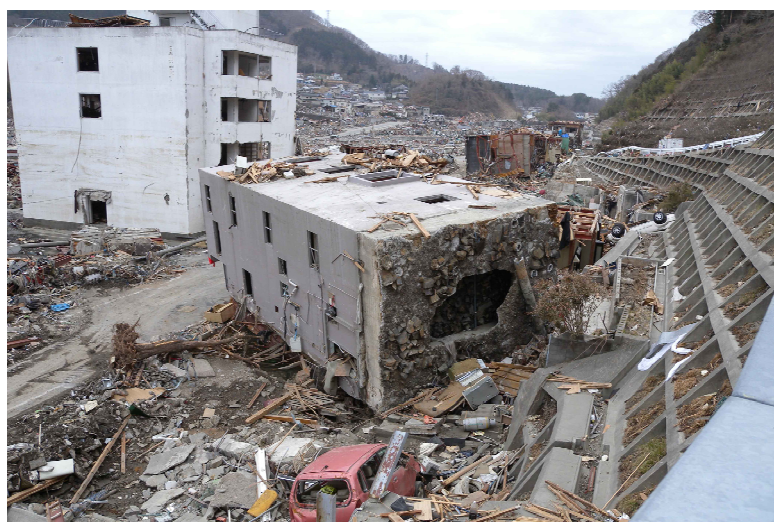
Figure 2. A 4-story RC building (7.0 m wide, 5.3 m deep and 13.3 m high) swept away about 70 m together with foundation piles of the friction type by the 2011 Tohoku Earthquake Tsunami (Onagawa in Miyagi pref.).

One of the features of the 2011 Tohoku Earthquake Tsunami is that a huge tsunami attacked many modern cities. As the results, the tsunami moved and/or toppled several reinforced concrete (RC for short) buildings whose height and depth were not enough for tsunami inundation depth (see Fig. 2). Since the 1933 Showa Sanriku Earthquake Tsunami, there has been an idea of RC building which has the role as a coastal dyke and is usually used as public facilities or private offices. This building has not only a function of reducing tsunami inflow into the backland but also that of the short-term tsunami refuge facilities. However, there is no guideline for the condition (depth, width, height, *etc.*) of the building which withstands tsunami with any inundation depth.

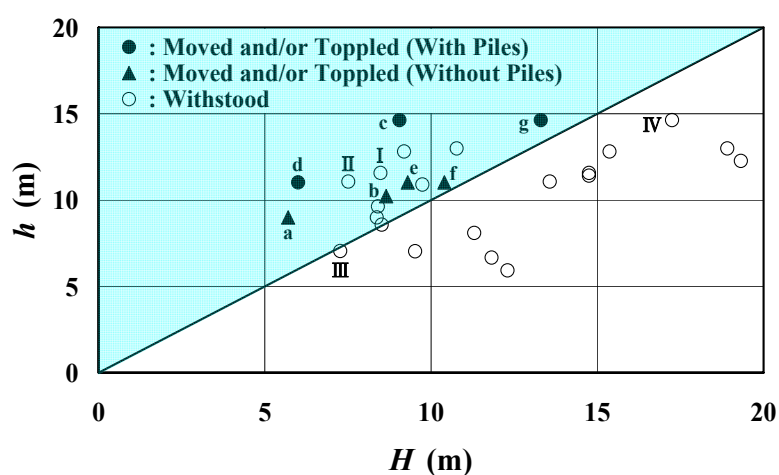
Figure 3 shows a relationship among RC building height H , inundation depth h and damage type of the building, where ● is the moved and/or toppled with foundation piles, ▲ the moved and/or toppled without foundation piles and ○ the withstood. These legends are the same in the following figures in this section. The solid line in the figure is the dividing line between the submerged and non-submergence. The figure indicates that 1) in this tsunami, there were no moved and/or toppled RC buildings with 5-stories and over including the submerged and inclined due to the ground erosion and 2) when Japanese RC buildings were not submerged at the maximum inundation depth of the tsunami, even those designed under the old earthquake-resistant standard before 1981 could withstand.

Figure 3. Relationship among RC building height H , inundation depth h and damage type of the building.

(11 m). As will be seen from Fig. 4, the building with a small submerged vertical section area has a tendency to be moved and/or toppled. The building (II) is considered to withstand because it has a larger submerged vertical section area, compared with the buildings (d) and (f). In Fig. 3, the withstood buildings in spite of the submergence have $O_p=17-38\%$ except for the building (II) and the move and/or toppled buildings have $O_p=0-10\%$. The former O_p is greater than the latter.

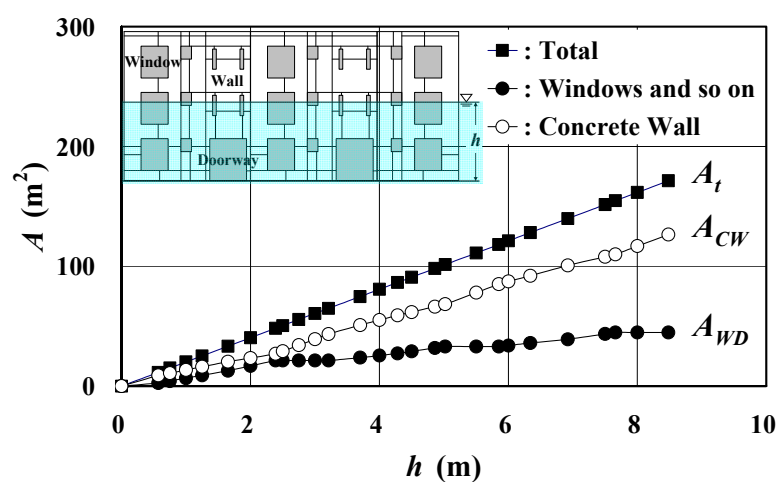
Figure 5 shows an example of relationship among inundation depth h and various submerged areas of the building on the side hit by the inundation flow, where A_{CW} is the area of submerged vertical concrete wall and $A_t = A_{CW} + A_{DW}$. The submerged areas are evaluated using the dimensions of building shown in Table 1 and pictures taken from the surroundings of building.

Figure 5. An example of relationship among inundation depth h and various submerged areas on the side hit by the inundation flow (a 3-story RC building in Rikuzentakata, Iwate pref.).

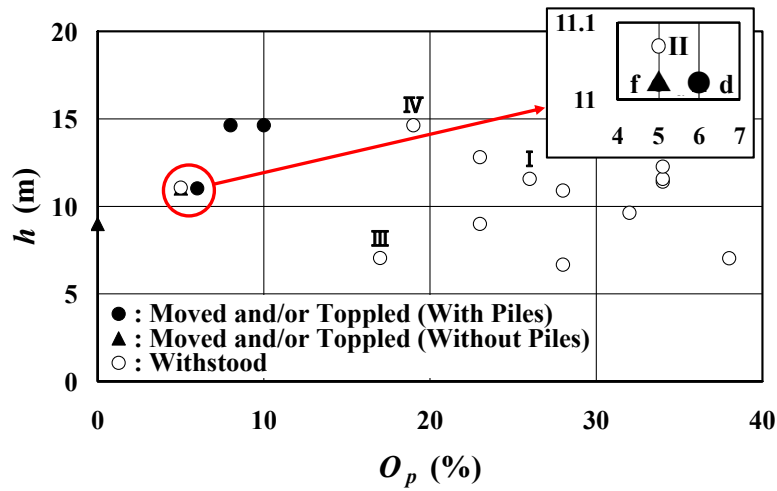
Figure 6. Relationship among the aperture ratio O_p , inundation depth h and damage type of the building.

Figure 6 shows a relationship among the aperture ratio O_p , inundation depth h and damage type of the building. The figure indicates that 1) the aperture ratio of actual RC building is around 38% at the maximum and 2) the building with a small aperture ratio is easy to move and/or topple, compared with that with a large aperture ratio. There are the withstood building (II) and the moved and/or toppled buildings (d) and (f) in spite of almost the same values of the aperture ratio (5%) and inundation depth

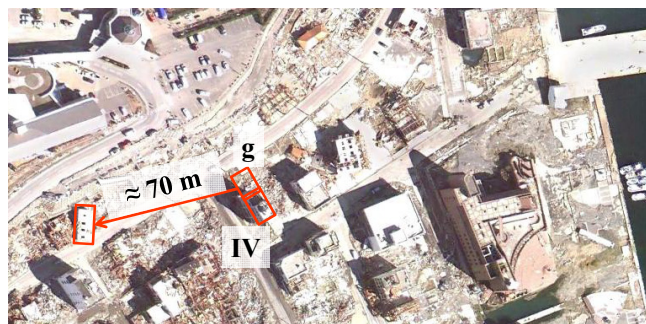
Figure 8. Withstood building (IV) and moved and/or toppled building (g) in Onagawa, Miyagi pref. (Google Earth)

There are two withstood buildings (III) and (IV) although their O_{pd} is negative. It is conceivable as the reasons that 1) the building (III) was not submerged because of a relatively shallow inundation depth ($=7.05$ m) and had a relatively large aperture ratio ($=0.17$), 2) the building (IV) with 5 stories was sheltered by many large buildings left on the sea side as shown in Fig. 8. The building (IV) and the moved and toppled building (g) with 4 stories were side by side and had the same inundation depth of 14.6 m. Although both aperture ratios on the land side are 0.29 together, those on the side are the building (IV) is 0.19 and the building (g) 0.08. Besides, as will be seen from Figs. 3 and 4, the height and submerged vertical section area of the building (IV) are larger than those of the building (g).

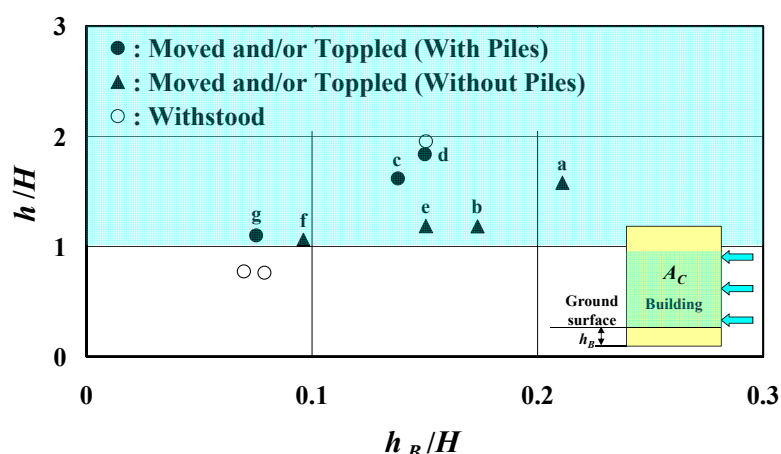
Figure 9 shows a relationship among the relative depth h_B/H of foundation part under the ground, relative inundation depth h/H and damage type of the building. The figure indicates that 1) the depth of foundation part under the ground of actual RC building is around 7-21% of the building height, 2) even

Figure 9. Relationship among the relative depth h_B/H of foundation part under the ground, relative inundation depth h/H and damage type of the building.

if the depth is 21% of the building height, the submerged RC building is moved and/or toppled, 3) as the relative depth increases, the relative inundation depth which RC building is moved and/or toppled has a tendency to increase and 4) a difference is recognized between the relative inundation depths that RC buildings with and without foundation piles were moved and/or toppled.

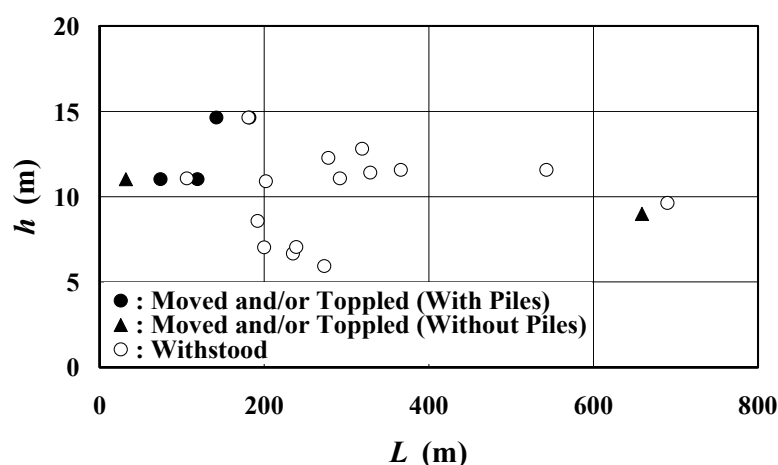
Figure 10. Relationship among the distance L from the sea to RC building, inundation depth h and damage type of the building.

Figure 10 shows a relationship among the distance L from the sea to RC building, inundation depth h and damage type of the building. Some of the distances in the figure are evaluated using the distance evaluation function of Google Earth. It is the judgment by limited data, but can be understood that RC buildings are moved and/or toppled regardless of the distance from the sea if inundation depth is large (deeper than 9 m in this tsunami) and RC buildings are submerged.

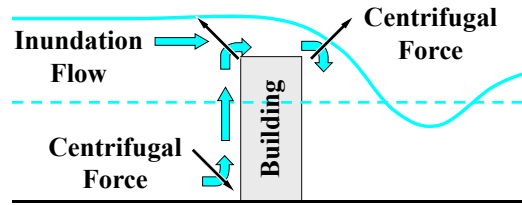
Figure 11. A schematic diagram of the centrifugal forces acting on on-shore building due to the overflowing tsunami.

The moving and/or toppling of RC building depend on the fluid force of tsunami on it. There is an opinion on the fluid force that the wave pressure of a quasi-steady tsunami inundating on flat land is the hydrostatic pressure distribution [e.g. Asakura *et al.*, 2000]. There is another opinion that as the dynamic pressure cannot be ignored, the wave pressure is the non-hydrostatic pressure distribution [Matsutomi, 2009b]. As one of the reasons of the non-hydrostatic pressure distribution, it is conceivable that the streamline with the diagonal downward convex part (the diagonal downward centrifugal force) in the lower front of the building is formed. When a huge tsunami as RC building is submerged overflows the roof or roof floor of the building, the formation of streamline with the diagonal upward convex part (the diagonal upward centrifugal force) in the upper front and back of the building would be related to the damage of the building. This schematic view is shown in Fig. 11.

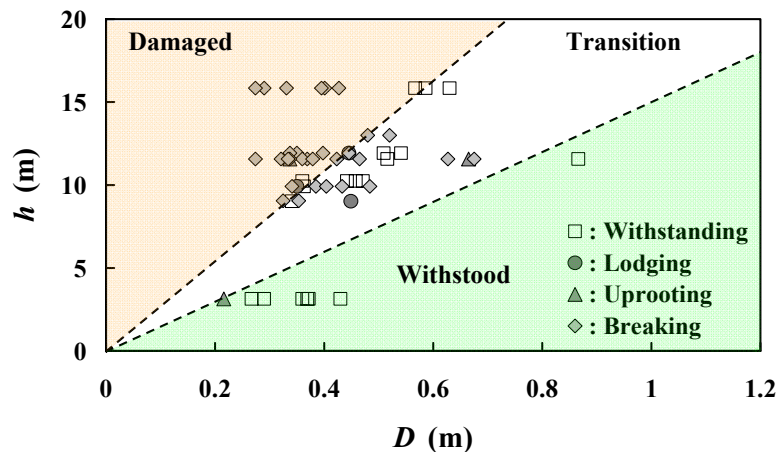
Figure 12 shows a relationship among the chest height diameter D of coastal black pine tree, inundation depth h and damage type (Lodging: ●, Uprooting: ▲, Breaking: ◆, Withstanding: □) of the tree. The figure indicates that 1) although the transition region where the damaged and the withstood were mingled is considerably large, both are relatively well classified by the chest height diameter and

Figure 12. Relationship among the chest height diameter D , inundation depth h and damage type of coastal black pine tree in the 2011 Tohoku Earthquake Tsunami.

the inundation depth, 2) as the ratio of the inundation depth to the chest height diameter becomes large, a tendency of the breaking becomes strong, 3) it is the same in the case of evergreen tree Sea Casuarina (another name 'coastal pine') in Indonesia [Matsutomi *et al.*, 2011] that the breaking data extend over both domains of the lodging and uprooting, and 4) the force at the uprooting tends to be smaller than that at the lodging. It is conceivable as the reasons of the result 4) that the main root which spreads laterally broke at a lodging stage besides the ground condition and ground water level.

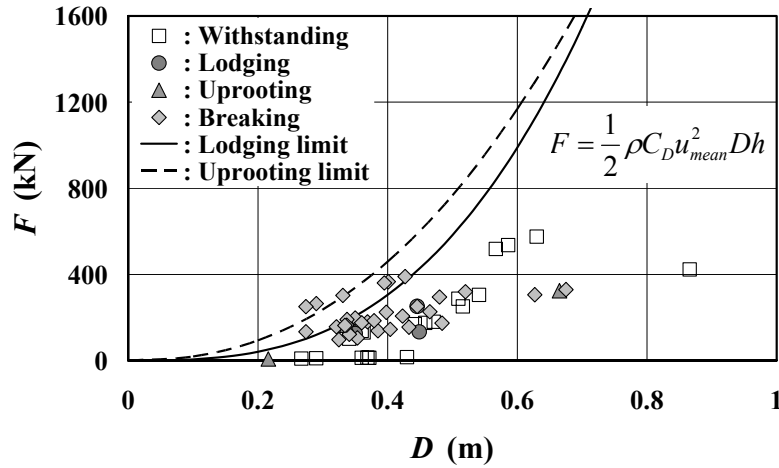
Figure 13. Relationship among the chest height diameter D , force F and damage type of coastal black pine tree (field surveys).

Figure 13 shows a relationship among the chest height diameter D , drag force F estimated by Eq. (2) and damage type of coastal black pine tree. Figure 14 shows a relationship among the chest height diameter D , moment M estimated by Eq. (3) and damage type of the tree. In the figures, the upper limit conditions of the lodging (solid line) and uprooting (dotted line) obtained by a field test for the lived Sea Casuarina carried out on the west coast of Central Sumatra, Indonesia [Matsutomi *et al.*, 2011] are also shown.

As will be seen from Fig. 13, at the viewpoint of the force, the field survey data have a tendency to be slightly smaller than the damage conditions of the upper limit for Sea Casuarina. On the other hand, at the viewpoint of the moment, the field survey data have a tendency to be larger than the damage conditions. The latter may be caused by the estimation method of the moment (Eq. (3)). Without distinction of Indonesia and Japan, the half of the inundation depth is adopted as the height from the ground to the point of action of the force in the field surveys, whereas the point of action of the force is fixed to the height of 1.2 m from the ground in the field tests. For your information, a lot of data of tree which broke at higher point than 1.2 m from the ground are included in the field survey data.

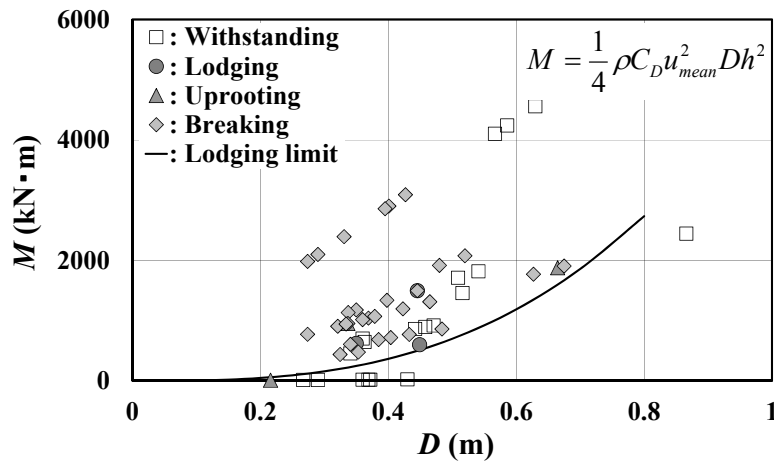
Figure 14. Relationship among the chest height diameter D , moment M and damage type of coastal black pine tree (field surveys).

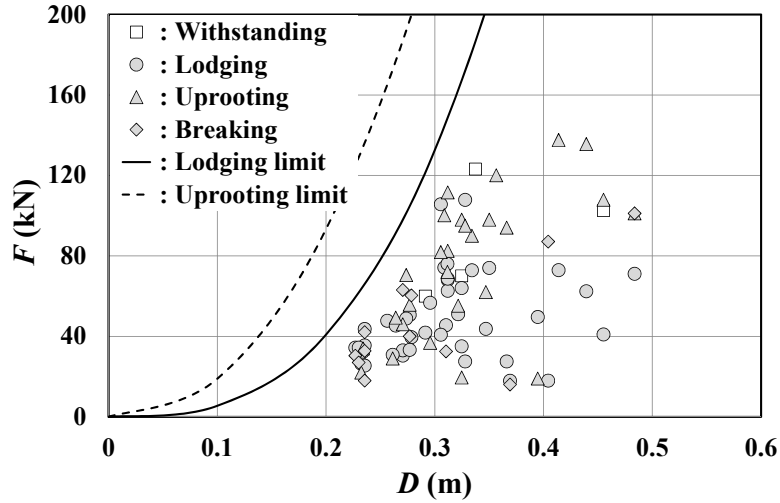
Figure 15. Relationship among the chest height diameter D , horizontal force F and damage type of coastal black pine tree (field tests).

Figure 15 shows a relationship among the chest height diameter D , horizontal force F and damage type of the tree. Figure 16 shows a relationship among the chest height diameter D , moment M and damage type of the tree. These are based on the field tests on the Taro and the Yamada coasts. In the figures, the upper limit conditions of the lodging and uprooting obtained by the field test for Sea Casuarina are also shown. It is the same as the case of Sea Casuarina that the breaking data extend over both domains of the lodging and uprooting. It is not sure for reasons of the withered trees and ground condition, the force to withstand of coastal black pine tree is weaker than that of Sea Casuarina. This is the same tendency as Fig. 13 and supports the adoption of the inundation flow velocity of Eq. (1) in the estimation of the drag force based on the inundation depth. Although the force to withstand the uprooting > the force to withstand the lodging is on the average, the upper limit of the force to withstand every the chest height diameter is almost the same in any damage type. As the field survey results shown in Figs. 12-14, the force of the uprooting is sometimes smaller than that of the lodging.

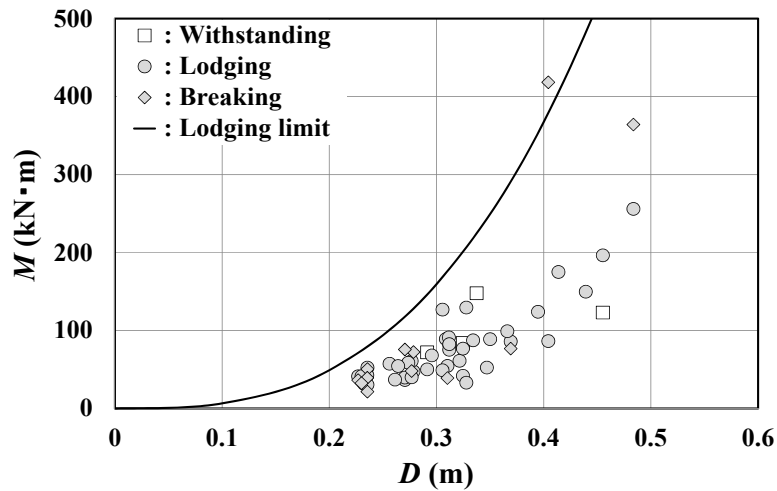
Figure 16. Relationship among the chest height diameter D , moment M and damage type of coastal black pine tree (field tests).

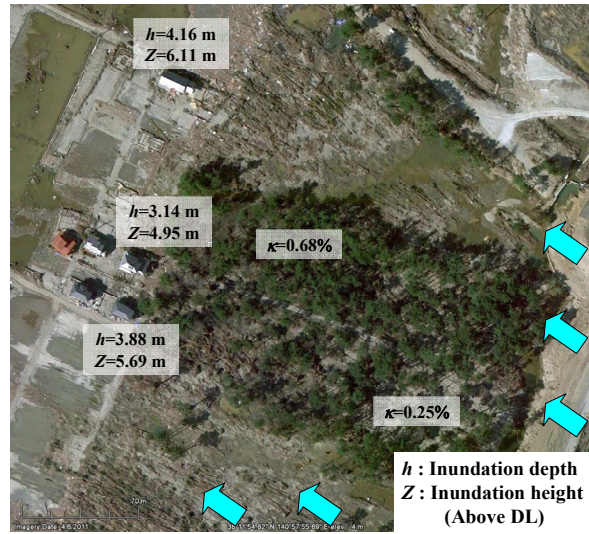
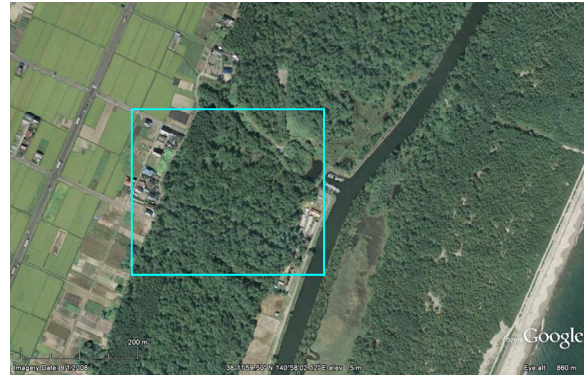
(a) After the tsunami suffering ($L_{CW}=140$ m, $W_{CW}=220$ m)

(b) Before the tsunami suffering ((a) is the rectangle part)

Figure 18. Effects and limits of coastal woods which consist of mainly coastal black pine trees in Higashiura on the Sendai coast. (Google Earth)

The effects of coastal woods on reducing the tsunami energy and force have been pointed out for a long time. Figure 18 shows one of the examples of the effects of coastal woods which mainly consist of coastal black pine trees in Higashiura on the Sendai coast (see Fig. 17), where κ defined by Matsutomi *et al.* [2007] is the mean tree density (%) of coastal woods estimated using the diameter of tree trunk at the chest height, L_{CW} the length of coastal woods area parallel to the shoreline and W_{CW} the width of coastal woods area perpendicular to the shoreline. Figure 18(b) shows the situation of the coastal woods before the tsunami suffering. It is unknown when a part of the coastal woods suffered the damage for the lodging, uprooting and breaking. It can be understood from the figure that both the inundation depth h and inundation height Z were reduced by around 1 m (25%) just behind the area where coastal trees survived. However, it is necessary to note that even if the depth of the coastal woods is around 220 m, those reduction are at most 25%. Coastal woods cannot be expected to largely reduce the tsunami energy and force.
