BEACH EROSION ON GOLDEN BEACH IN SOUTH TAIWAN

INTRODUCTION

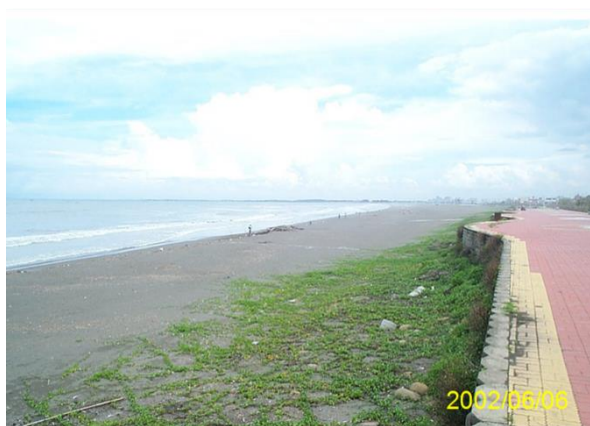
Figure 2. Photograph of Golden Beach taken on June 6, 2002.

The construction of the Anping Harbor breakwaters started in 1999 and completed by 2004. In 1985, a wide sandy beach extended on Golden Beach. After the construction of Anping Harbor, the shoreline on this beach retreated by 120-160 m due to the erosion. In this study, the damage of Golden Beach and shoreline changes were investigated using site photographs and satellite images as well as the analysis of the bathymetric survey data. The shoreline on Golden Beach has retreated in recent years, and the seawall was severely damaged. On June 6, 2002 before the erosion, a wide foreshore extended, and a vegetation zone extended in front of the seawall, implying that the backshore was stable against waves, as shown in Fig. 2. The seawall, however, had been severely damaged by January 26, 2011, and the walkway fell down owing to the successive erosion, and concrete blocks were placed in front of the damaged seawall (Fig. 3).

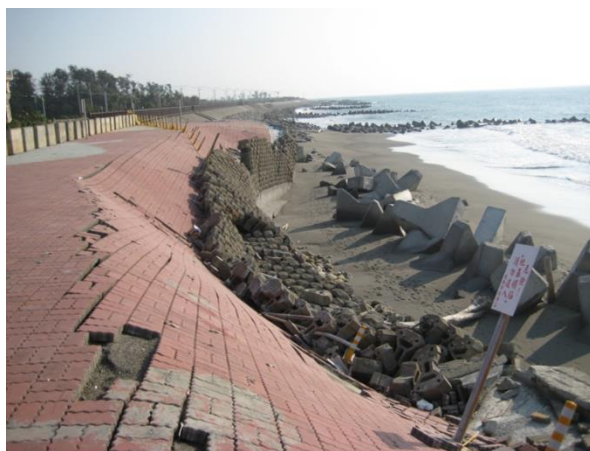
Figure 3. Damaged seawall on Golden Beach on January 26, 2011, looking south.

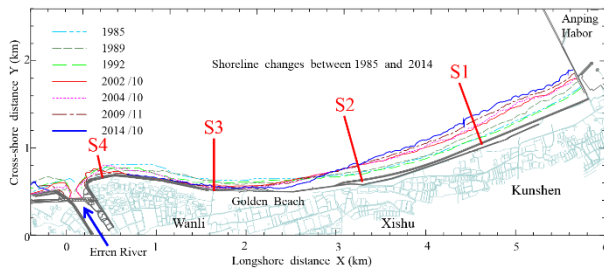
Figure 4 shows the shoreline changes between 1985 and 2014 in the study area. The shoreline gradually advanced in the area between $X = 2.8$ km and Anping Harbor between 1985 and 2014. In contrast, the shoreline between the Erren River mouth and $X = 2.8$ km retreated with a maximum shoreline recession of 140 m. A wide foreshore was formed south of the Anping

Figure 4. Shoreline changes between 1985 and 2014.

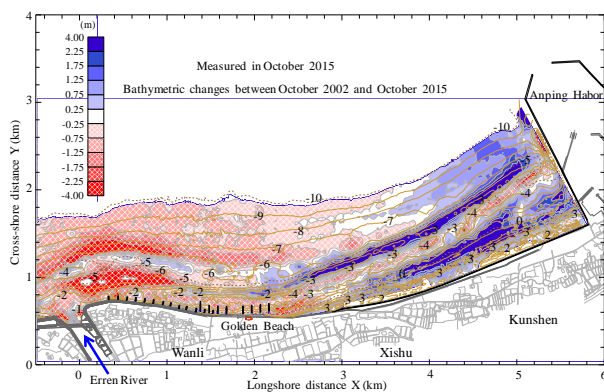
Figure 7. Bathymetric changes between 2002 and 2015.

Harbor breakwater, and a lowland with an elevation of 2.2 m above MSL were formed because of successive sand supply from the south. The bathymetry in the study area is shown in Fig. 5, together with four transects along which profile changes were compared between November 2010 and October 2015. Figure 5 clearly shows that northward longshore sand transport was entirely blocked by the south breakwater of Anping Harbor, and a large amount of sand was deposited. Figure 6 shows the bathymetry in October 2015 of the same area as that shown in Fig. 5. Although the overall features of the bathymetry do not change in the five years, many groins were constructed between the Erren River mouth and Golden Beach as a measure against beach erosion, with 13 shorter groins near the river mouth and 8 longer groins in front of Golden Beach. Despite the construction of these groins, wide beach, as shown in Fig. 2, has not been restored. Figure 7 shows the bathymetric changes between 2002 and 2015. A large amount of sand was deposited north of $X = 2.8$ km, whereas severe erosion occurred in the south part, particularly offshore the Erren River mouth. Offshore of the deposition zone south of Anping Harbor, a slender erosion zone with depths ranging -3 or -5 m extends northward until the attachment to the south breakwater. Although significant profile changes can be seen in offshore area, the profile changes almost converge -6 m, implying that the depth of closure h_c is -6 m. When longshore sand transport is blocked by a structure, sand is deposited upcoast of the structure, resulting in shoreline advance, whereas on the downcoast, the shoreline retreats and a concave profile is formed owing to the successive erosion. In this case, the change in shoreline position Δy and the change in the cross-sectional area ΔA can be determined from the profile changes. If we consider the correlation between ΔA and Δy , a linear relationship is generally obtained between them, and this regression coefficient between them gives the characteristic height of beach changes h which can be used as a constant for transforming the change in the foreshore area of the beach into the change in the volume of sand of the beach (Uda, 2017). In the present case, we obtained the relationship of $\Delta A = 9.2\Delta y$, and h becomes 9.2 m. This value is close to the sum of the berm height h_R of 2.2 m and the depth of closure h_c of 6 m. Furthermore, the increase in foreshore area south of Anping Harbor is given by $2.2 \times 10^5 \text{ m}^2$ from the shoreline change. When multiplying this value by $h = 9.2$ m, the entire volume of sand deposited upcoast was calculated to be $2.0 \times 10^6 \text{ m}^3$. Since the construction of the Anping Harbor breakwaters began in 1999, 16 years have passed since then, and the annual rate of the deposition of sand has become $1.25 \times 10^5 \text{ m}^3/\text{yr}$, which is equal to longshore sand supply from the south coast. Thus, it was concluded that the beach erosion and accretion were triggered by this longshore sand transport.
