IMMEDIATE IMPACTS OF HURRICANE IKE ON THE TEXAS COAST

Billy L. Edge¹, Lesley Ewing², Robert G. Dean³, James M. Kaihatu⁴, Margery Overton⁵, Spencer M. Rogers⁶,
Paul A. Work⁷

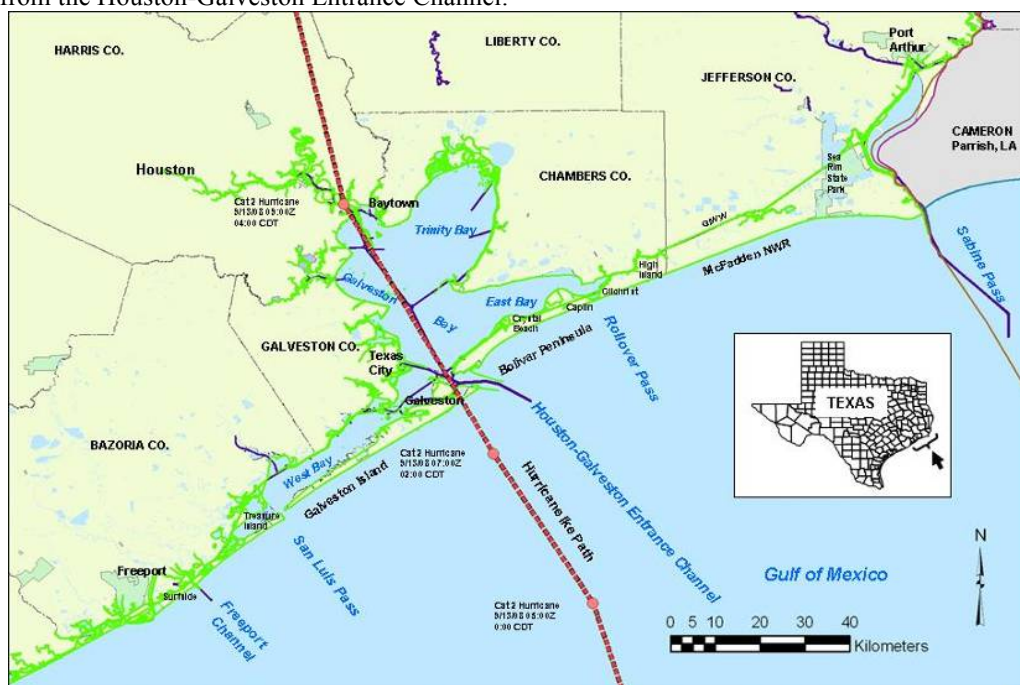
Figure 1. There is very little shoreline and flooding protection around the interior of Galveston Bay. Figure 1 also illustrates the track of Hurricane Ike as it approached and crossed the Galveston Island and continued over the Bay to Houston and Baytown, Texas.

Figure 1 Track of hurricane Ike over Galveston Island

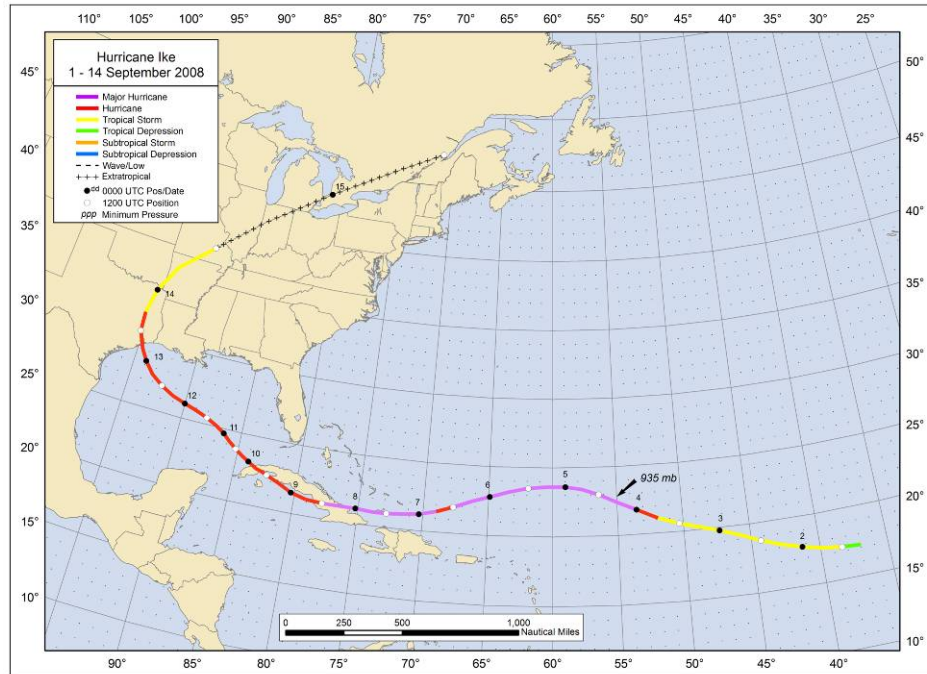
Figure 2 shows the track of Hurricane Ike as it formed from a tropical wave off the coast of West Africa on August 28, 2008. It became a tropical depression on September 1 in the Atlantic basin and moved west northwest over the tropical Atlantic Ocean and rapidly intensified to a tropical storm. By September 3, Ike was a Category 1 hurricane and it quickly grew to a Category 4 storm with peak winds of 65 m/s (126 kts). Although it weakened to a Category 2 on the 5th and 6th, it regained strength to a Category 4 storm on the 7th. After it passed over Cuba it lost and then regained strength until it was a Category 2 hurricane and continued northwestward through the Gulf of Mexico. Ike made its U.S. landfall over the northeastern end of Galveston Island about 2:10 a.m. CDT on September 13, maintaining its strength as a Category 2 storm. The National Hurricane Center (NOAA) reported maximum sustained winds at 49 m/s. Ike did not begin to weaken until it moved inland after traversing Galveston Bay at which time it quickly downgraded to a tropical storm. At landfall the storm was moving to the northwest at 8.6 kts, and the sustained wind speed of 49 m/s, made Ike a strong Category

Figure 2 Best track positions for Hurricane Ike, September 1-14, 2008. Source: Berg (2008)

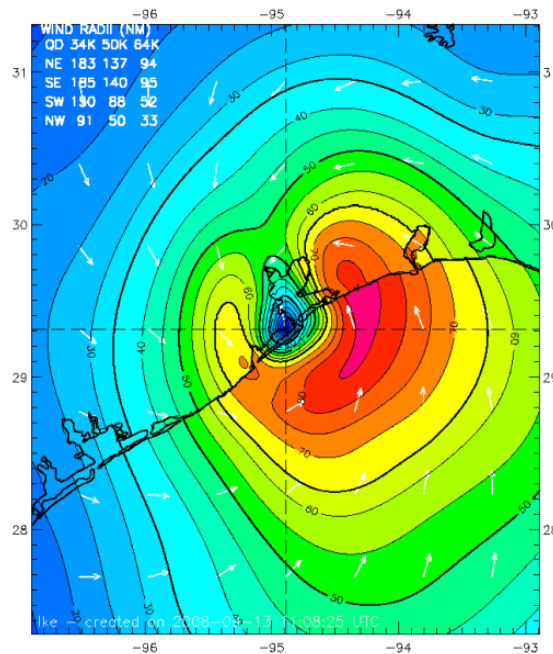
2 storm (National Hurricane Center archived reports). Ike had hurricane strength winds extending up to 190 km from the center of the storm, with tropical storm force winds to 440 km as shown in Figure 3.

Figure 3 Wind field at 7:30 a.m. on September 13, 2008, as Hurricane Ike made landfall near Galveston. (Wind speed is in knots) Source: NOAA Hurricane Research Division

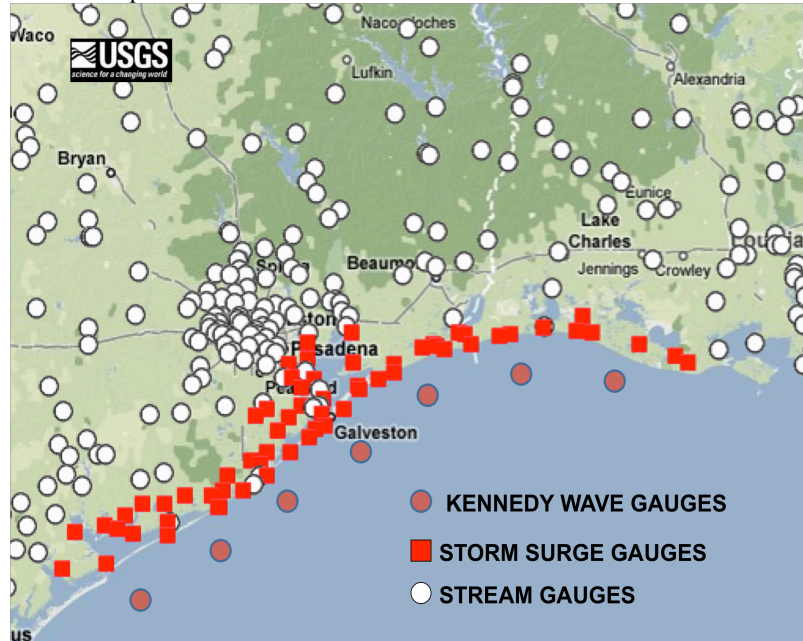
NOAA maintains several stations for measurement of winds and water levels in the area and immediately before the storm the USGS placed numerous storm gages throughout the coastal area as shown in Figure 4. Several of the NOAA water-level sensors failed as water levels increased during the storm; thus, the peak storm surge was not recorded everywhere. However, in many cases, backup

Immediately before landfall, Prof. Andrew Kennedy (2010) of Notre Dame University deployed nine gauges, which recorded surges and waves offshore at locations shown in Figure 4. Eight of these gauges were recovered and provided excellent data.

Figure 4. Location of storm surges and wave gages

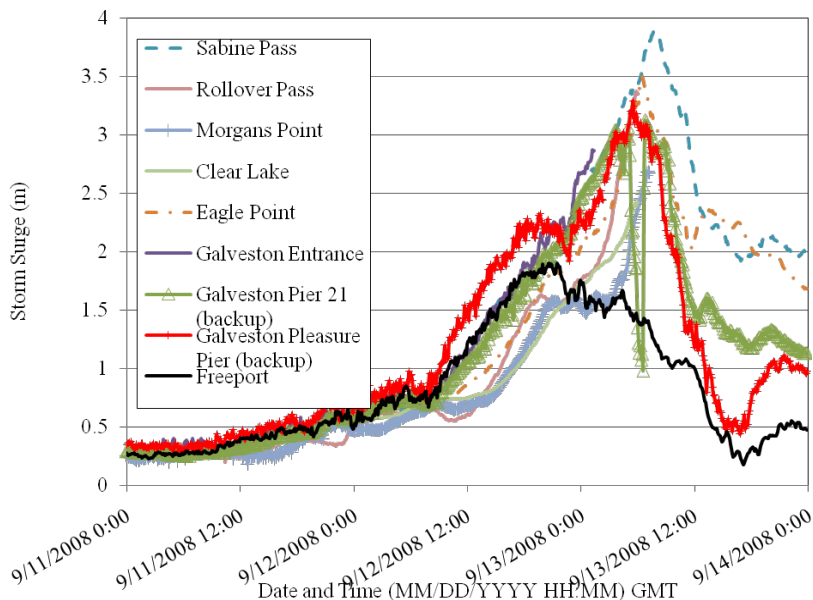
systems recorded data throughout the storm. Figure 5 presents the storm surge anomalies recorded in the general area from NOAA gages. An interpretation of these results is also presented by Kraus and Lin (2009). Results discussed here are based on preliminary data. Subsequent watermark surveys were conducted by FEMA, the state, and others, including members of the ASCE site visit team. These surveys will increase knowledge of the water levels during the storm.

Figure 5 Storm surge hydrographs recorded at NOAA stations near Galveston with tides and waves removed.

appears in the record, occurring about 6 hours before the main peak of the storm surge. This is also apparent in the NOAA backup gage at Galveston Pleasure Pier as seen in Figure 5.

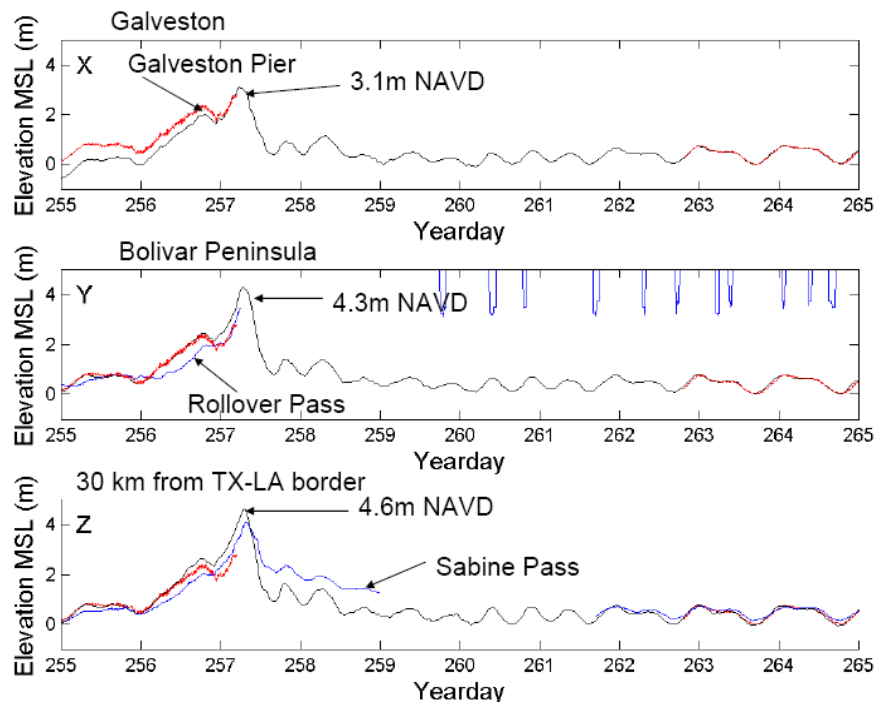
Figure 6 compares the water levels from the Kennedy gauges installed in approximately 9 m depth near Galveston, Bolivar Peninsula, and Rollover Pass with tide gauges at Galveston Pier, Rollover Pass, and Sabine Pass. The black lines in the figures represent the Kennedy gauge results. For the results presented, the peak storm surge occurs at Sabine Pass and is approximately 4.6 m above MSL. Another very interesting observation from this data is the forerunner (Bunpapong et al. 1985) that

Figure 6 Storm surge results based on gauges installed by Kennedy (2010) compared to tide gauge results at Galveston Pier, Rollover Pass, and Sabine Pass

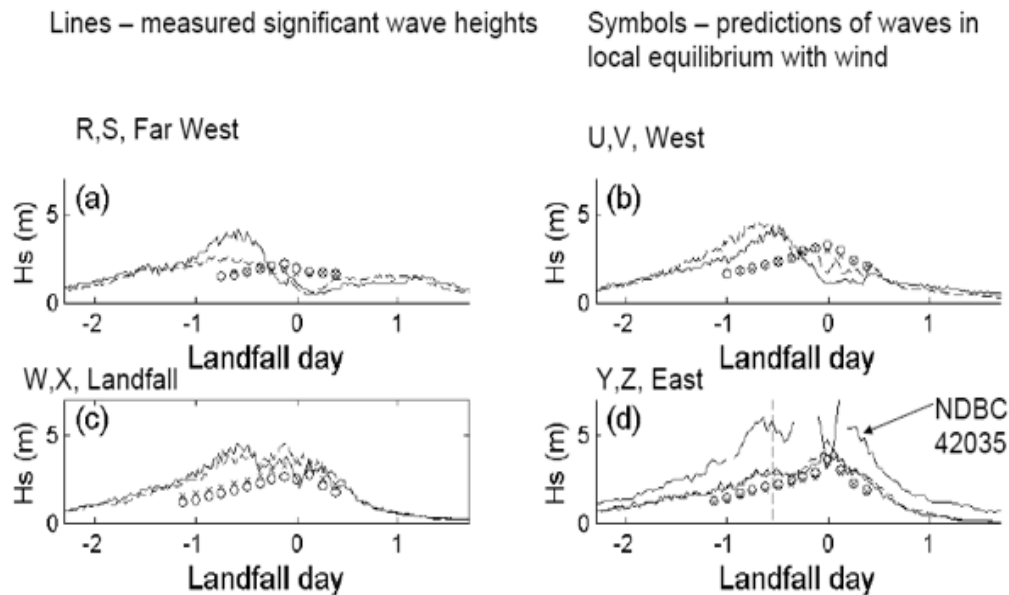
Figure 7 presents measurements of significant wave heights from all eight gauges that provided data along the Texas Coast. Also included are (1) the measured wave heights from NDBC Buoy 42035 that broke its mooring and drifted during the storm and (2) the significant wave heights if the waves were in local equilibrium with the winds at the time. The time axis is relative to “Landfall Day.” It is very interesting to observe that the peak waves occurred from six to 18 hours before landfall. It is very clear that the largest waves were in the region of High Island or the upper end of Bolivar Peninsula.

Figure 7 Significant wave height at all eight Kennedy gauges that recorded waves during Ike.
