### PROBLEMS OF DESIGN AND CONSTRUCTION OF AN OFFSHORE SEAWATER INTAKE

D.W. STANDISH-WHITE<sup>\*</sup>

J.A. ZWAMBORN<sup>\*\*</sup>

#### ABSTRACT

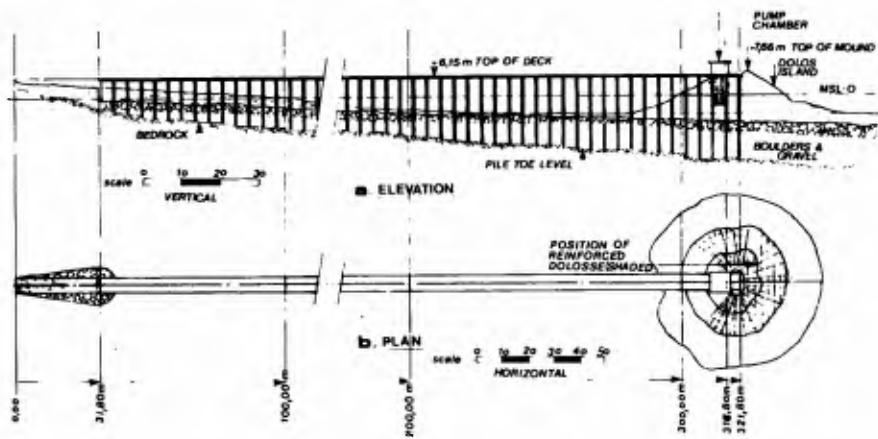
FIG. 3 FINAL JETTY LAY-OUT

After full scale tests on shore, a redesigned special pile which would penetrate down to the bedrock and then allowed for subsequent axial drilling, rock anchoring and grouting was developed. The modified pile toe adopted consisted of a long, thick-walled steel tube with a specially hardened cutting edge (see Fig. 1.b). A new similar jetty 321 metres long (but 1.5m higher) was successfully constructed on this basis adjacent to the old one between September 1975 and February 1976 (see Figs. 2 and 3).
