REPORT ON THE DAMAGES TO THE  
SINES BREAKWATER, PORTUGAL

Possible contributing factors to the 1978 failure of the massive main breakwater at Sines, Portugal are presented in a selective summary of the report of the Port Sines Investigating Panel. A failure scenario involving the impact breakage of unreinforced concrete armor units is developed.

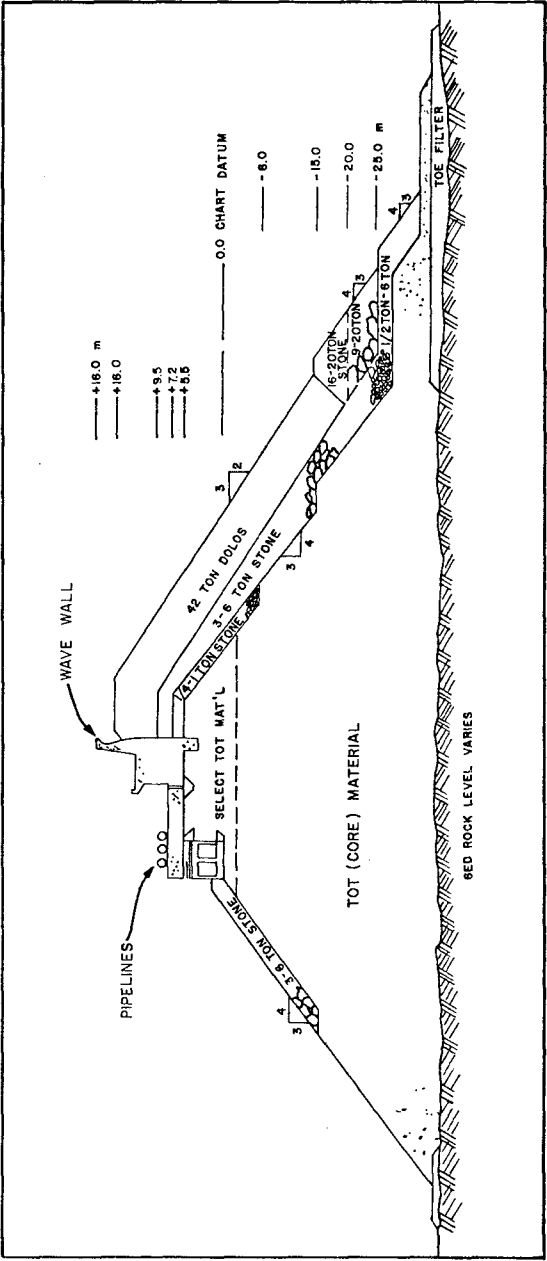
Figure 4 Cross-section of the final design

The breakwater is a dual-purpose structure, supporting oil pipelines as well as providing shelter from the Atlantic for the port. A quarry fill core is armored with heavier-cut stone, and on the seaward side that "selected" stone is blanketed with 42 metric concrete dolos. A concrete superstructure includes a wave wall, an inner (portside) roadway, and support for the oil pipelines. The latter are intended to serve the three harbor-side berths, built on caissons and connected to the breakwater. The three berths, beginning with the closest to shore, are intended to accommodate 100,000, 350,000 and 500,000 DWT tankers, respectively. A cross-section of the final breakwater design is shown in Figure 4.
