## CONSTRUCTION OF A BREACH CLOSURE IN A BARRIER ISLAND

A breach was opened in the barrier beach along the south shore of Long Island, New York during a winter storm in January, 1980. Due to public safety and environmental concerns, a contract to close the breach using sand fill was awarded to a local contractor. This paper discusses the evolution of the construction procedures developed to allow the contractor to successfully complete the project on schedule and on budget.

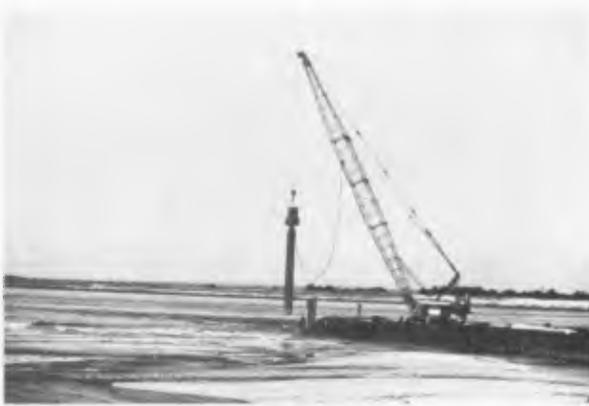
**Figure 7 - Pile Driving Equipment**

Placement of the sheet pile walls was accomplished using a Link Belt 138, 70 ton crane fitted with a vibratory hammer as shown on Figure 7. Construction operations were able to be continued during most weather and sea conditions although at several times the safety of the construction crew guiding the sheet piles into position required shutdown of these activities as shown on Figure 8.

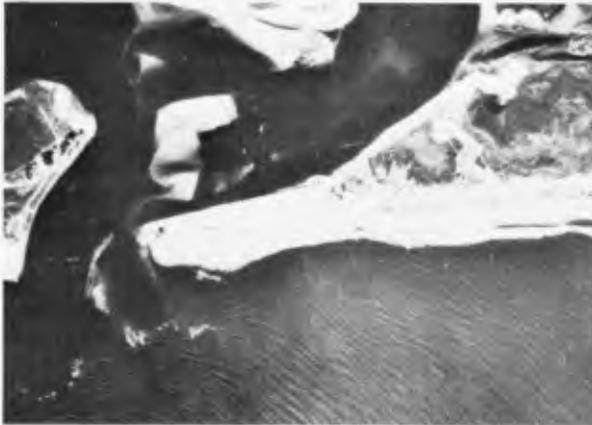
Figure 10 - Construction Progress (12/4/80)

Placement of sand from upland sources and by dredging continued until mid January, 1981. The sheet pile walls were also removed during this period and all construction activities were completed by the beginning of February 1981.
