LONC TERM EXPERIENCE WITH SEAWALLS ON AN EXPOSED COAST

by Orville T. Magoon¹, Joan L. Pope², Robert L. Sloan³, and Donald D. Treadwell⁴

Appropriately designed, constructed, and maintained rubble mound seawalls are an efficient and cost-effective means of protecting erodible sections of exposed coastline. This conclusion is supported by more than 25 years of satisfactory seawall performance along the Pacific Ocean coast of Santa Cruz County, California, U.S.A. Important factors in satisfactory seawall performance include a clear understanding of the oceanographic and geologic design parameters, a vigorous inspection program during construction, and continued observation and maintenance of the structures.

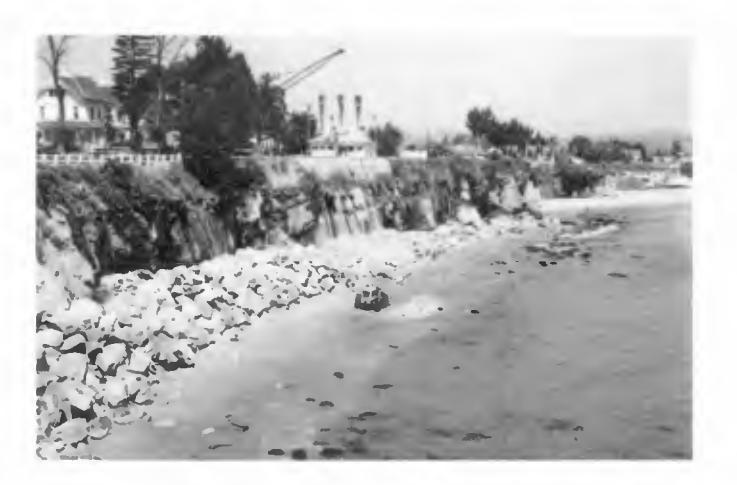
Figure 6 - Seawall during Construction (April 1962)

The plan of protection for West Cliff Drive provided for rubble-mound, or riprap seawalls and/or revetments at critical reaches, totaling about 4,150 feet in length (Figures 6 and 7). These seawalls have a maximum width of 10 feet at an elevation of 17.5 feet above mean lower low water, and a seaward slope of 1 on 1-1/2 after anticipated settlement. The individual face or cap stones have a minimum weight of 4.5 tons so as to resist an anticipated wave 9.5 feet high. In accordance with then current design practices, the core of the seawalls consisted of quarry run stone from 10 to 1,000 pounds with 50 percent greater than 500 pounds. A stone filter blanket was placed prior to placement of larger stone when the thickness of the sand layer at the seaward toe of the seawalls exceeded one foot. The design was predicated on the premise that the (Federal) project could only protect the bluffs from that component of the erosion caused by direct wave action, and that erosion caused by other causes (i.e., surface runoff, wave splash erosion due to geologic causes, etc.) could not be a part
