## CHAPTER 244

### ST. PAUL BREAKWATER, PHASE 1

#### The Project, the Failure and the Subsequent Investigations

Torben Sørensen<sup>1</sup> and Ole Juul Jensen<sup>2</sup>

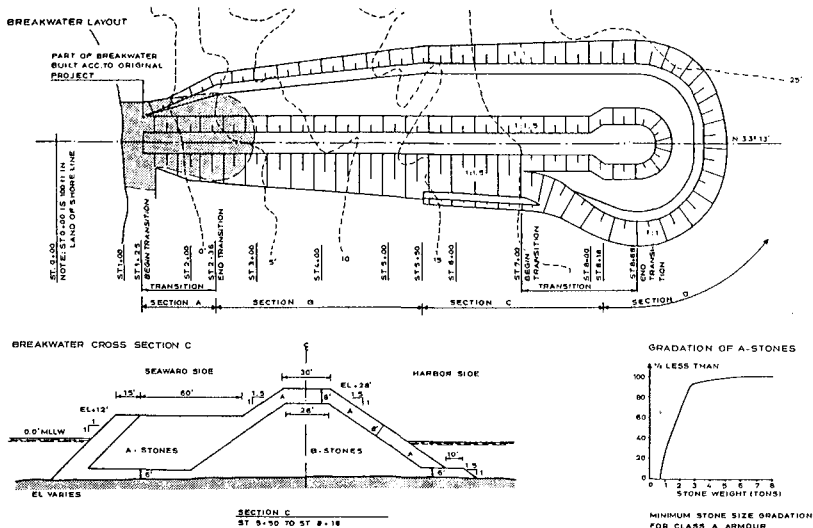
On 20 July 1984, DHI was authorized to perform a model test programme to be executed during the first two weeks of August 1984. This is to be seen on the background that Phase 1 of the breakwater, i.e. the first approximately 900 ft of a 2050 ft long breakwater, should be completed before the start of the winter, presumably before November 1984. The revised breakwater design (Fig. 1) involved only two stone gradations, called A and B-stones. The A-stones, also called the "1-8 t" gradation, were the armouring with a prescribed minimum gradation curve and the B-stones were 0 to 0.5 t quarry run. DHI's final report of September 1984 states the following with respect to the A-stones: "It is recommended that the coarse "1-8 t" gradation used in the tests is made a minimum requirement for construction, understood so that the material built into the breakwater should at no point have a gradation curve below (with smaller stones) than the "1-8" t stones".
