RESULTS OF FIELD MONITORING OF THE NEW CORE-LOC BREAKWATER at PORT ST FRANCES - SOUTH AFRICA

D Phelp ¹, A Holtzhausen ², J Melby ³

Abstract

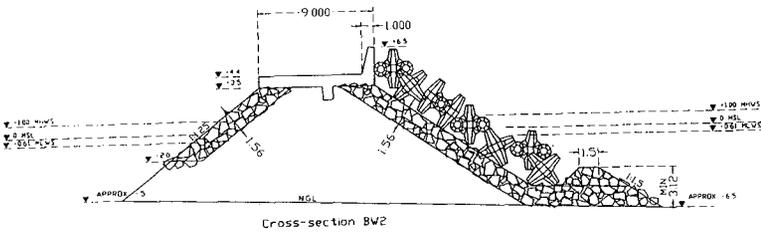
Figure 3: Cross section of the breakwater

The total protective structures include a main outer breakwater and an inner peninsula revetment, both protected by 15 ton Core-locs. The breakwater consists of a rubble mound at a slope of 1:1,5 with 1,5 ton median under-layer rock and a concrete mass capping. A total number of 800 Core-loc units were used plus 20 spare units cast (approximately 560 for the breakwater and 260 for the revetment). The finish level of the mass capping is +4,4 m MSL and splash wall at +6,5 m MSL. The inner slope of the main breakwater is rock protected towards the head (Figures 3 and 4) and abuts directly onto the main harbour quay wall.

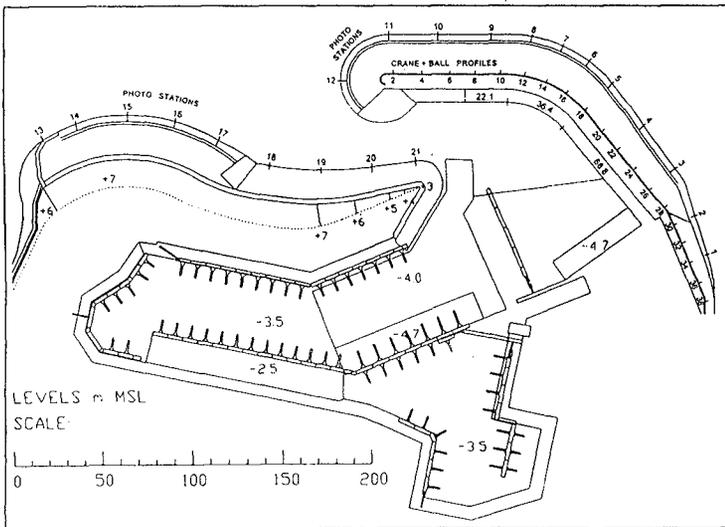
Figure 4: Layout of small craft harbour of Port St Francis -showing the positions of the photo stations and crane and ball profile positions

A "Robinson 44" 4-seater helicopter, was used for the photographic survey. It allowed the camera to be elevated to a position perpendicular to the slope of the Core-loc armouring. Pre-determined coordinates were chosen to give good coverage, with photo stations spaced at 26m centres on the straight sections of breakwater and 13m over the curved sections. Figure 4 shows the layout of the survey stations on both the outer breakwater and inner revetment.

The photographs were taken with a Nikon FM 35 mm camera with a 50 mm lens and using 200 ISO colour film. The photo stations were marked on the breakwater and the revetment and numbered 1 to 12 and 13 to 21 respectively (Figure 4) and were positioned at the centre of each photograph. This allowed for each station to include approximately 50 Core-loc units per photograph. By careful observation of the approaching waves, the photographs were taken at maximum wave draw-down to ensure the maximum area of Core-locs (approximately 90%) exposed, including those toe units located below the still-water line.

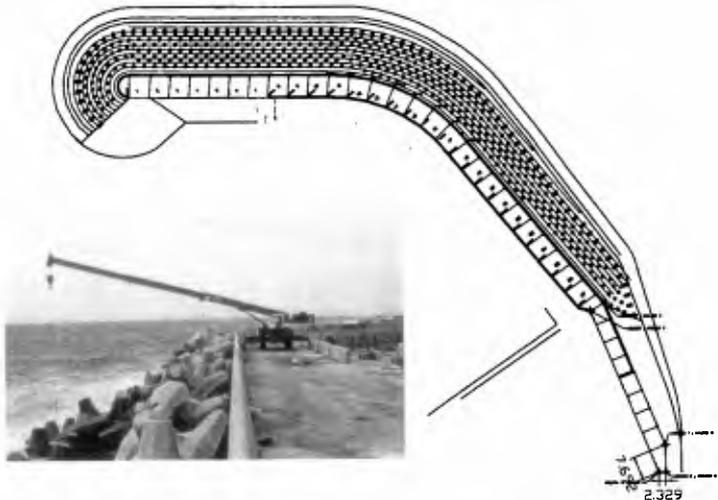
Figure 7: Crane and ball survey stations

A mobile crane with an 18 m reach was used for the “crane and ball survey”. The radius of the ball used for the survey was 1 metre. The survey was carried out by positioning that crane at each station (Figure 7) with the boom perpendicular to the breakwater. The profile of the Core-loc armour units was then measured by suspending the ball from the boom by a calibrated staff. Starting from the splash wall the levels were measured at 3 m intervals, horizontally along the boom.
