DAMAGE ALONG COASTS IN SENDAI BAY CAUSED BY THE 2011 GREAT TSUNAMI

Kazuya Sakai¹, Takaaki Uda¹, Toshiro San-nami² and Tatsuya Shimizu³

Keywords: 2011 Great Tsunami; tsunami damage; trench formation; coastal dike; coastal forest

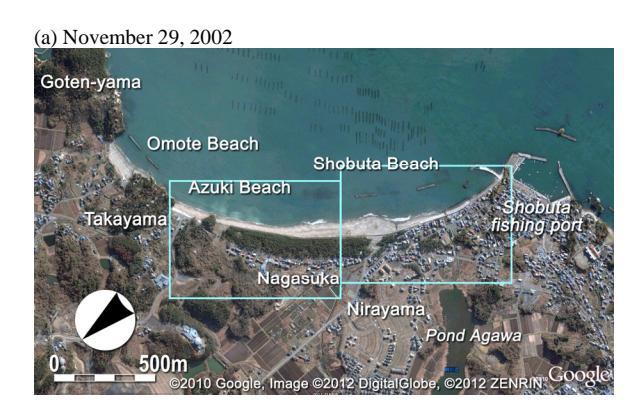
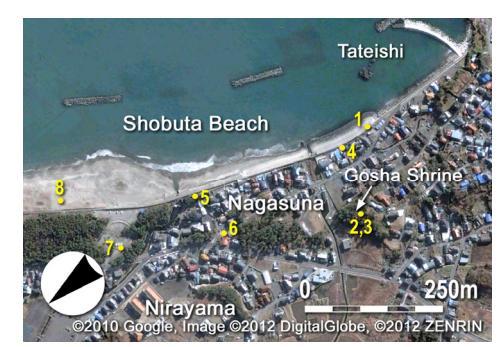
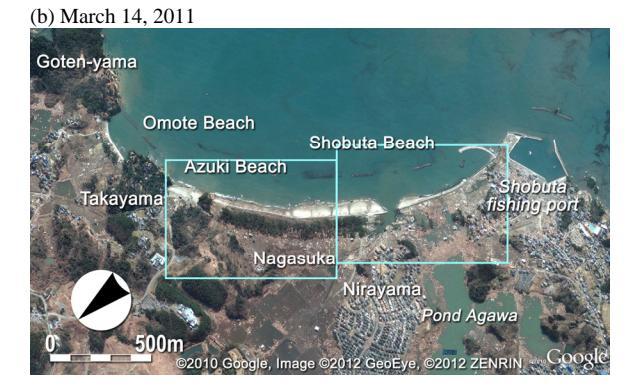
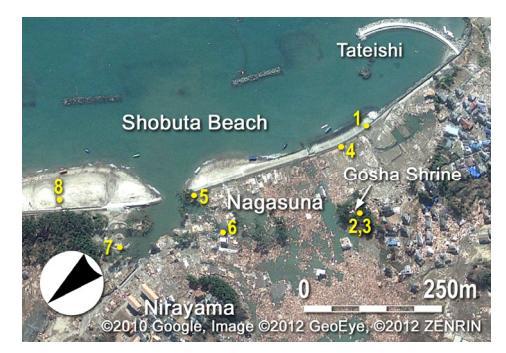
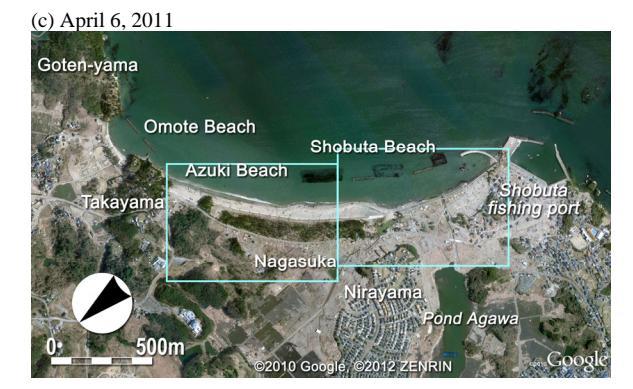
Figure. 3. Satellite images of Shobuta Beach taken on November 29, 2002, March 14, 2011, immediately after the tsunami, and on April 6, 2011.

Comparing the satellite images in Figs. 3(a) and 3(b) taken in 2002 and on March 14, 2011, respectively, it is observed that a curved groin next to Shobuta fishing port had already been constructed with a total length of 200 m, and many houses had been built in the hinterland of Shobuta Beach before the tsunami. A massive tsunami hit these areas, resulting in major damage to the coastal area and destroying many houses built along the coastline. The largest change was the breakdown of the coastal dike in front of Nirayama Town owing to the tsunami return currents, leaving a deep wedge-shaped scouring hole in the hinterland. The breakdown of the coastal dike occurred at the opening of the detached breakwaters, implying that the tsunami currents concentrated there.

In Fig. 3(c) taken on April 6, 2011, the opening of the coastal dike formed by tsunami currents was buried by the sand transported from both sides to the opening. The beach width increased in the area between the north end of Shobuta Beach and Azuki Beach. Because this area is a pocket beach with a closed system with no sand supply by longshore sand transport, shoreward sand transport was assumed to occur under calm wave conditions after the tsunami, resulting in sand deposition near the shoreline. Since the image in Fig. 3(c) was taken in a period when the sea water was transparent, artificial reefs placed between the detached breakwaters on the shallow seabed can be clearly identified.

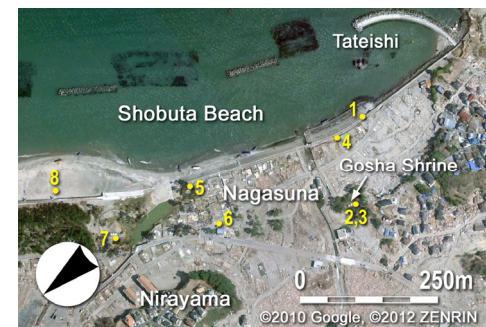
Figure. 4. Enlarged satellite images of southern Shobuta Beach.

On April 20, 2011, site observation was carried out on Shobuta Beach to investigate tsunami damage from the south end to the north end of the beach. Figure 4 shows enlarged images of the rectangular area shown in Fig. 3 with the location of the observation points. The number in each image corresponds to the number of the site photograph.

Photo 4 shows the scouring hole formed by the overflow of the tsunami over the top of the coastal dike, where houses had been built, as shown in Fig. 4(a) before the tsunami. All the houses were destroyed by tsunami currents. Photo 5 shows the site of the complete breakdown of the coastal dike, as shown in Fig. 4(b). A large hole was formed by the tsunami currents that broke down the concrete coastal dike.

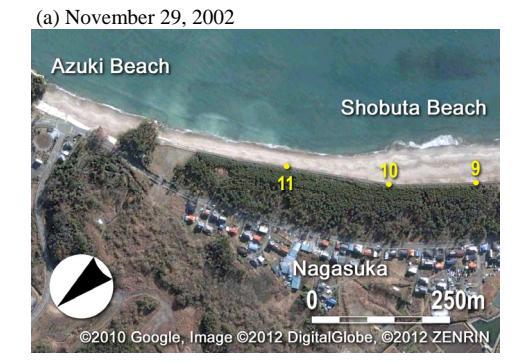
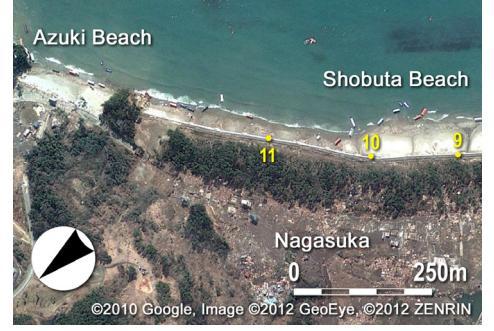
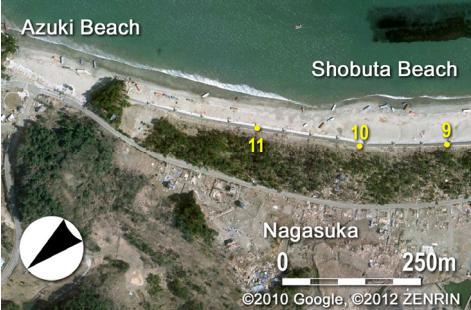
Figure. 5. Enlarged satellite images of northern Shobuta Beach.

Figure 5 shows the northern half of Shobuta Beach with the numbers of observation points. All the houses in Nagasuka Town built behind the coastal forest of 100 m width were entirely destroyed. Because this town had been protected by the coastal dike and a densely planted coastal forest, people believed that this area would be safe against tsunamis, but in reality, all the houses were destroyed by the tsunami along with the destruction of the coastal pine trees, suggesting the limited effectiveness using pine trees as a defence against tsunamis.

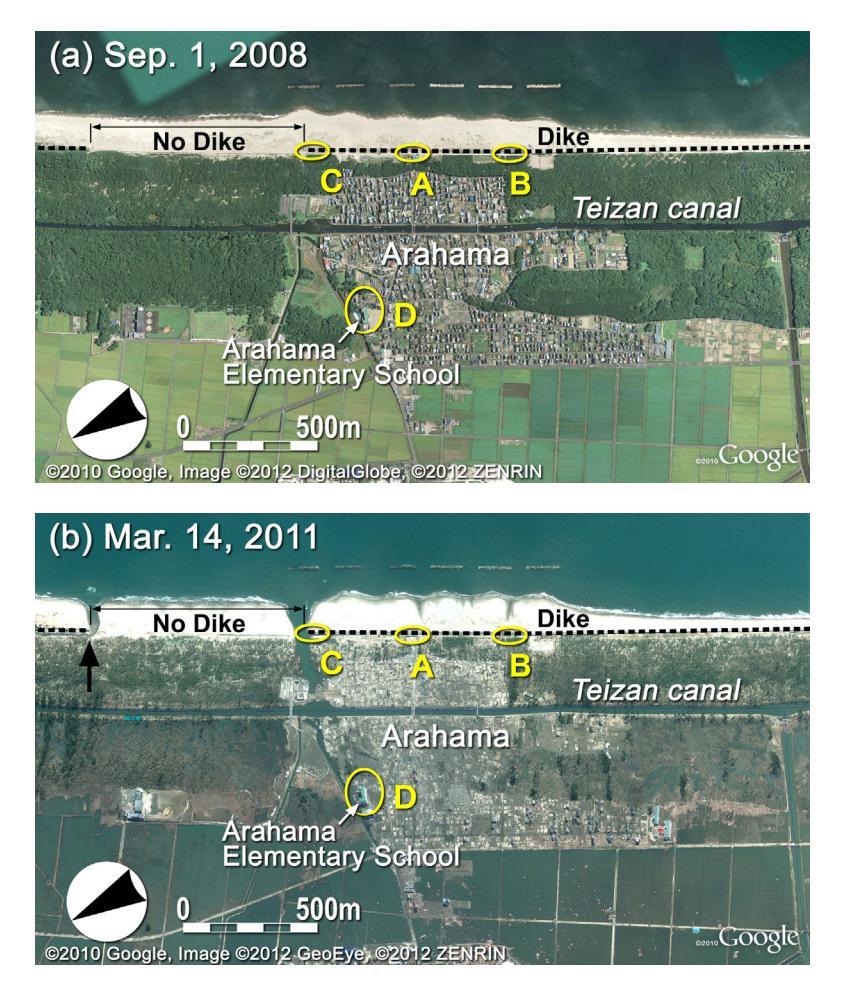
Figure. 6. Satellite images of Arahama Town obtained on September 1, 2008 and on March 14, 2011.

The residential area in Arahama Town was completely destroyed; in particular, the houses were destroyed to their foundations in the seaward area of the canal, and sand was deposited over the debris of houses, which was transported by landward tsunami currents. Although the coastlines north and south of the detached breakwaters continuously extended before the tsunami, as shown in Fig. 6(a), the sandy beach in the lee of the north detached breakwater disappeared, and a channel of 80 m width was formed by the tsunami (Fig. 6(b)). This channel expanded a long distance landward as a wedge along the north end of the residential area in Arahama Town. The location of the newly formed channel is superimposed on the junction between two small rivers, at which the two rivers obliquely joined each other before the tsunami (Fig. 6(a)), suggesting that its elevation was relatively low. The return flow of tsunami that deeply inundated inland areas was partly blocked by the coastal dike, causing longshore return flow along the coastal dike. The concentration of this flow is assumed to be one of the reasons for the formation of the channel. Once the channel had formed, the return flow of the tsunami is expected to have become further concentrated in this channel. A similar channel perpendicular to the shoreline was formed 800 m north of this channel, as shown by a black arrow in Fig. 6(b).

Photo 12 shows a large scouring hole formed at the south corner of a public restroom located at the entrance to the beach seaward of point A in Fig. 6. At the corner of the building, a large scouring hole of 3 m depth, directed slightly northward, was formed; the depth was greatest at the corner of the building and gradually decreased landward. Sand was not deposited in the vicinity of this hole, implying that sand was transported further landward by tsunami currents.

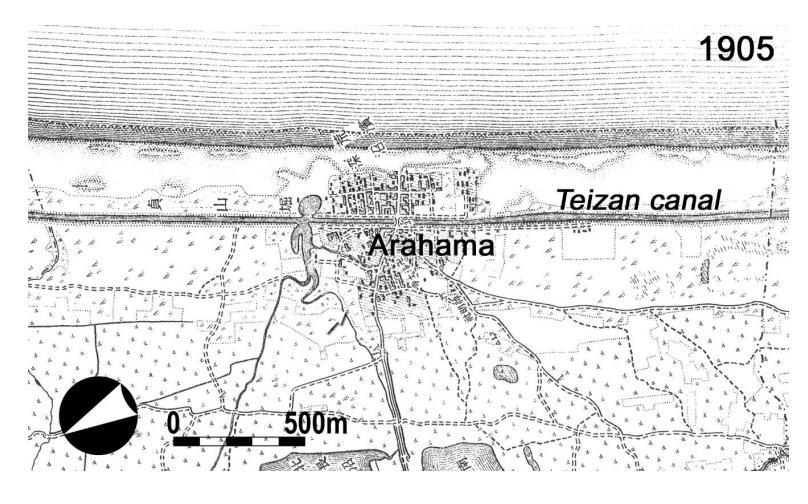
Figure. 7. Old map of Arahama Town produced in 1905.

The condition of the area approximately 100 years ago was indicated in an old map produced in 1905. Figure 7 shows that the residential area seaward of the canal had not been developed recently; it already existed in 1905 in the Meiji era. This old map was produced nine years after the great Sanriku Earthquake in 1896.

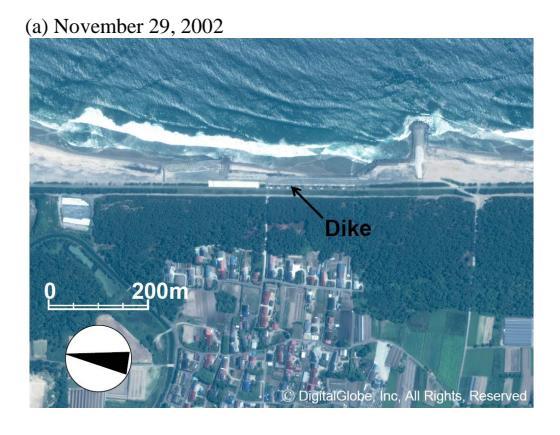
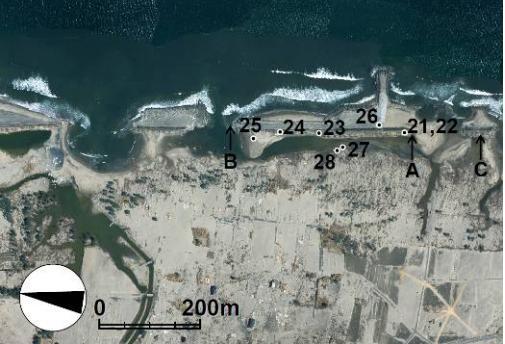
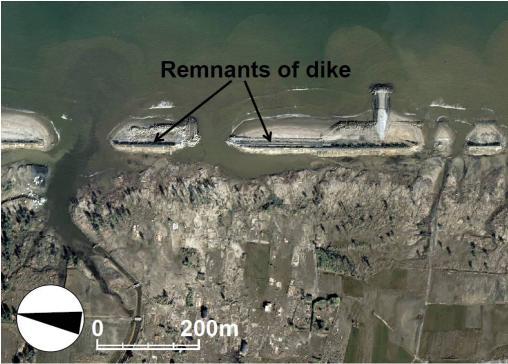
Figure. 8. Satellite images of Yamamoto coast and locations where photographs were taken.

Photo 22 shows the coastal dike and a trench north of point A. There was no deformation of the asphalt pavement of the crown, although the pine trees planted on the seaward slope of the dike were uprooted. In contrast, the back slope of the concrete dike was destroyed, and a trench of 50 m width was formed inland of the destroyed back slope. The destruction of the back slope was considered to be due to the local scouring at the toe of the back slope and the suction of the sediment that filled the dike when the tsunami flooded over the dike. Photo 23 shows the damage to the crown in an area further north. The back slope, as well as the asphalt pavement, was much more severely damaged than that in the southern part. Approaching the north end of the coastal dike (point B in Fig. 8(b)), the coastal dike was destroyed and almost the entire crown of the dike collapsed (Photo 24).

Photo 25 shows the cuspate foreland behind the coastal dike, which was formed near point B, as shown in Fig. 8(b). Because the partly destroyed coastal dike functioned as an impermeable detached breakwater, a large-scale cuspate foreland was formed behind the partly destroyed dike. In contrast to the severe damage to the back slope, no major changes were observed on the seaward slope, as shown in Photo 26.

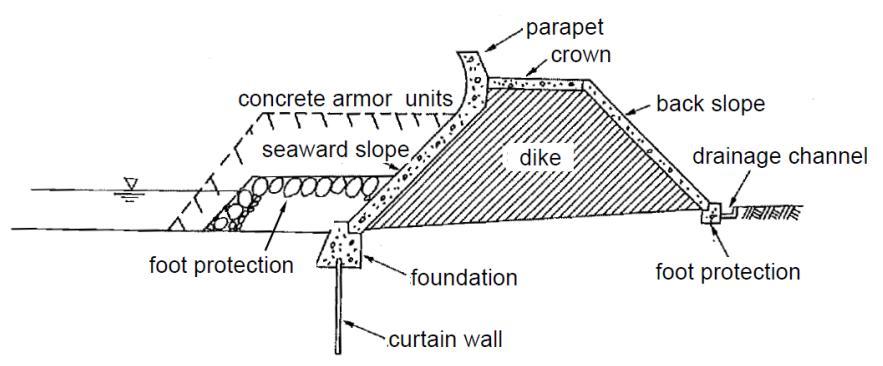
Figure. 10. Typical cross section of coastal dike based on Japanese shore protection manual.

The general cross section of a coastal dike in the design manual of shore protection facilities in Japan is shown in Fig. 10. On the toe of the seaward slope of the dike, a curtain wall must be built because the seaward slope is expected to be subject to strong wave action, and there is only a small amount of foot protection and a small drainage channel at the tip of the back slope. Considering wave overtopping, the top of the dike and the back slope must be protected using concrete, as indicated in the Japanese design manual. However, regarding the back slope, there is no suggestion that large scouring may occur at the toe of the back slope. Thus, the back slope is considered a weak point of the structure against local scouring behind the dike during a tsunami with a height exceeding the crown height.
