TSUNAMI DAMAGES OF NAKOSO COAST DUE TO THE 2011 TOHOKU TSUNAMI

A post-2011 Tohoku earthquake tsunami survey was conducted at the Nakoso Coast, Fukushima Prefecture, Japan, on Mar 24-25 and Apr 1-2, 2011. Spatial distribution of the tsunami inundation height, together with the seawall height and damages, was investigated. We found a sharp contrast of tsunami damages within the target area; tsunami damage is the most serious in the north region (north of the Samegawa River) where seawalls with different heights played diverse roles for protection of local community. A relatively high seawall in this region kept intact after tsunami attack, and protected the lee side human properties; whereas, 71% of the low seawalls were broken during the tsunami and the disaster developed in the corresponding sheltered area. A sharp contrast at the boundary of these two types of seawalls was observed. Behind the high seawall, the tsunami intensity and velocity were significantly reduced and the inundation depth is only 0.6 m. Nevertheless, tsunami intensity was enhanced in the seawall-broken area with an inland inundation depth being 4.7 m, which ruins away the local houses. In the middle region be

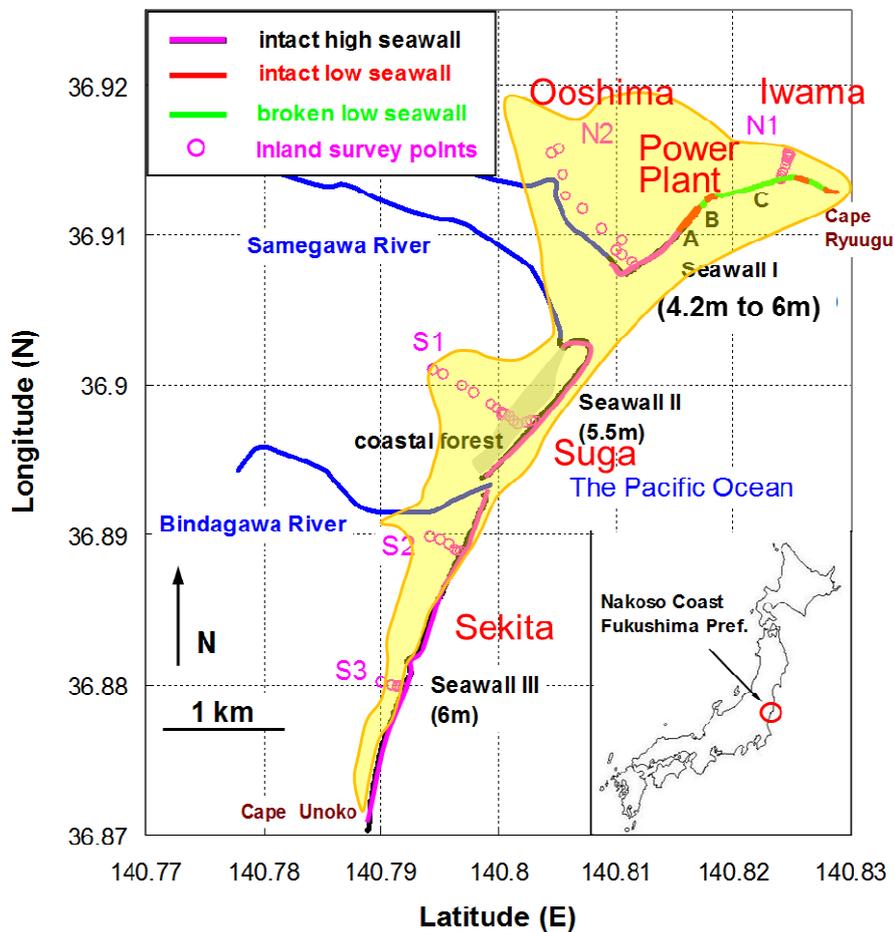
Figure 1. Field survey at the Nakoso Coast, Fukushima Prefecture, Japan; Yellow zone represents inundation. The coastal area is divided into five districts, Iwama, Power Plant, Ooshima, Suga and Sekita Districts

corresponding to the north of the Samegawa River, Seawall II corresponding to the area between the Samegawa River and the Bindagawa River, and Seawall III corresponding to the south of the Bindagawa River. Subsequently, five survey lines behind the seawall, *i.e.*, N1, N2, S1, S2 and S3 in Fig. 1, were also considered to estimate the tsunami damping along the cross-shore direction.
