DESTRUCTIVE WAVE OVERTOPPING TESTS ON GRASS COVERED LANDWARD SLOPES OF DIKES AND TRANSITIONS TO BERMS

Gosse Jan Steendam¹, Jentsje W. van der Meer², Bianca Hardeman³, André van Hoven⁴

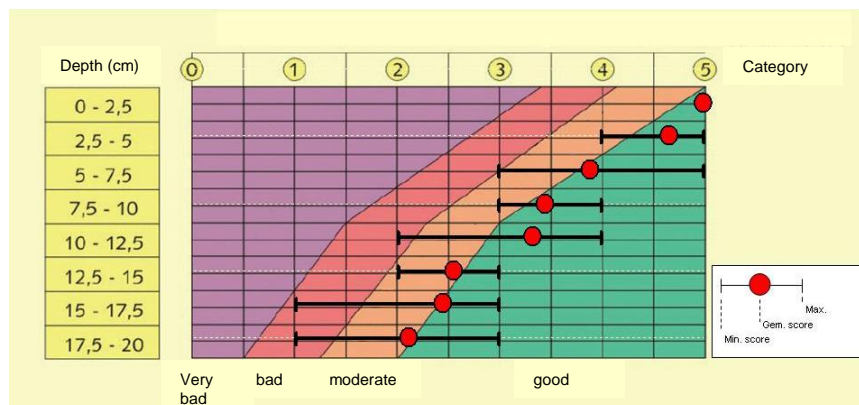
Figure 3. Average score according to VTV2006 of quality of the root system, February 2009

Figure 3 shows that the root system at the Afsluitdijk was in a good condition (average number of roots, represented by categories, in each depth segment in the green area). Also it was found that the quality during winter did not decrease. With that it has to be noticed that the winter of 2008 / 2009 was very moderate with temperatures just incidentally below freezing point. Nevertheless, also during other winters it has been seen that the root system stays in fairly good condition in the Dutch climate. The same results were found at the Vecht dike.

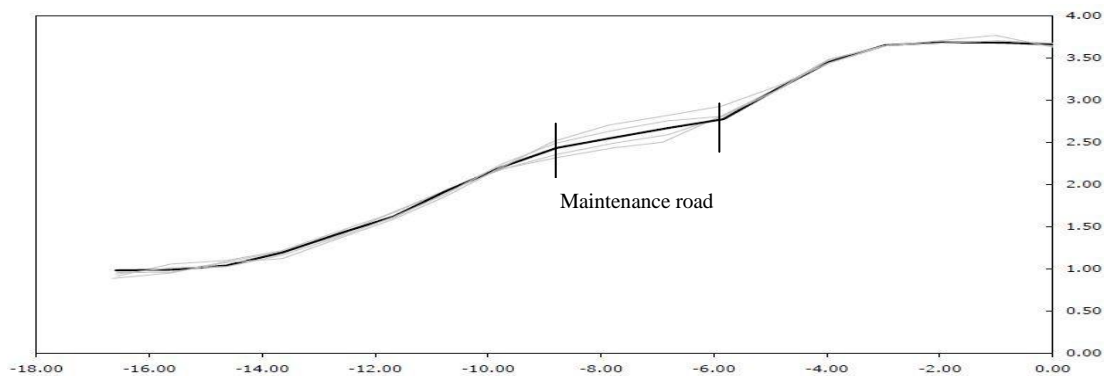
Figure 17. Cross section V1 (measures in meters)

Just above the maintenance road deep track was present, showing a vertical ridge against the concrete bricks.

Results of test series V1. During the 1 l/s per m test initial damage developed at the vertical ridge just above the maintenance road. These damages evolved slowly at 10 l/s per m (Figure 18) and at 30 l/s per m these damages developed to two substantial holes undermining the road. (Figure 19).

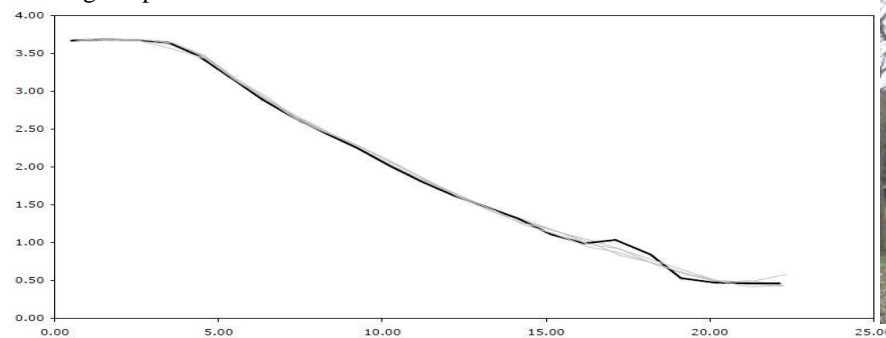
Figure 22. Cross section V2 (measures in m)

At the second test section at the Vecht dike a large tree (trunk 0.8 m wide) was present at the toe of the dike (Figure 21). Figure 22 shows a cross section. This cross section shows the slope to be somewhat hollow with the bump marking the position of the tree.

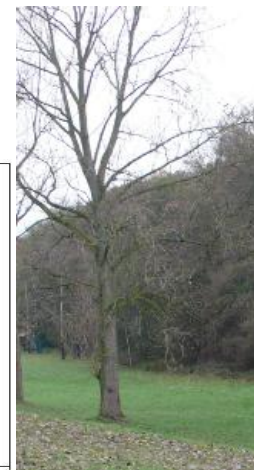
Figure 21. Tree at the landward berm

Results of test series V2. At the 5 l/s per m test the grass cover around the tree disintegrated showing a lot of near surface roots from the tree. The damage developed fast at the 10 l/s per m test (Figure 23).

In the 30 l/s per m test the surface of the slope did not change much. The damage at the tree increased. In the next test (50 l/s per m) the damage at the tree expanded to over 4 m² and sand was washed out. The test was stopped after 5½ hours; the dike at the tree was considered to have failed (Figure 23 on the right).
