CHAPTER 3

STORM SURGE EFFECTS AT LEIXÕES

by C. Campos Morais, research officer

Laboratório Nacional de Engenharia Civil, Lisboa, Portugal

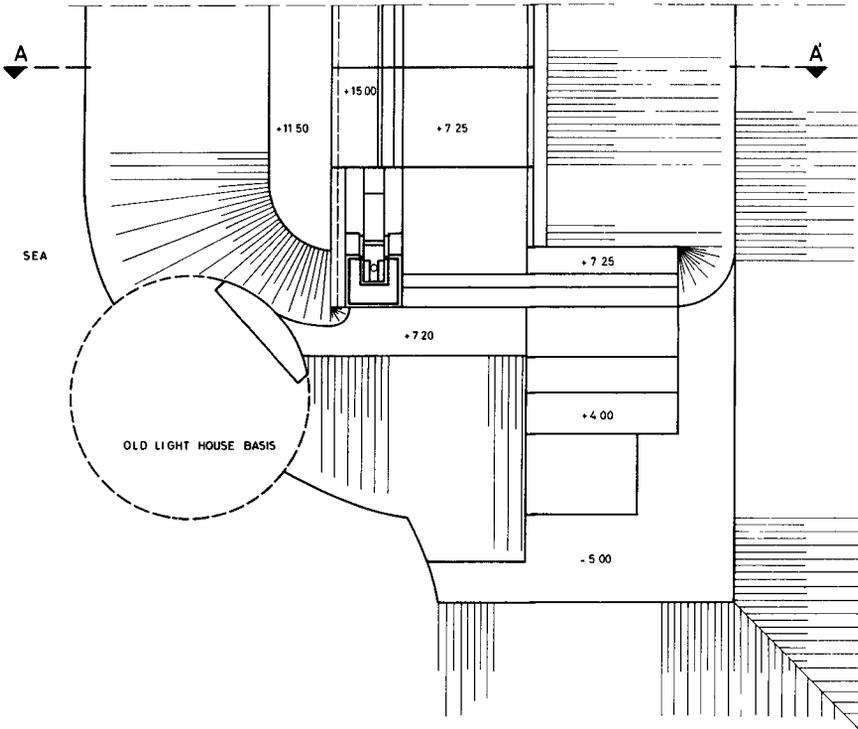
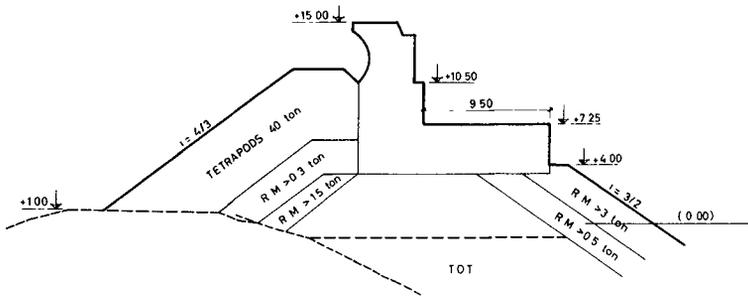
Fig. 3 - Head and cross-section of North breakwater

The harbour construction started in 1884-1892 ; it was formed at that time only by the outer basin. In 1937-1941 the n^o 1 inner dock and the outer breakwater, as a submerged breakwater, with a top elevation of +1 m above datum were built (datum is arbitrary, a few centimeters below the minimum low water level, astronomical spring tides). The cover layer of the breakwater was formed by concrete cubic blocks of 90 metric tons. The construction of the n^o 2 inner dock started by the end of the fifties and is still in expansion. In 1971 the outer breakwater was raised until +15 m, in order to create behind it a crude oil terminal for 100,000 tdw tankers. This raising was carried out by means of a sloping mound structure, the cover layer of which, with an upper berm at elevation +11.50 m is formed by 40 metric tons tetrapods (fig. 3); between +11.50 m and +15 m there is a concrete superstructure with a curved face looking seawards.

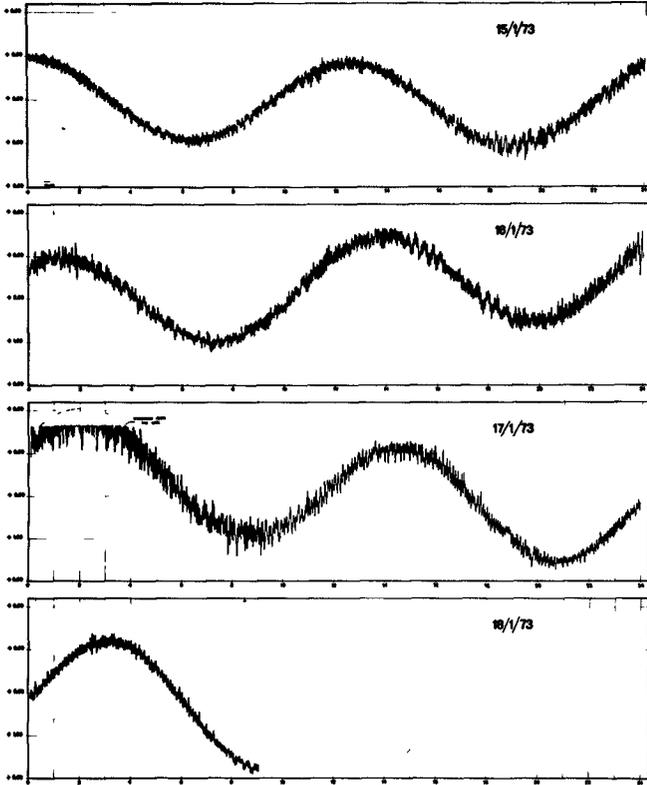
Fig. 8 - Tide record

If the tide record is searched (fig. 8) for long period waves and the part of the record that corresponds to the occurrence of the storm surge (fig. 9) is more carefully inspected, it is possible to observe that waves with periods of about 4, 8, 16, 20 and 40 minutes were present, with rather significant amplitude. The more persistent wave is the 4 minutes one, more precisely 220 s.

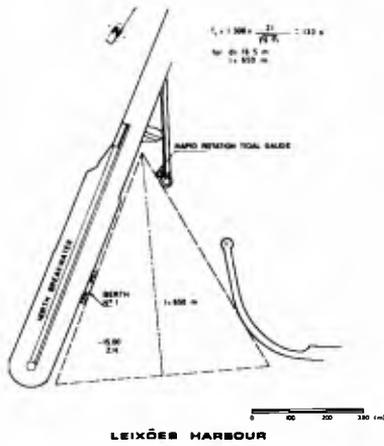
Fig. 20 - Hypothetical
ressonant area

A possible hypothesis for predicting the resonance period consists in considering the water mass limited by the outer breakwater, the north breakwater of the outer basin and the end of its south breakwater as a triangular wedge (fig. 20). For $d = 16.5$ m and $l = 650$ m
